Geological Report

APN 588-311-009 (Vacant Lot) Fault Hazard Study

Yucca Valley, California

Fault Hazard Evaluation
APN 588-311-009 (Vacant Lot)
Yucca Valley, California
LCI Project No. LP04125

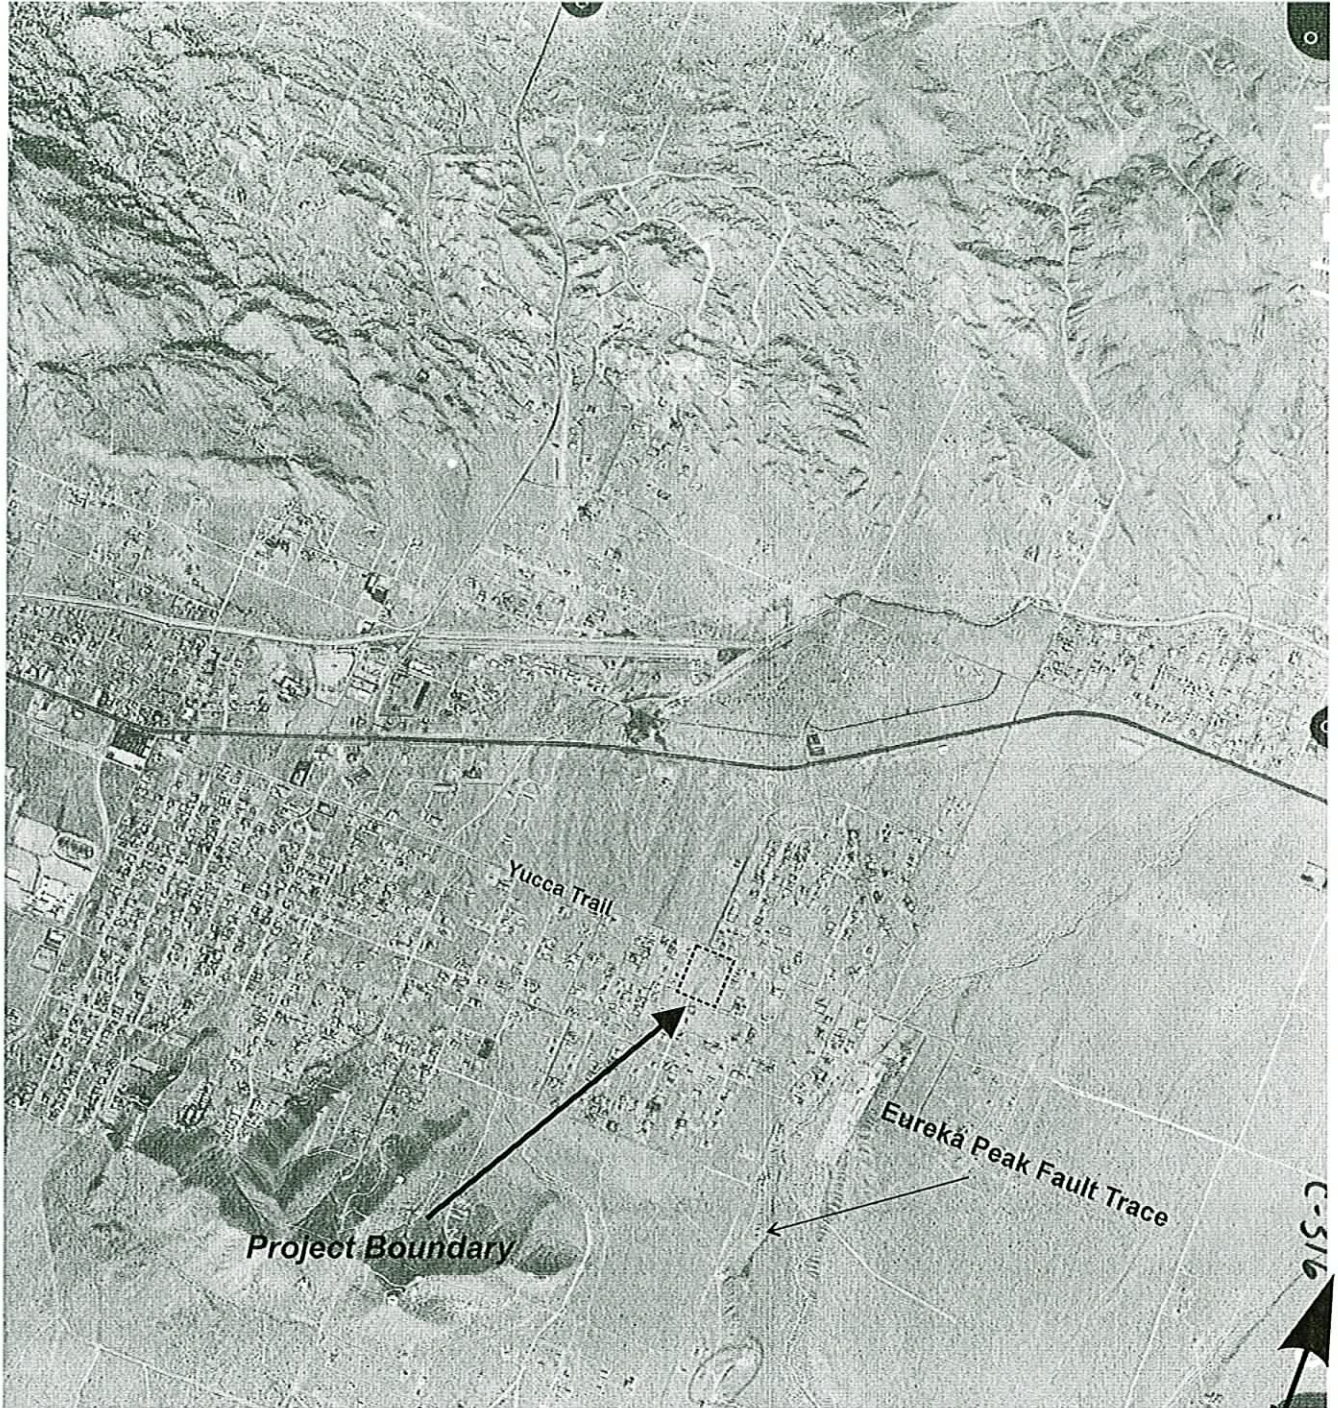
Plate
A-7

Stereoscopic aerial photographs dated 1964, 1977, 1989, and 1993 were reviewed as part of this investigation. A faint lineament was noted in the 1977, 1989, and 1993 aerial photographs (Plate A-7 through A-9) that likely corresponds to the delineated trace of the Eureka Peak Fault. The lineament was most readily noted along the west side of a stream channel near Palomar Avenue southeast of the project site. No lineaments were noted within the project site area on the aerial photographs reviewed.

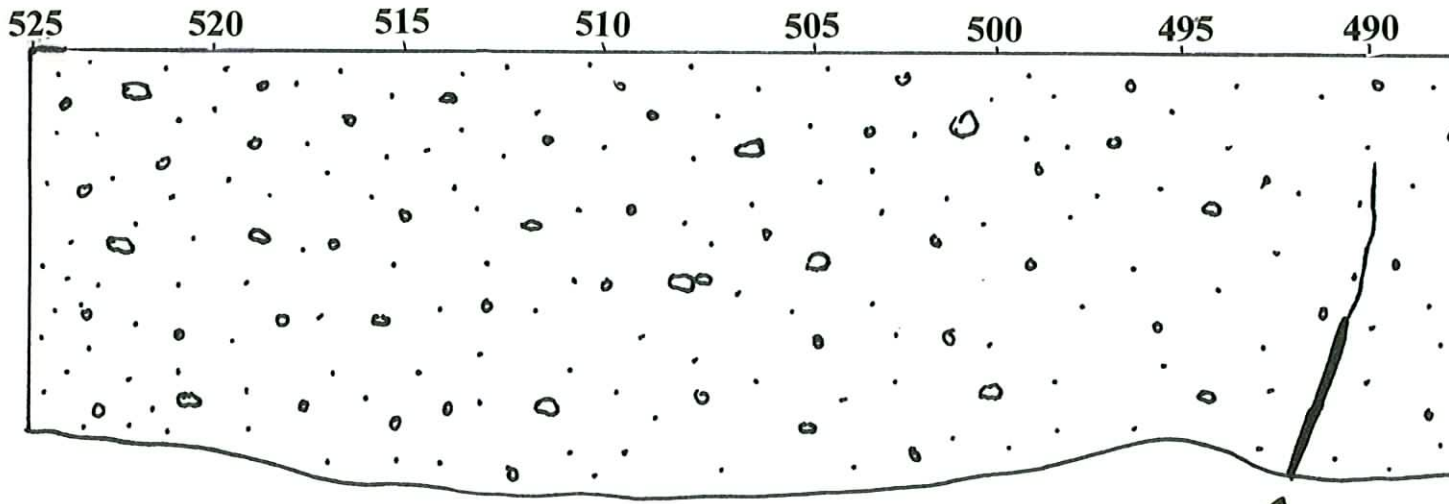
Fault N22W, 75W

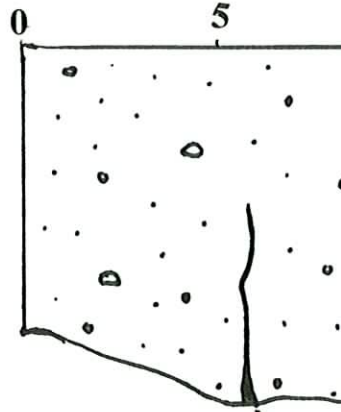
Fault N22W, Vertical

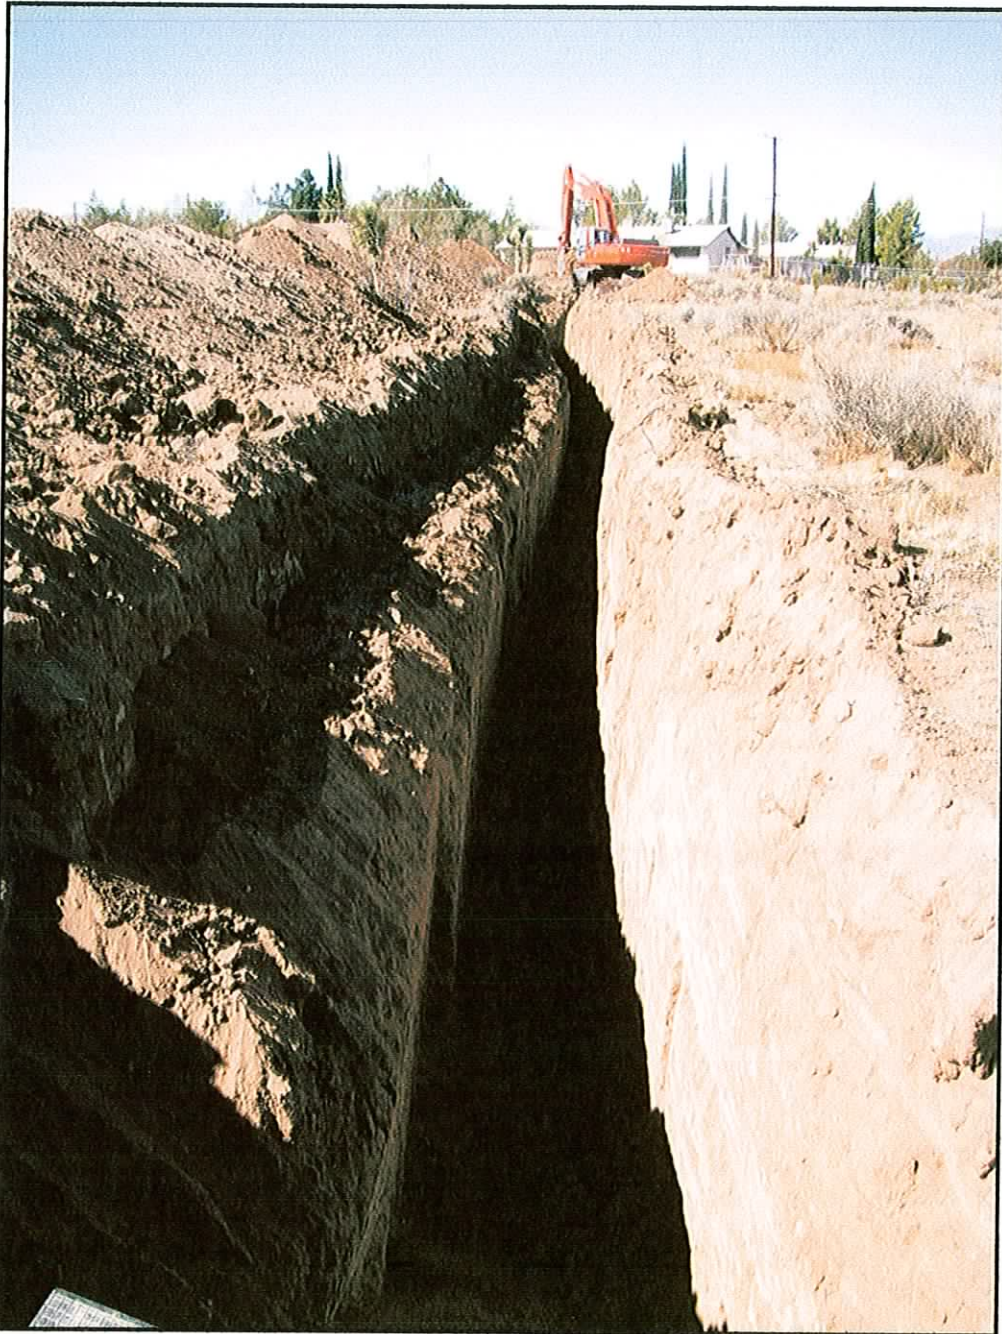
Trench 2 was approximately 565 feet in length, crossing the site diagonally from the east to the west and traveling in a northeast-southwest direction. The western portion of the trench was sited perpendicular to the mapped trace of the Eureka Peak Fault on the project site. A fault trace was located approximately 85 feet east of the western property boundary and 160 feet north of the southern property boundary. The trace was marked by carbonate precipitates along the rupture zone on the north and south trench walls.

Photo 1: Fault trench No. 2 located across the site traveling in a southwest-northeast direction. A discernable fault trace was located within the trench near the southwest.

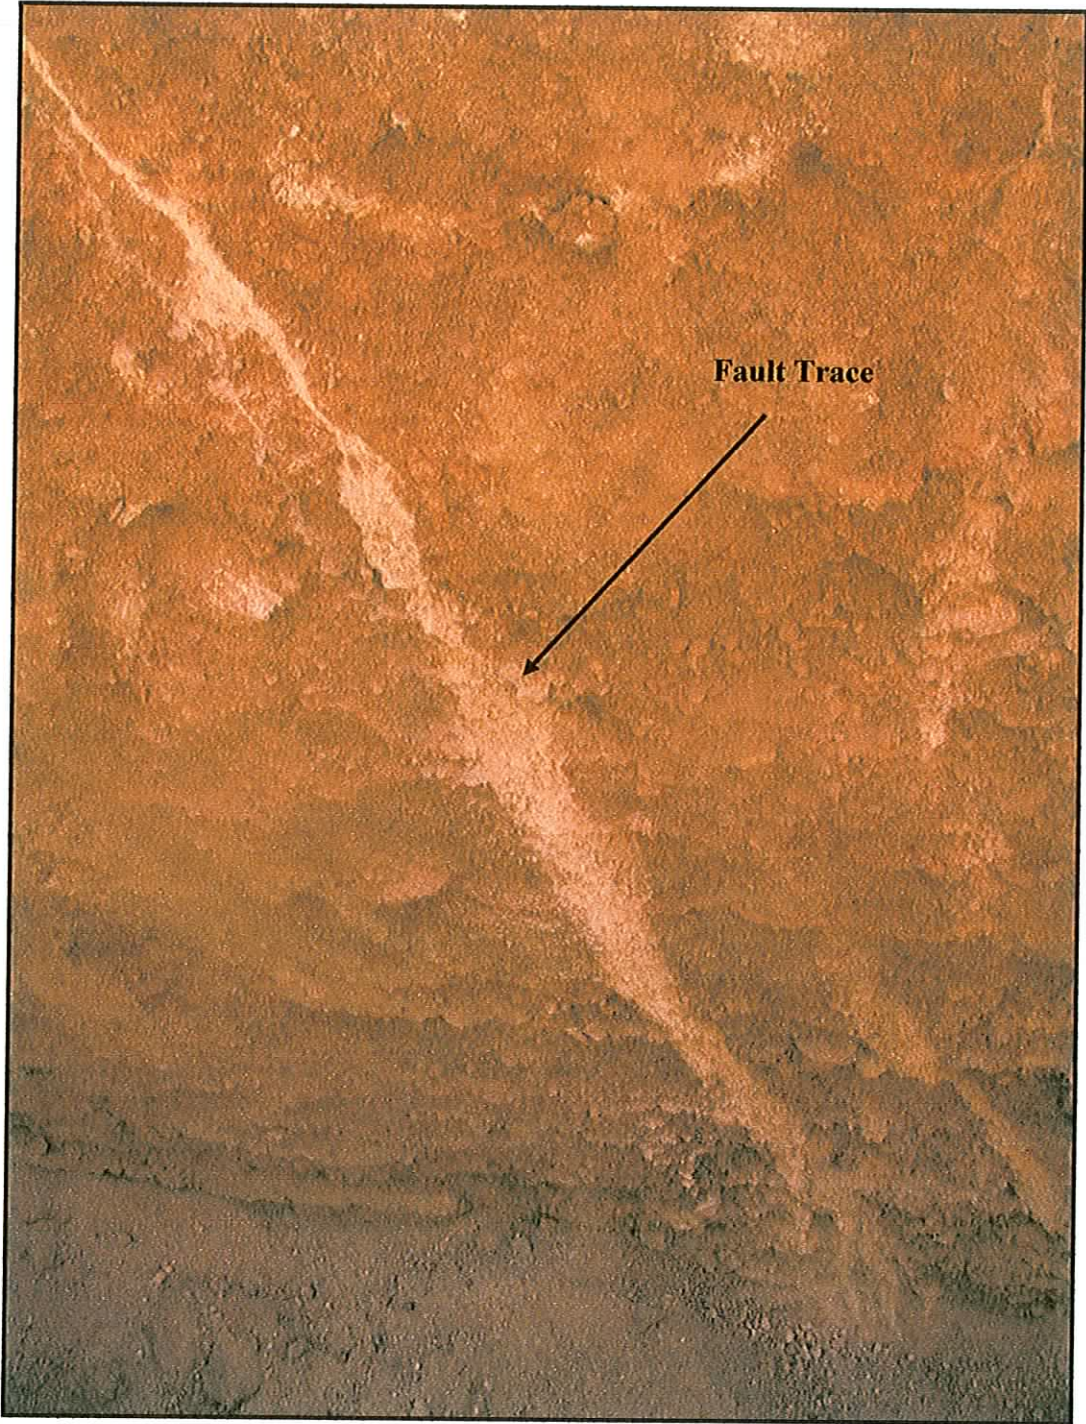
- Fault traces were encountered in two of the exploratory trenches excavated at the project site. The fault trace strikes approximately N22W and dips 75 degrees west to near vertical, which is consistent with the mapped trend of the Eureka Peak Fault in this area.

Photo 2: Fault trace on south sidewall at approximately 490 feet within Trench T-2.

- The potential for fault related ground rupture during the lifetime of the planned development is considered high along the trace of the Eureka Peak Fault. Ground rupture may also occur on fault splays proximal to the main fault trace. The fault trace was observed within one to two feet of the surface fading out in the near surface soils indicating recent ground rupture at the project site. *A minimum setback of 50 feet from the mapped main fault trace is recommended to incorporate potential undocumented fault splays.*

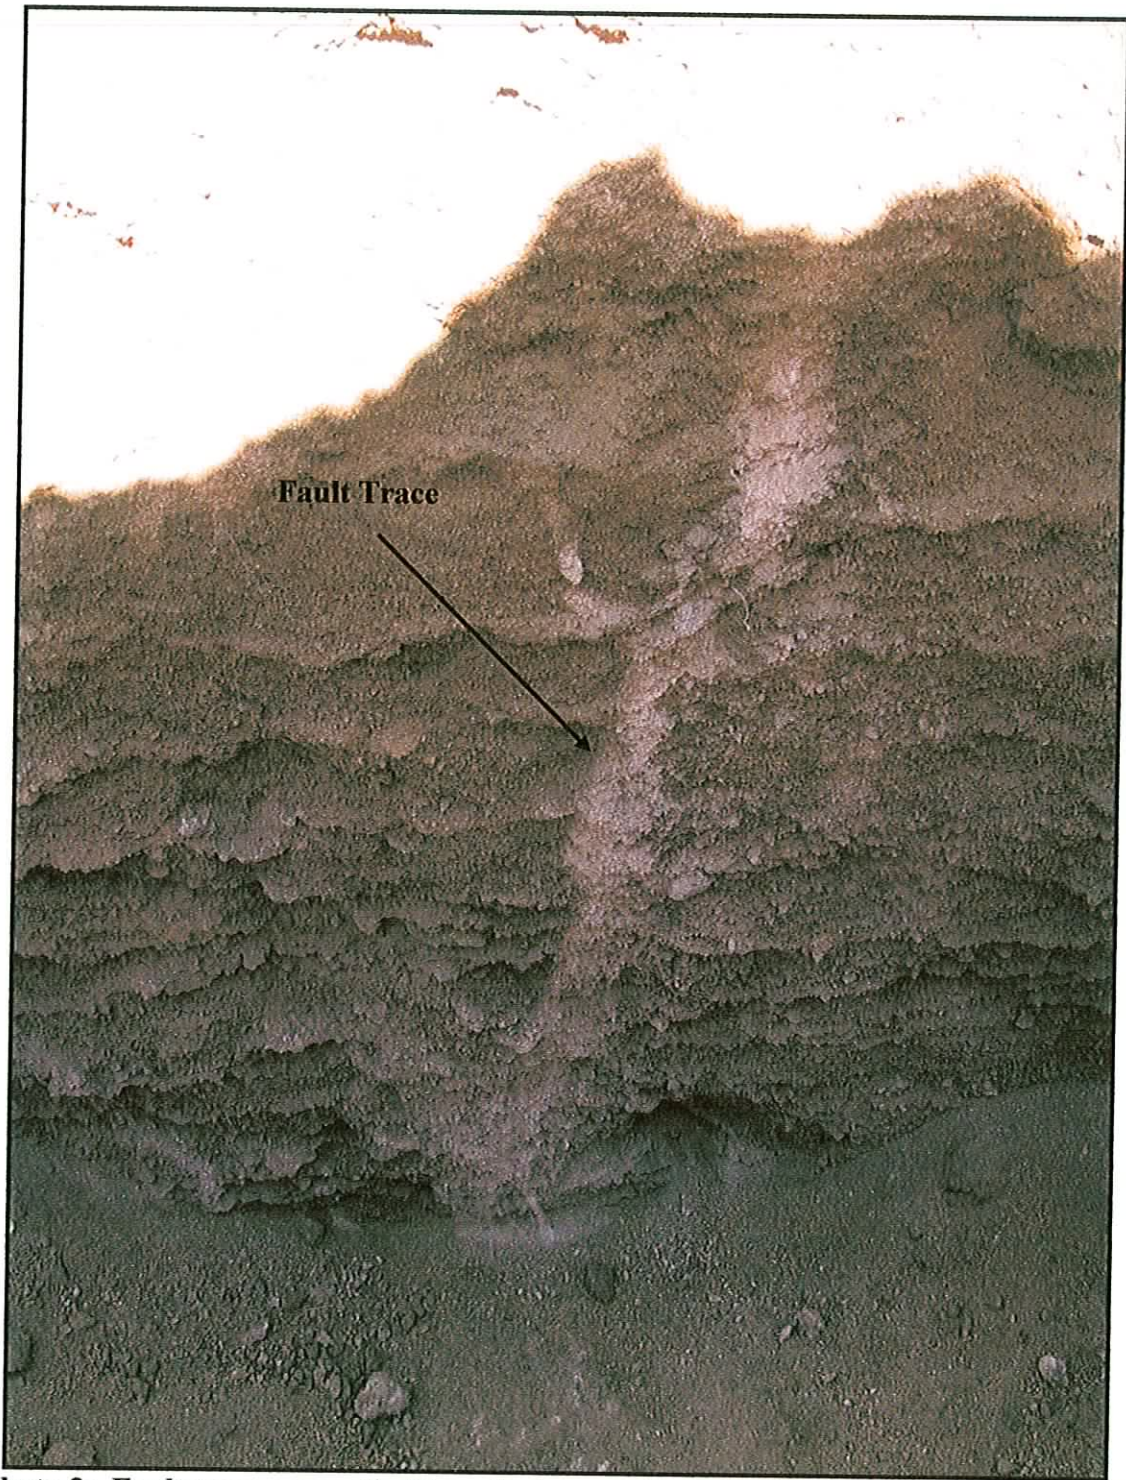
Photo 3: Fault trace on north sidewall at approximately 490 feet within Trench T-2.

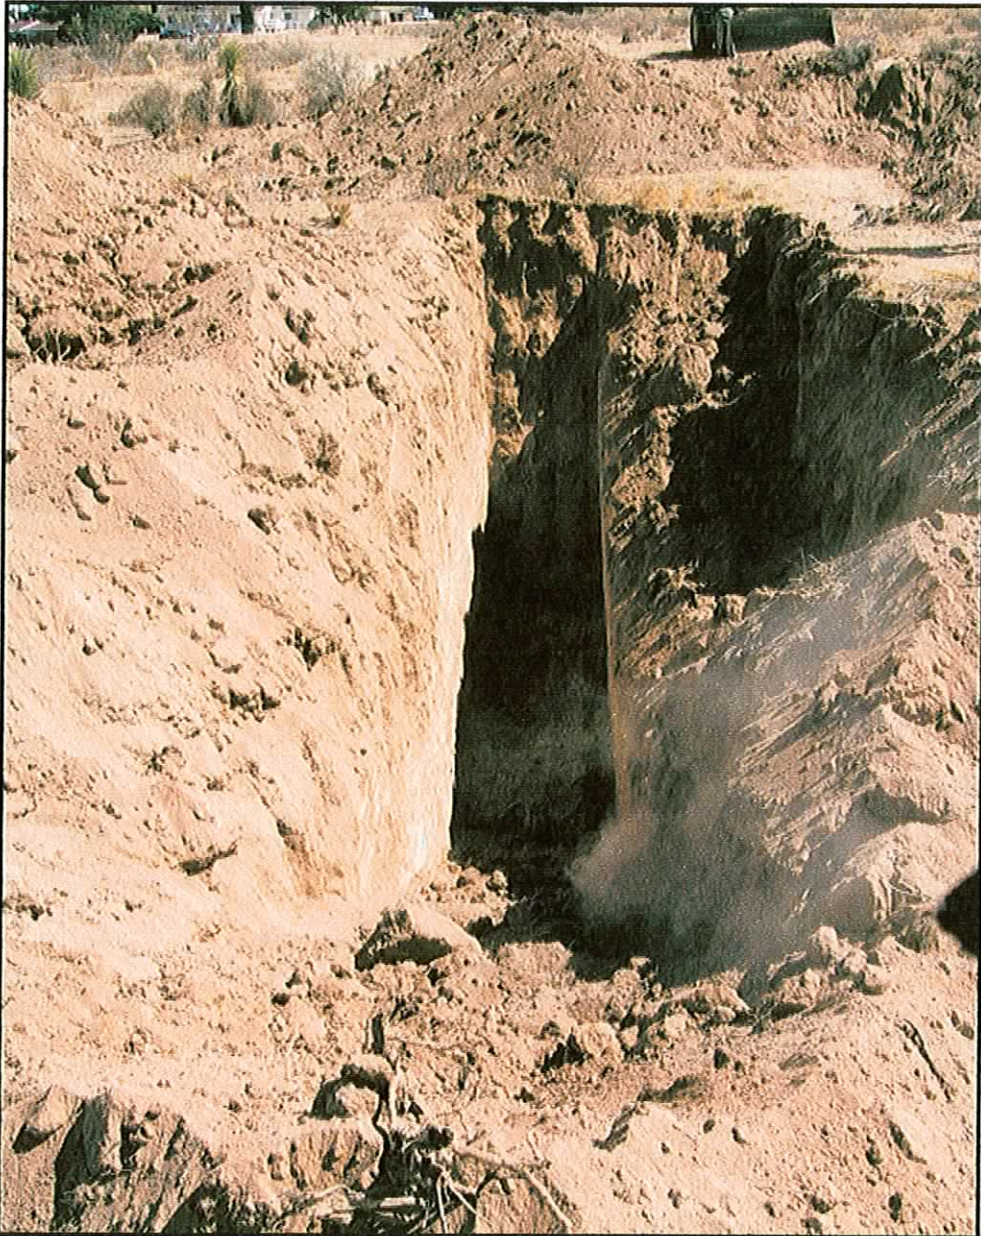
Trench 4 was located approximately 10 feet north of the southwest portion of Trench 2 and was 15 feet in length. This trench was made to determine if the suspected fault trace encountered in Trench 2 was continuous.

Photo 4: Fault trench No. 4 located directly to the north of Fault trench No. 2. A discernable fault trace was located within the trench.

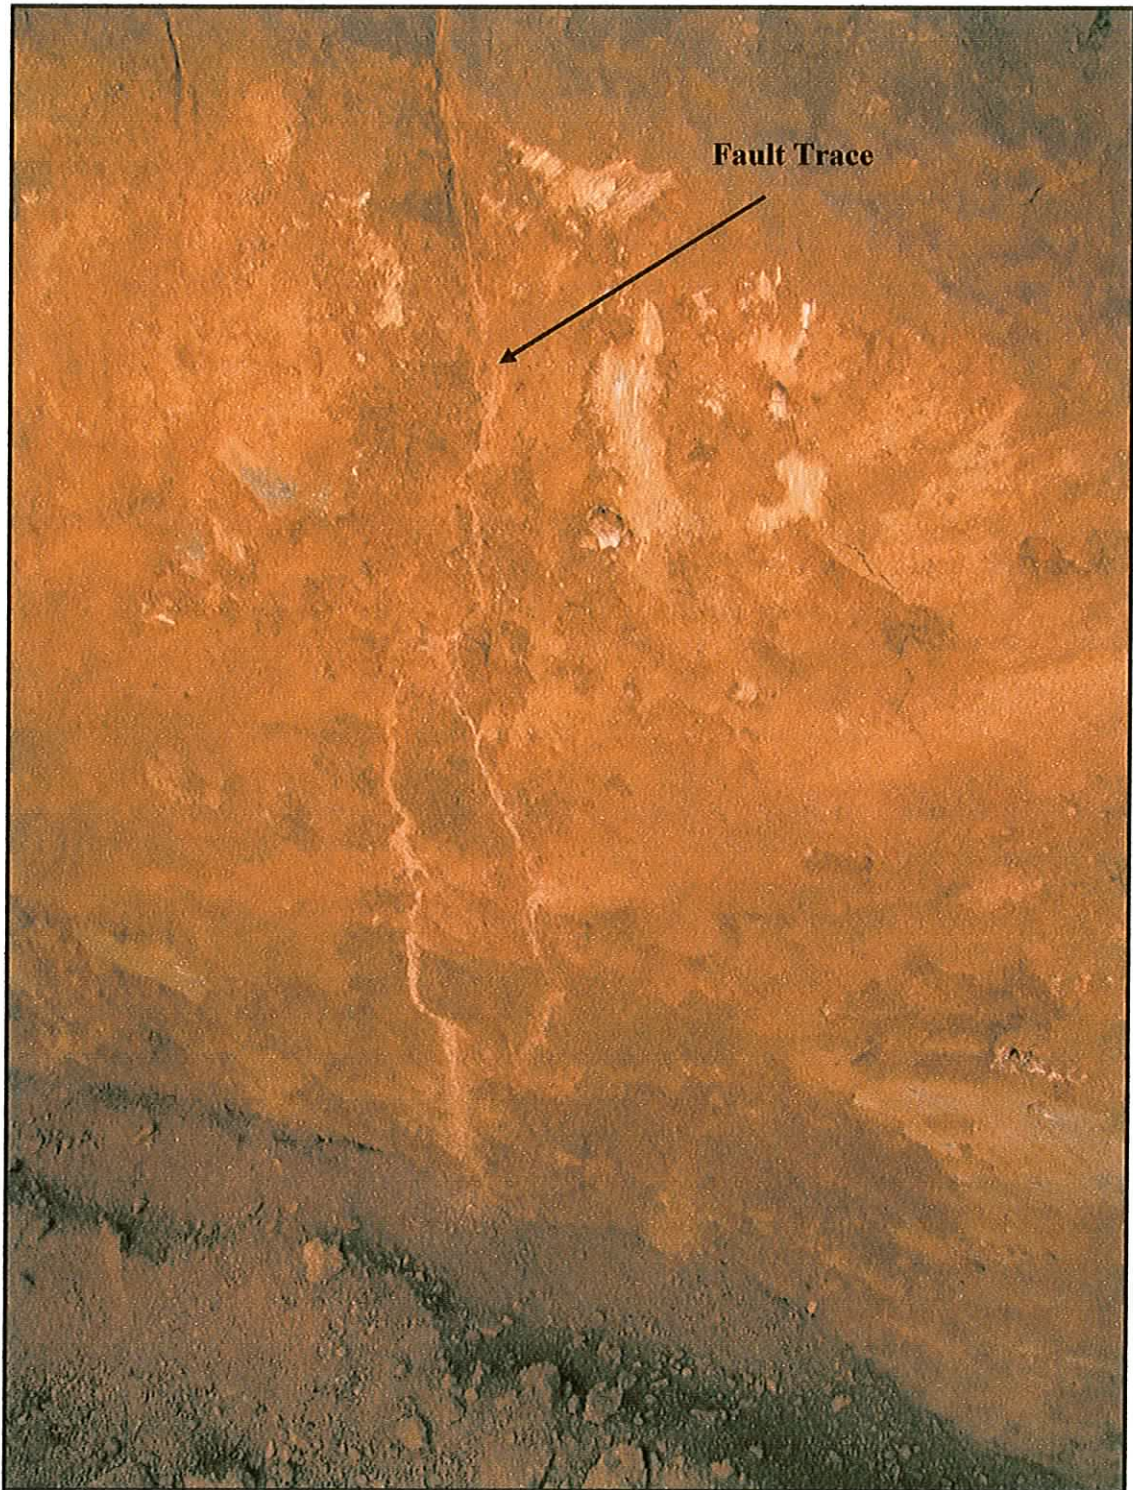
Photo 5: Fault trace on south sidewall at approximately 5 feet within Trench T-4.
