**REPORT OF LIMITED FAULT HAZARD
EVALUATION
PROPOSED CONVENIENCE STORE AND FUEL
CANOPIES
APN 0601-543-01
AVALON AVENUE
YUCCA VALLEY
SAN BERNARDINO COUNTY
CALIFORNIA**

PROJECT NO.: 1664-01
REPORT NO.: 1

AUGUST 22, 2024

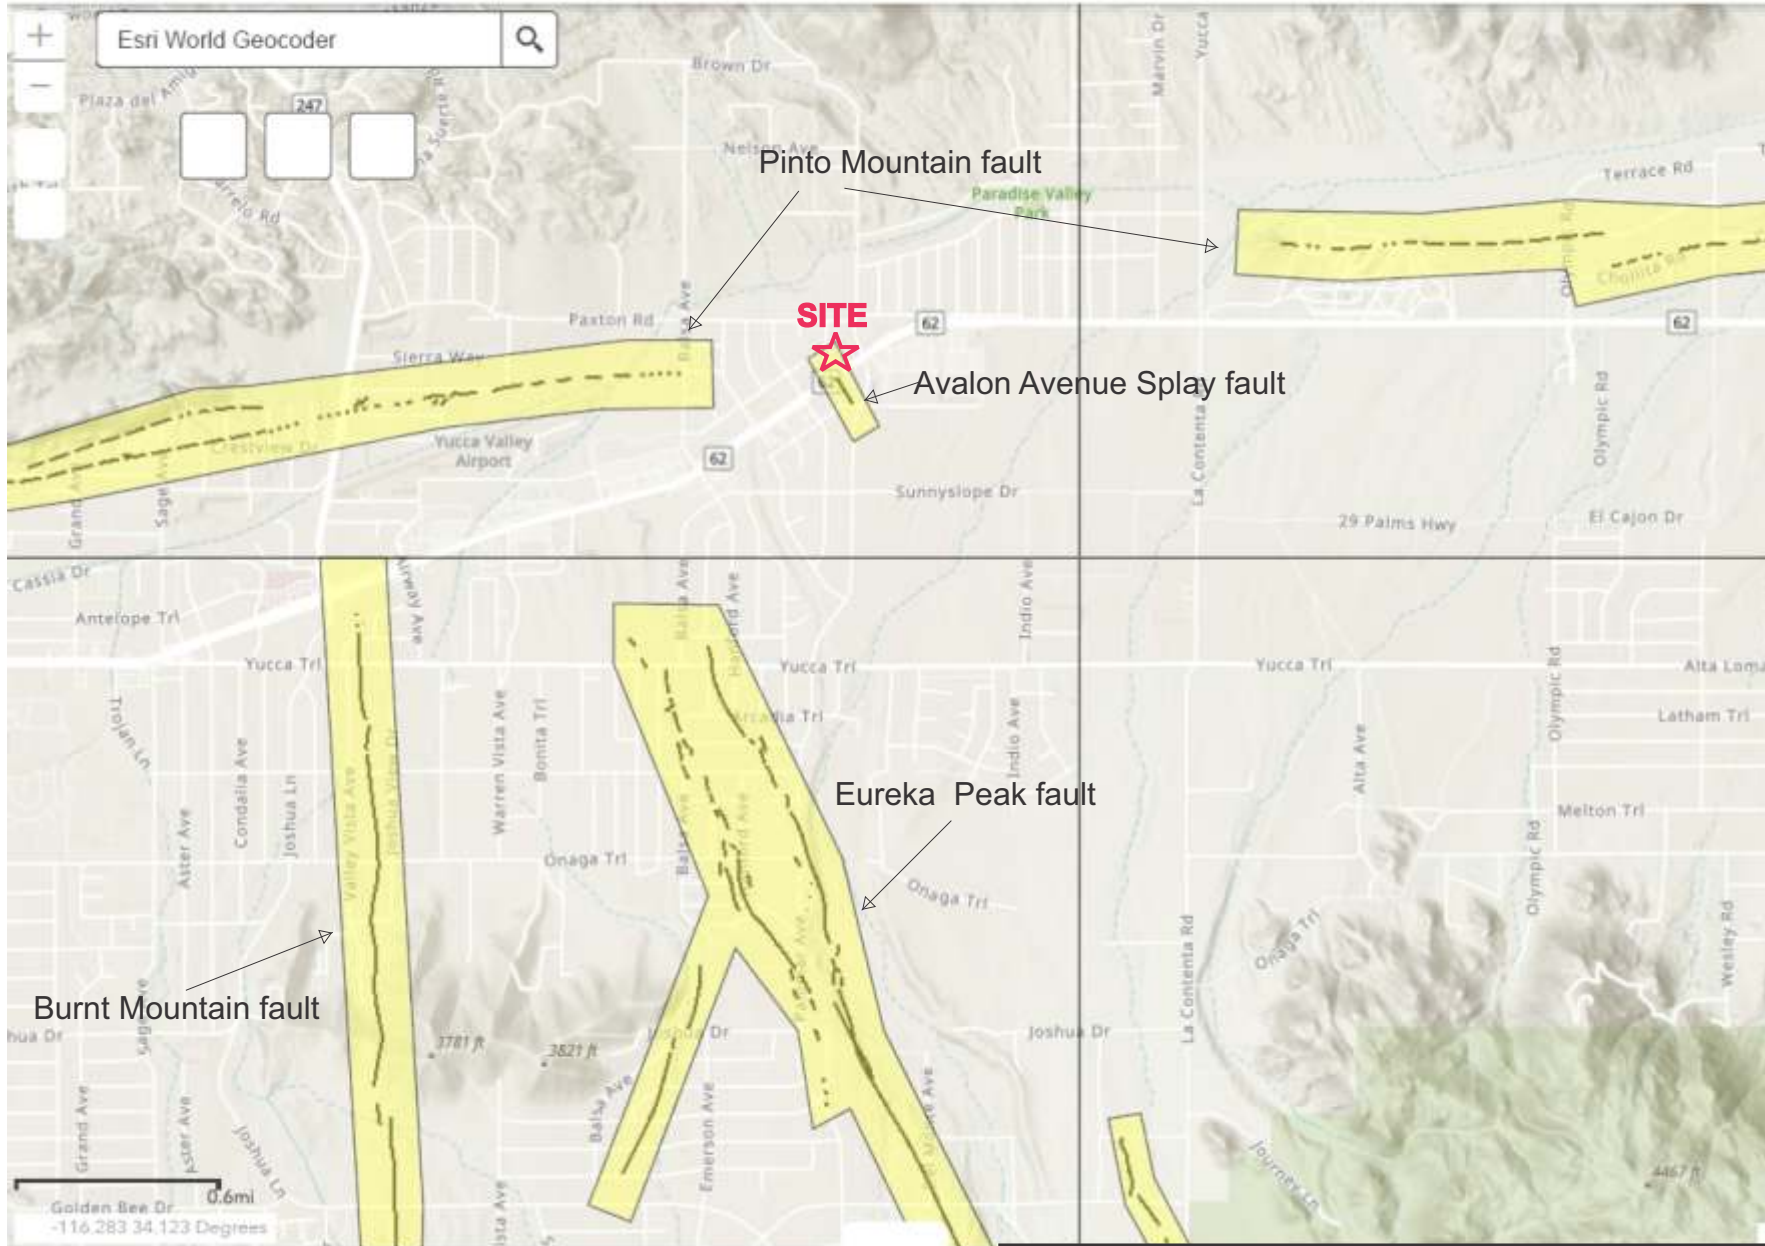
Figure 3

The Eureka Peak fault is located approximately 0.6 miles southwest of the site per Earthquake Zone of Required Investigation (**Figure 3**). The Eureka Peak fault is included in an Alquist-Priolo Earthquake Fault Zone, designated by CGS, as a result of the Landers Earthquake. Investigations by Rasmussen & Associates documented up to 8 inches of right-lateral, strike-slip offset along the Eureka Peak fault associated with the Landers earthquake (Rasmussen, 1992).

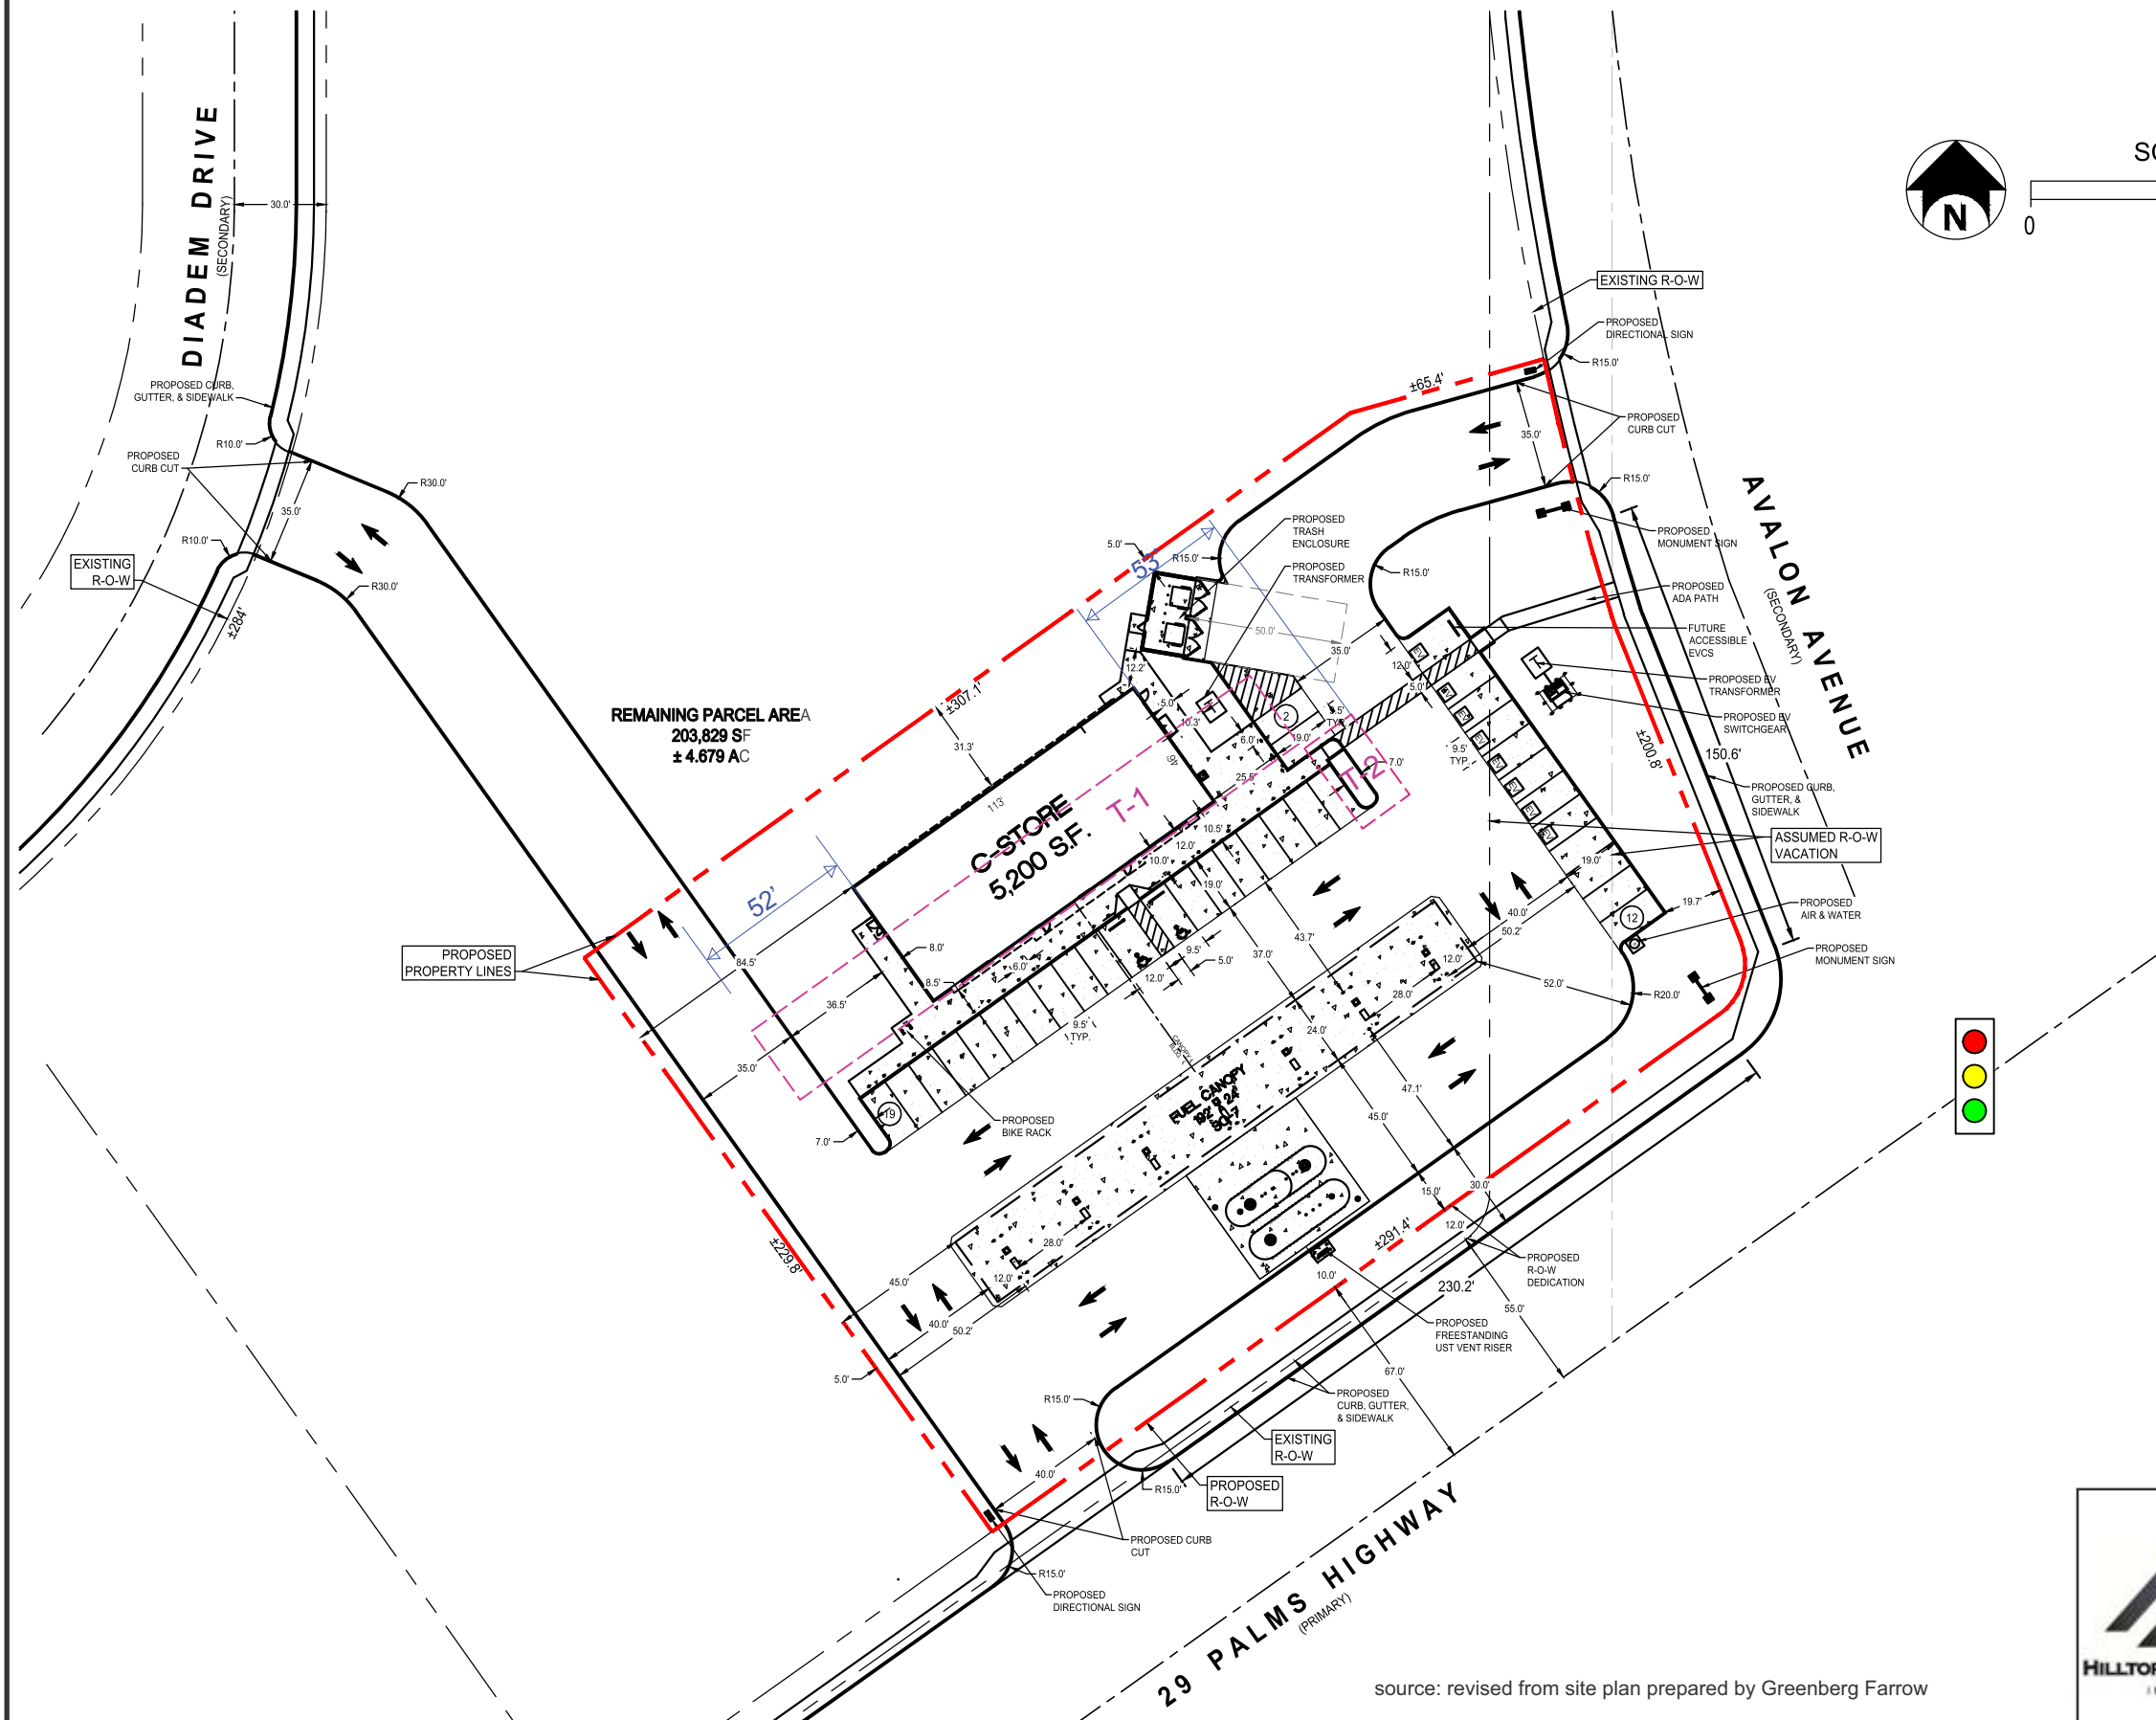
Site Plan and Exploratory Trench Locations	
	APN 0601-543-01, Avalon Avenue, Yucca Valley	
	By: MC	Date: 8/2024
	Project No.: 1664-01.1	Plate No. 1

Per our aerial photo review, no lineaments which can be interpreted as potential fault ruptures were observed in the immediate vicinity of the subject site. Two exploratory trenches were excavated to a depth of 12 feet and 218 feet in length, which meet the San Bernardino County fault study criteria. The relative soil ages indicate that Holocene and Pleistocene age earth materials were exposed within the exploratory fault trenches. Fault trenching results indicate that there is no fault trace encountered within the investigated area.

Based on our document research, field reconnaissance, review of aerial photographs, and lineament analysis, the potential for surface fault rupture on the investigated area is considered low. But any potential fault trace beyond the fault study area cannot be excluded. Therefore, the proposed building should be limited to the investigated area, which is shown on Plate No. 1.
