Subject: **Addendum Report in Response to Fault Hazard Report Review, Proposed Convenience Store and Fuel Canopies, APN: 0601-543-01, Avalon Avenue, Yucca Valley, San Bernardino County, California.**

**REPORT OF LIMITED FAULT HAZARD
EVALUATION
PROPOSED CONVENIENCE STORE AND FUEL
CANOPIES
APN 0601-543-01
AVALON AVENUE
YUCCA VALLEY
SAN BERNARDINO COUNTY
CALIFORNIA**

PROJECT NO.: 1664-01
REPORT NO.: 1R

Subject: **Report of a Limited Fault Hazard Evaluation, Proposed Convenience Store and Fuel Canopies, APN 0601-543-01, Avalon Avenue, Yucca Valley, California.**

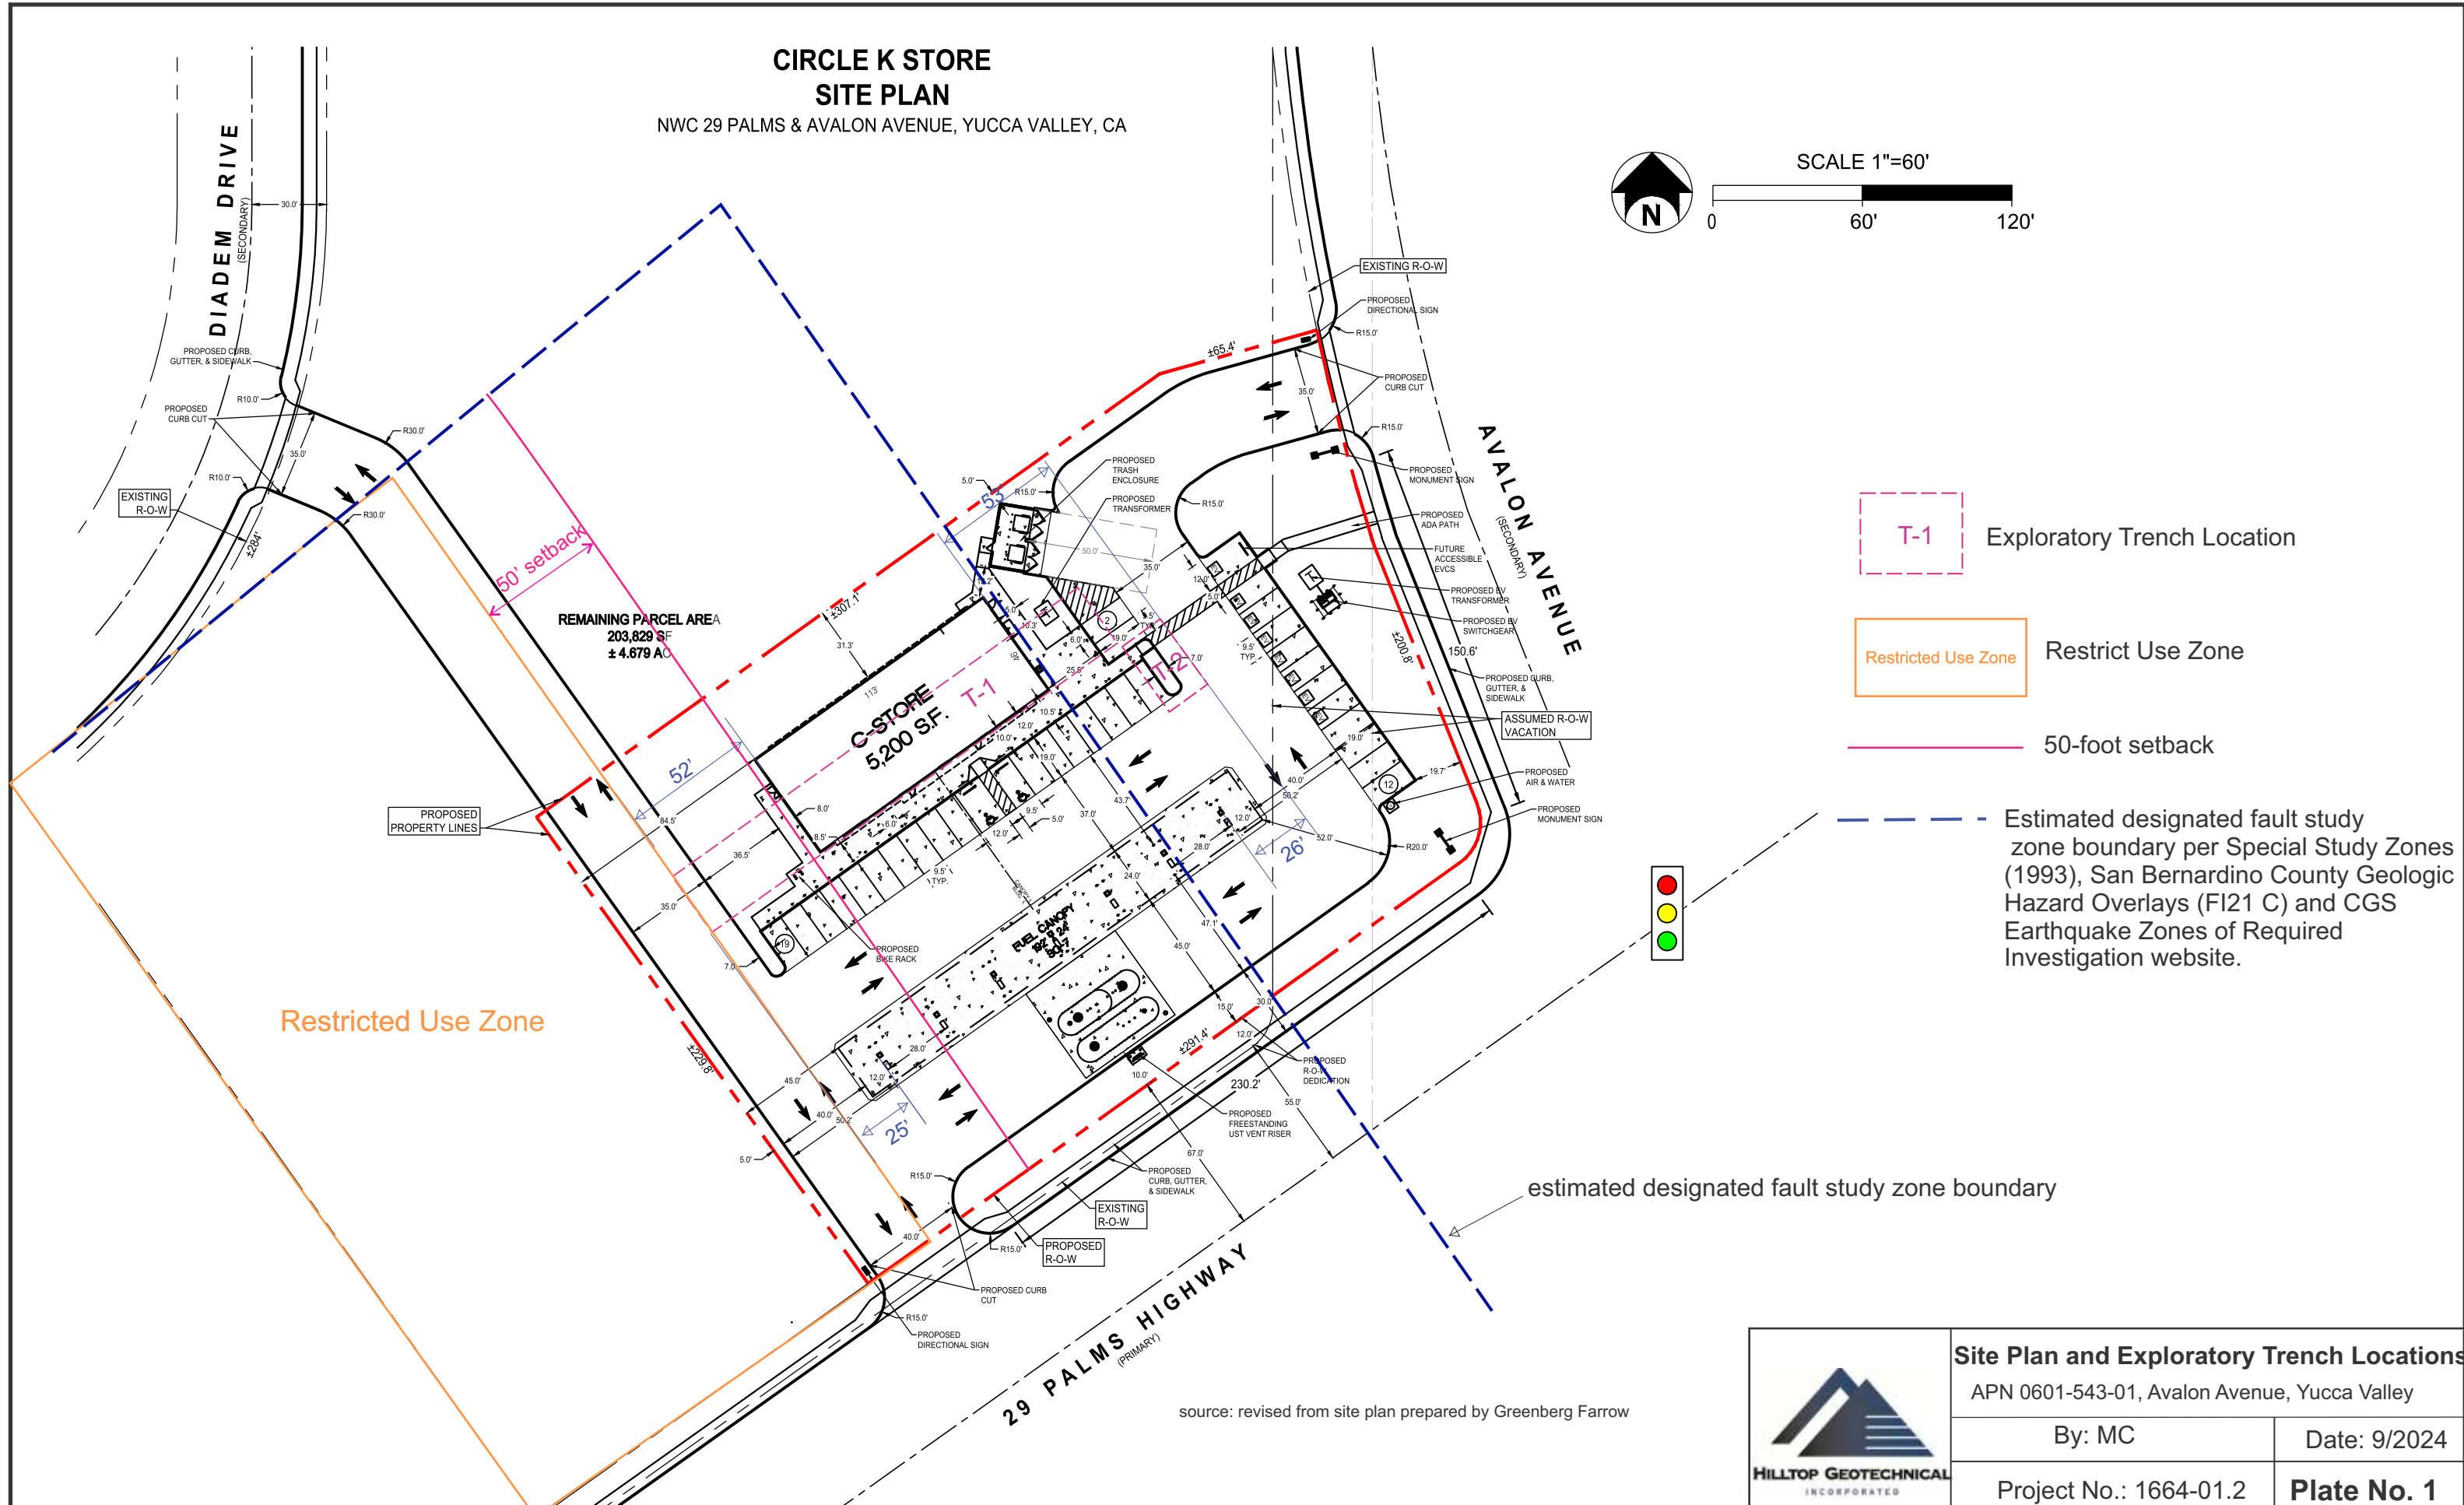
Site Plan and Exploratory Trench Locations APN 0601-543-01, Avalon Avenue, Yucca Valley	
	By: MC	Date: 9/2024
	Project No.: 1664-01.2	Plate No. 1

- a) Please provide a Site Plan illustrating the Restricted Use Zone (RUZ) for the entire project site. The setback and RUZ should be projected across the site. No habitable structures may be constructed within the RUZ unless further investigation indicates that Holocene active faults do not underly those portions of the subject property.

Based on Special Studies Zones-Yucca Valley North Quadrangle-Revised Official Map Effective: July 1, 1993, which is shown in Figure 4, only the west portion of the subject site was designated in a fault study zone. The site plan has been revised to illustrate RUZ and a 50-foot setback. No habitable structures shall be constructed within the RUZ unless further investigation indicates that Holocene active faults do not underly those portions of the subject property.

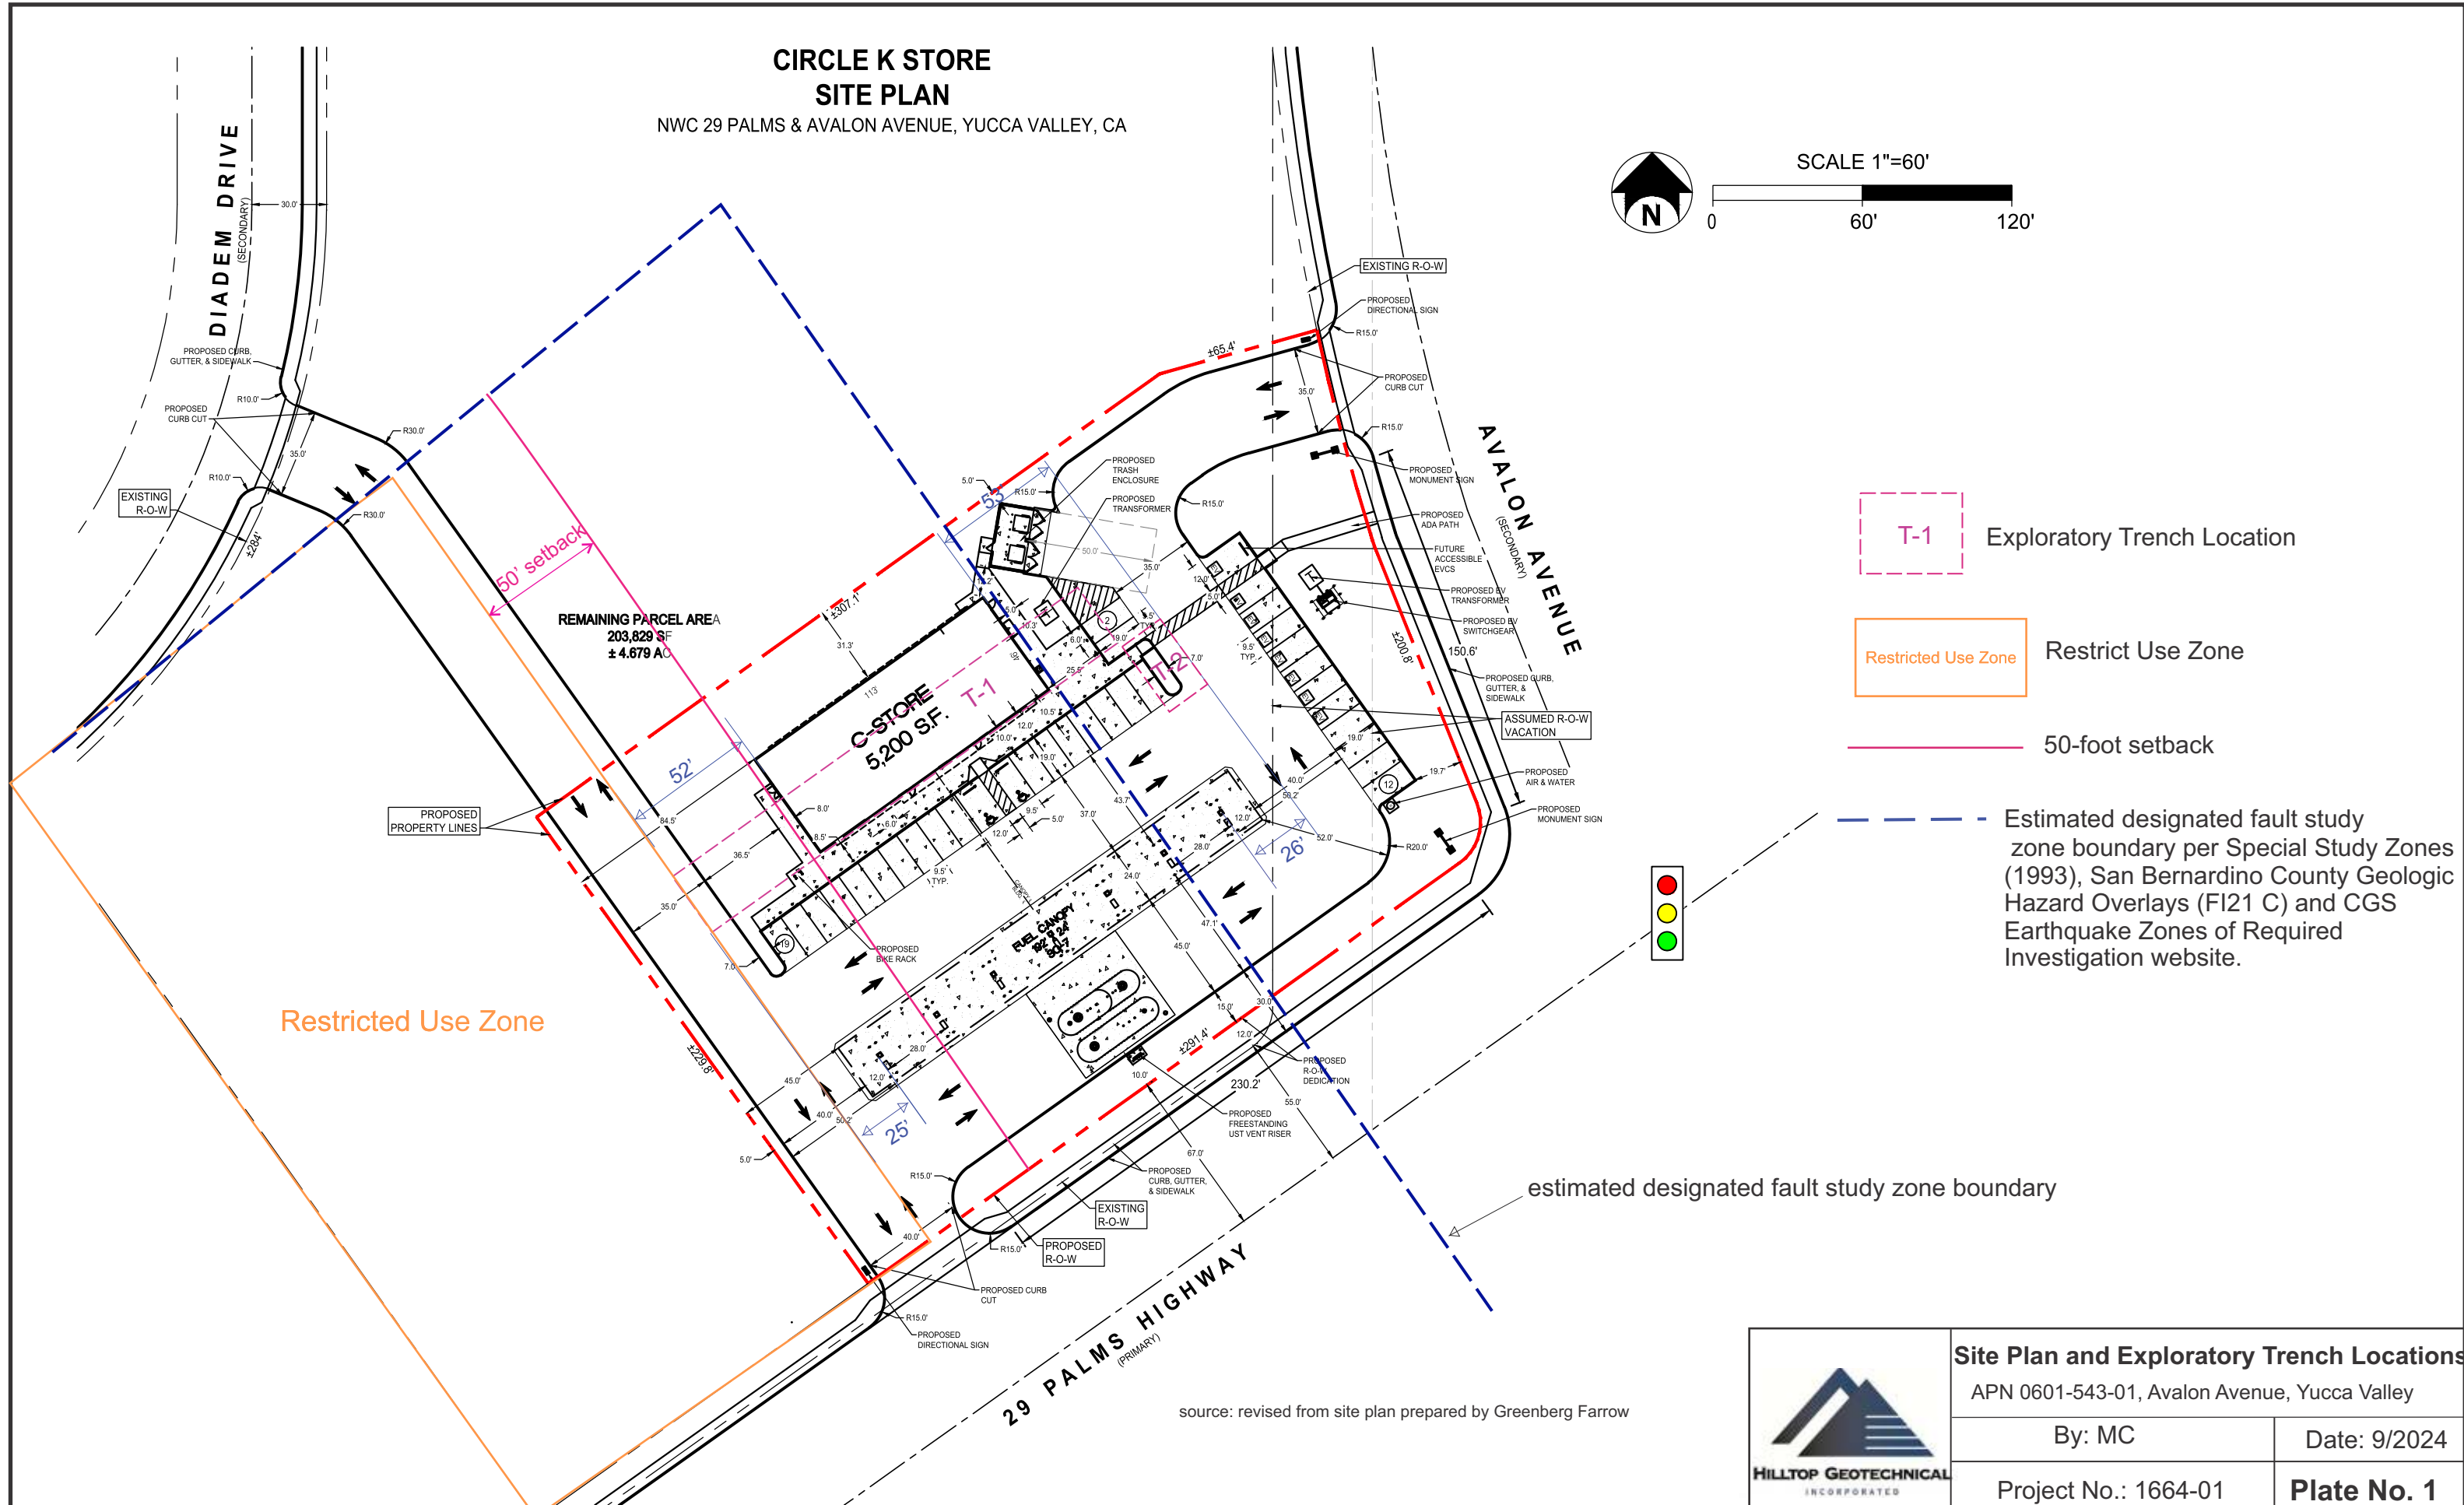
Based on our document research, field reconnaissance, review of aerial photographs, and lineament analysis, the potential for surface fault rupture on the investigated area is considered low. But any potential fault trace beyond the fault study area cannot be excluded. Therefore, the proposed building should be limited to the investigated area, which is shown on Plate No. 1.

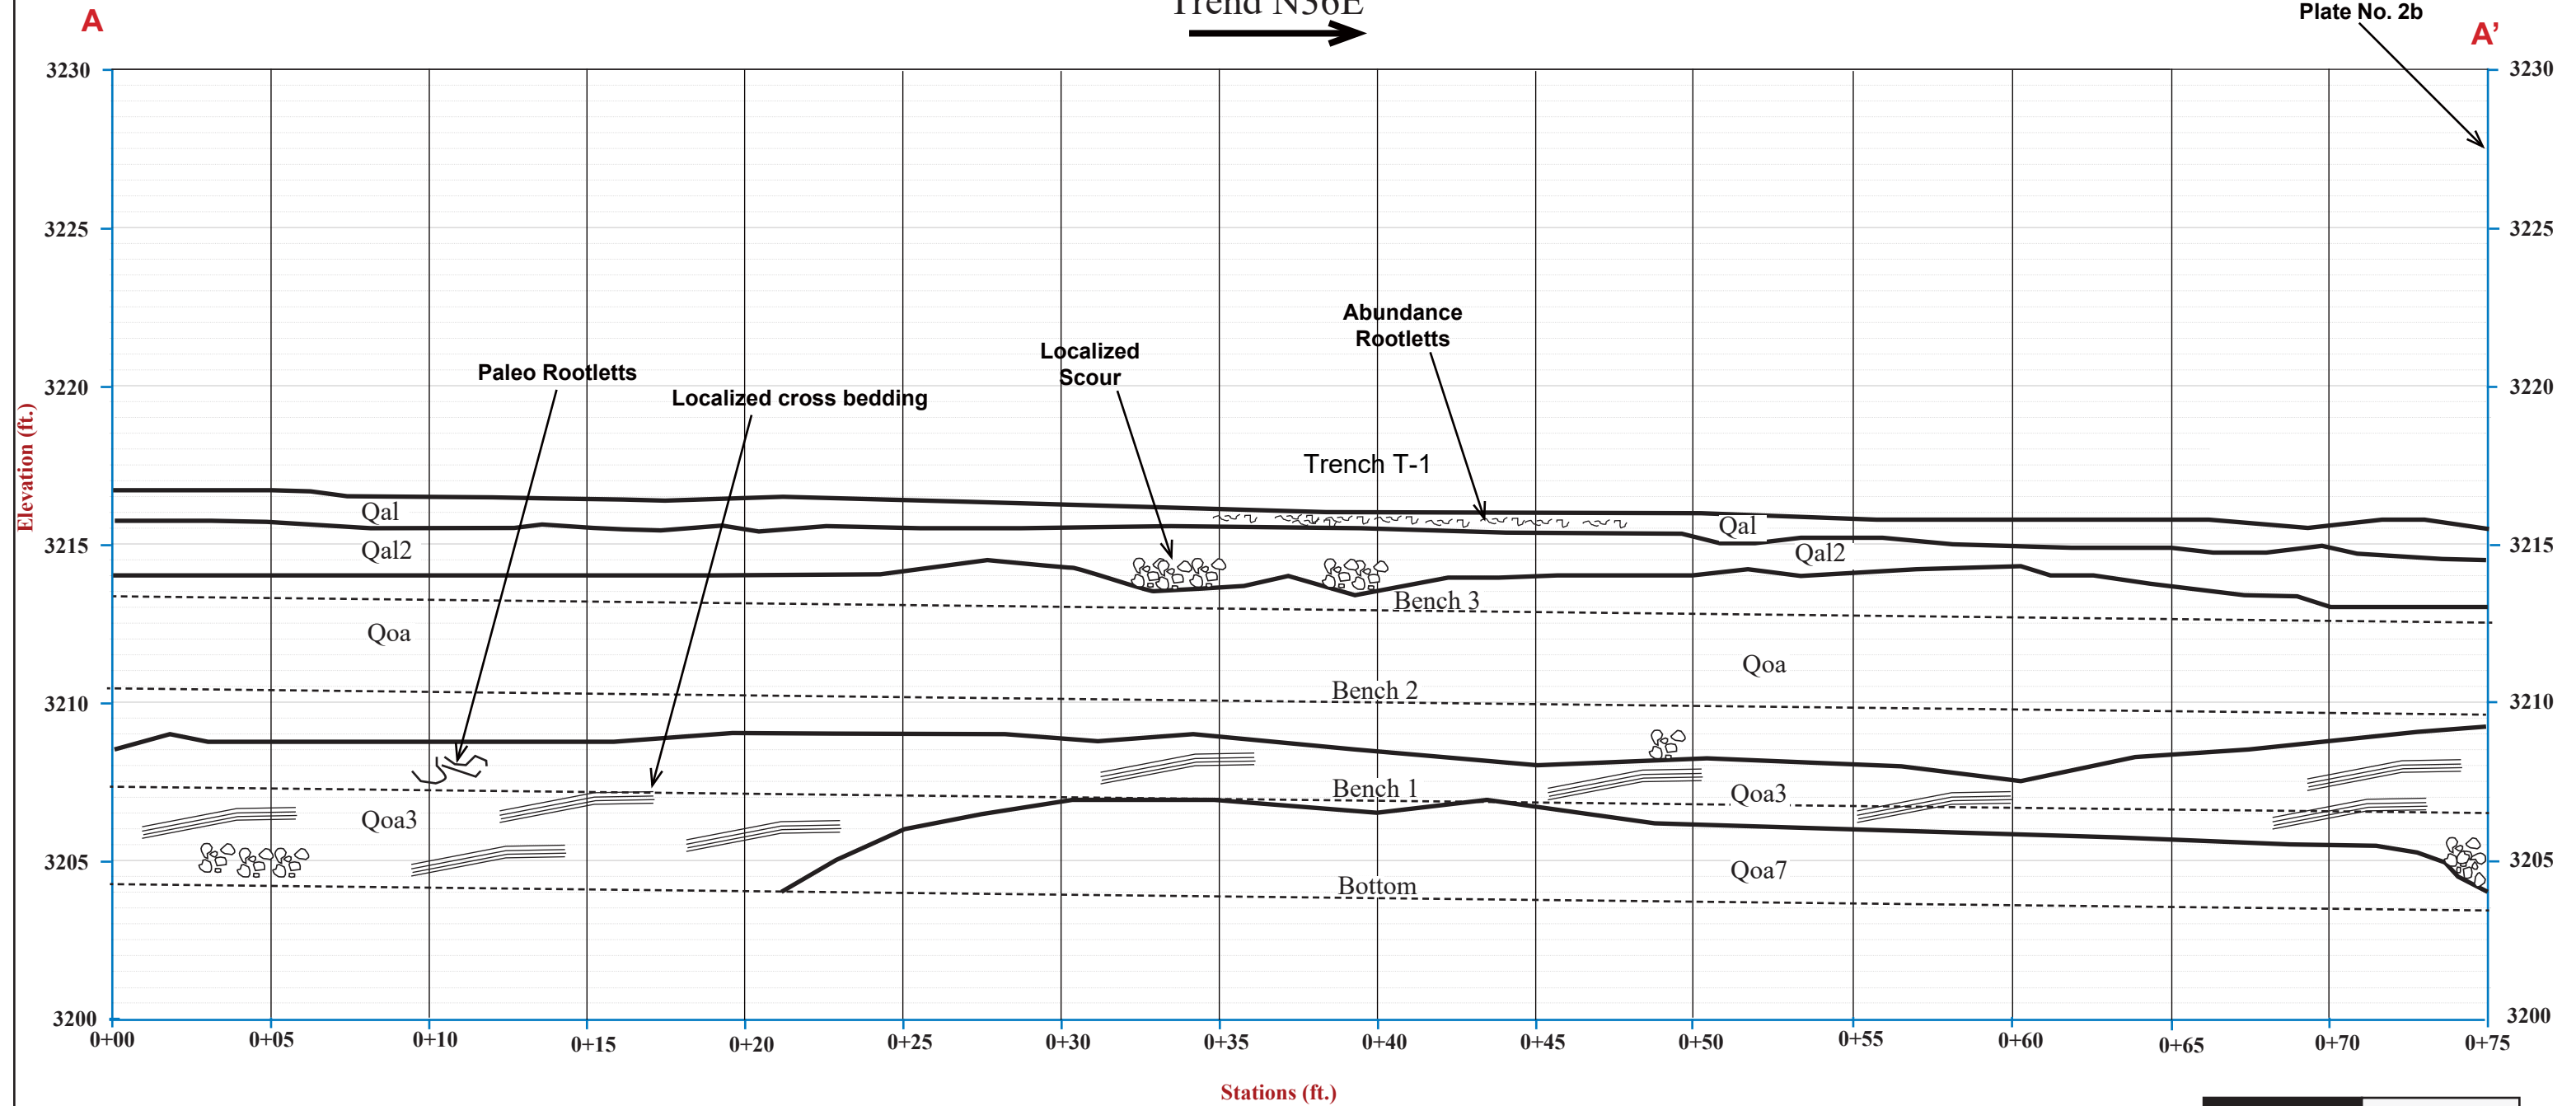
Plate No.:
2a

Trench T-2 log was showed at the east end of the fault trench profile in our fault hazard report. To clarify the fault trench profile, we also revised our fault trench logs to indicate an overlap of trenches T-1 and T-2.

Per our aerial photo review, no lineaments which can be interpreted as potential fault ruptures were observed in the immediate vicinity of the subject site. Two exploratory trenches were excavated to a depth of 12 feet and 218 feet in length, which meet the San Bernardino County fault study criteria. The relative soil ages indicate that Holocene and Pleistocene age earth materials were exposed within the exploratory fault trenches. Fault trenching results indicate that there is no fault trace encountered within the investigated area.
