Geological Report

APN 588-311-009 (Vacant Lot) Fault Hazard Study

Yucca Valley, California

Fault Hazard Evaluation
APN 588-311-009 (Vacant Lot)
Yucca Valley, California
LCI Project No. LP04125

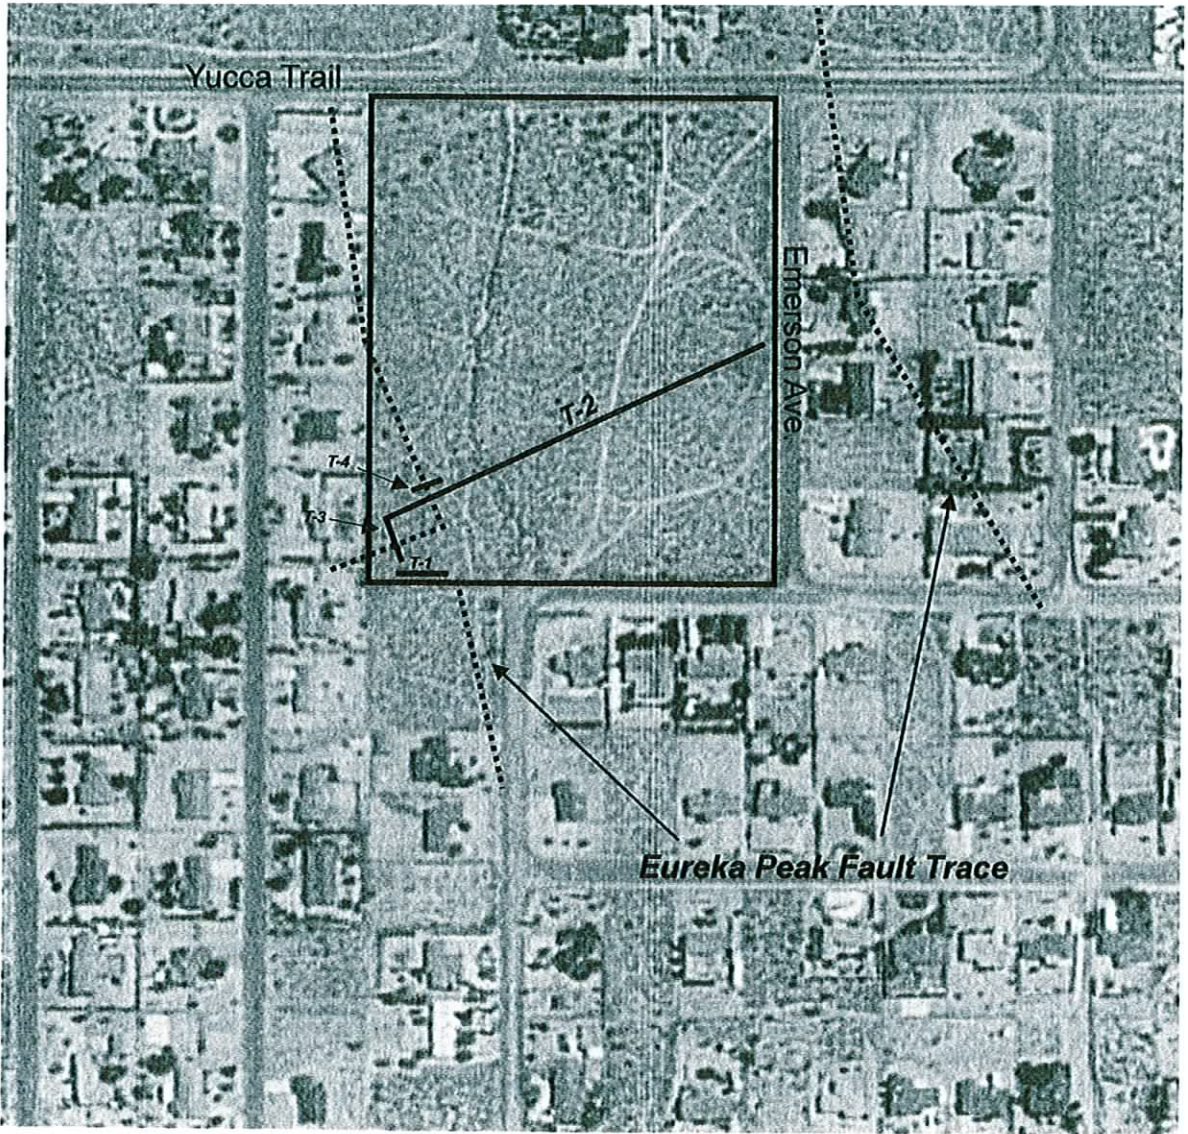
Plate
A-2

The field exploration was conducted on September 21 through 30, 2004 using an excavator to excavate four (4) trenches to an approximate depth of eight to twelve (8 to 12) feet below the ground surface (Plate A-2). Three trenches were located at the mapped trace of the Eureka Peak Fault near the southwest corner of the site. **The largest continuous trench (Trench 2) crossed the site which is located within the A-P zone and encompassed the mapped trace of the Eureka Peak Fault.** Subsurface soils within the trenches consisted mainly of gravelly silty sand. Some cobbles were noted in the sediment. The soils were consolidated and massive with no bedding features readily visible.

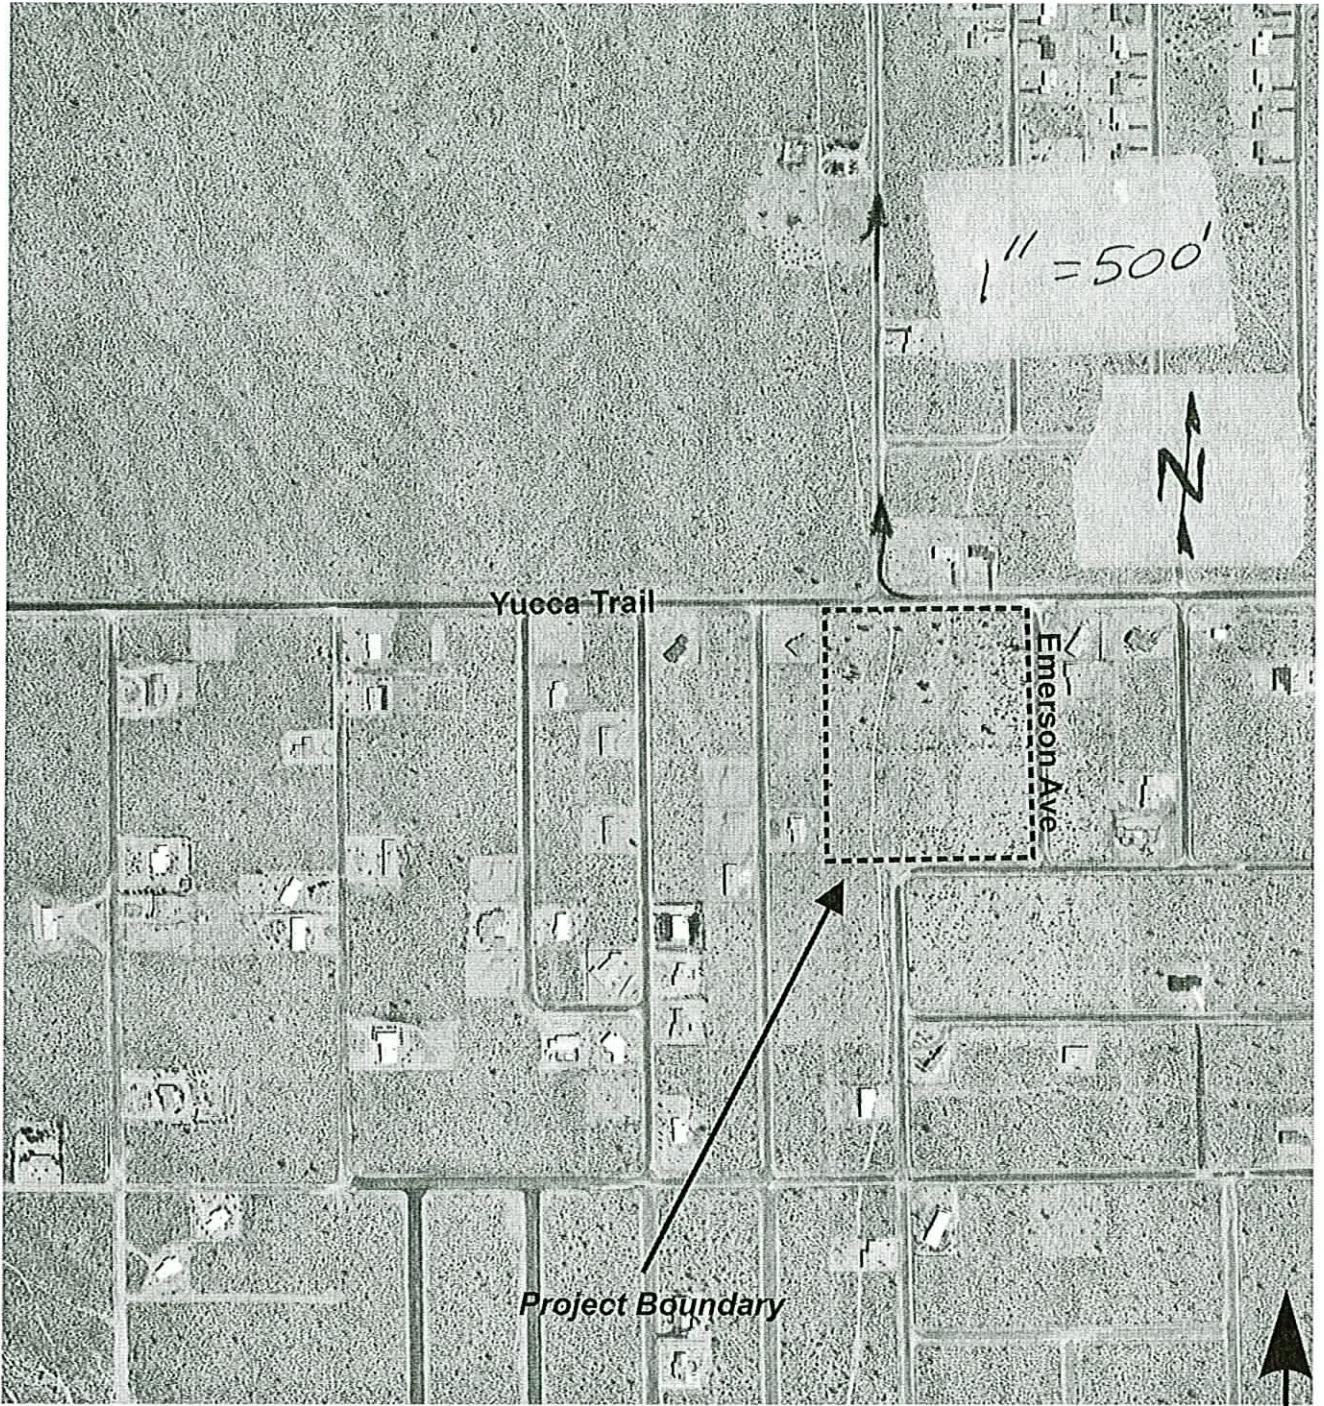
Plate
A-7

Stereoscopic aerial photographs dated 1964, 1977, 1989, and 1993 were reviewed as part of this investigation. A faint lineament was noted in the 1977, 1989, and 1993 aerial photographs (Plate A-7 through A-9) that likely corresponds to the delineated trace of the Eureka Peak Fault. The lineament was most readily noted along the west side of a stream channel near Palomar Avenue southeast of the project site. No lineaments were noted within the project site area on the aerial photographs reviewed.
