**REPORT OF LIMITED FAULT HAZARD
EVALUATION
PROPOSED CONVENIENCE STORE AND FUEL
CANOPIES
APN 0601-543-01
AVALON AVENUE
YUCCA VALLEY
SAN BERNARDINO COUNTY
CALIFORNIA**

PROJECT NO.: 1664-01
REPORT NO.: 1

AUGUST 22, 2024

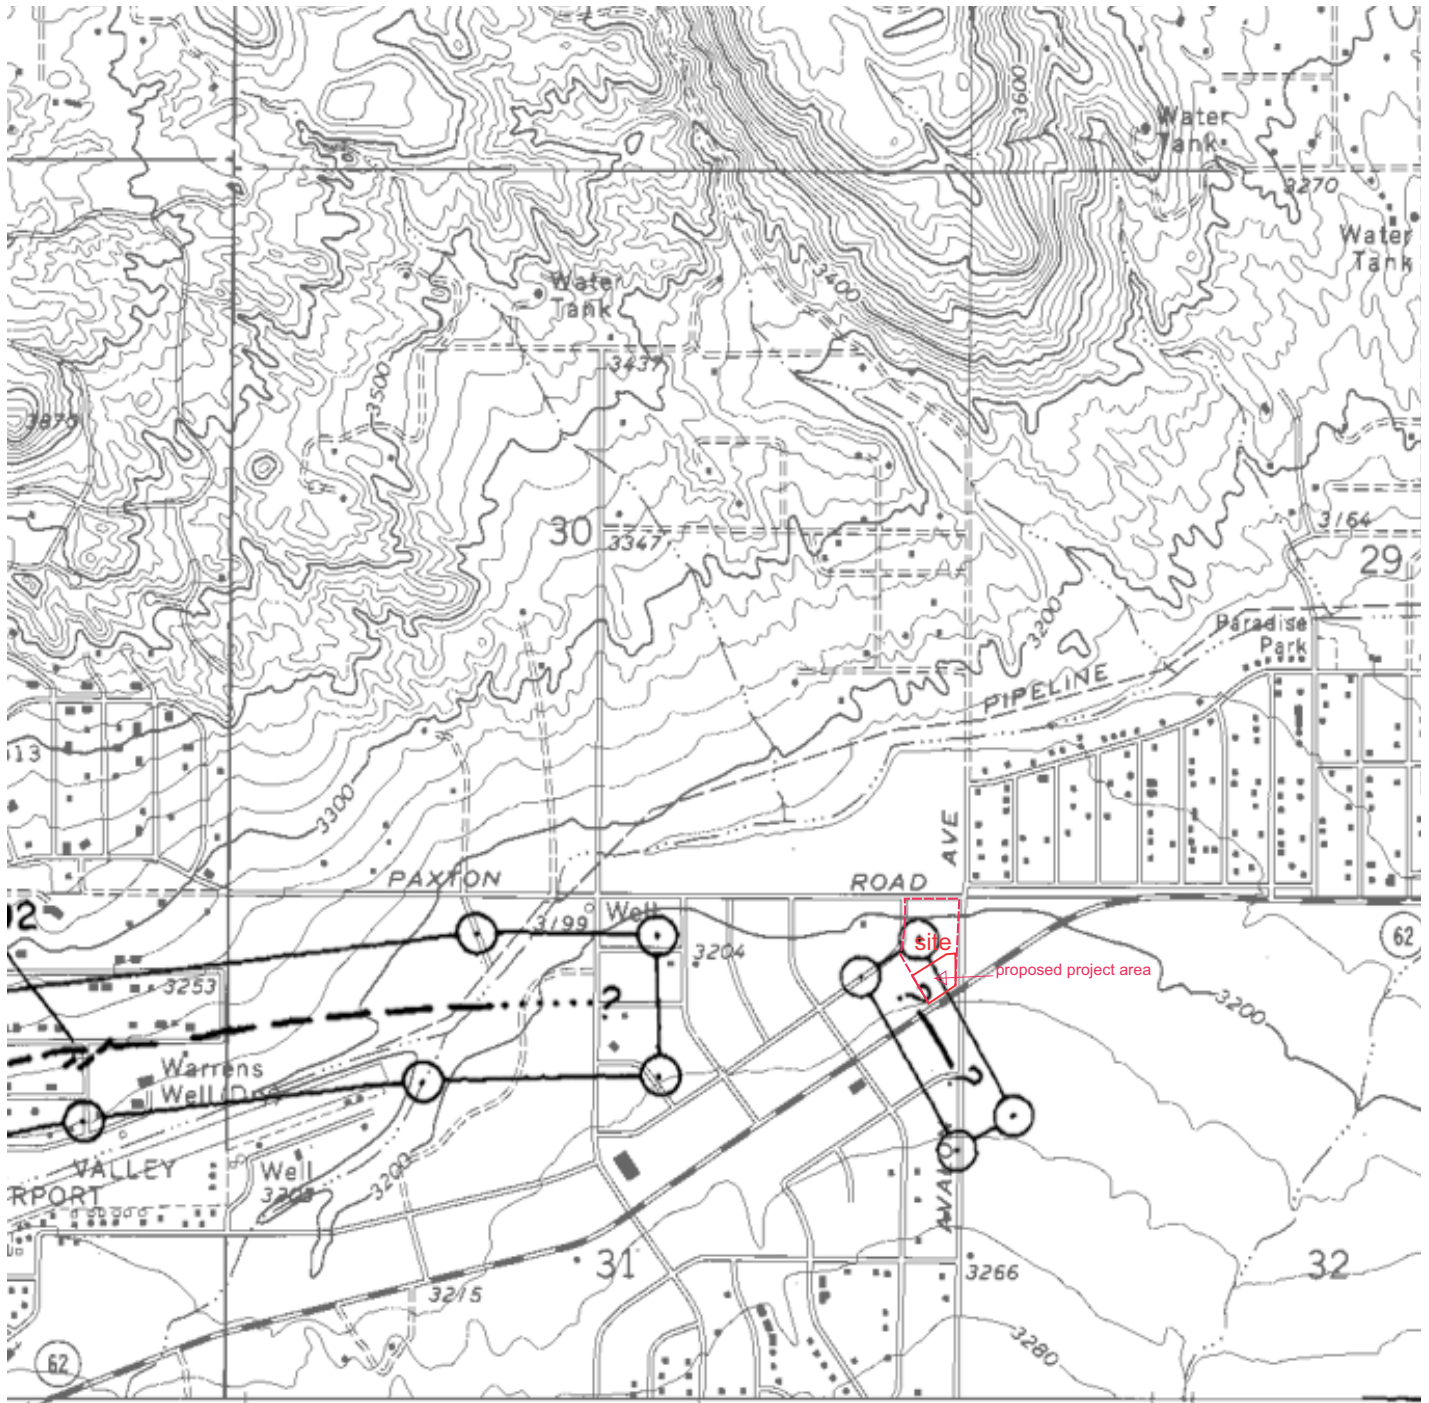
Figure 3

The Eureka Peak fault is located approximately 0.6 miles southwest of the site per Earthquake Zone of Required Investigation (**Figure 3**). The Eureka Peak fault is included in an Alquist-Priolo Earthquake Fault Zone, designated by CGS, as a result of the Landers Earthquake. Investigations by Rasmussen & Associates documented up to 8 inches of right-lateral, strike-slip offset along the Eureka Peak fault associated with the Landers earthquake (Rasmussen, 1992).
