**GEOTECHNICAL ENGINEERING INVESTIGATION**

**PROPOSED CIRCLE K**

**NORTHWEST CORNER OF TWENTYNINE PALMS HIGHWAY**

**Project Number: G28851.02**

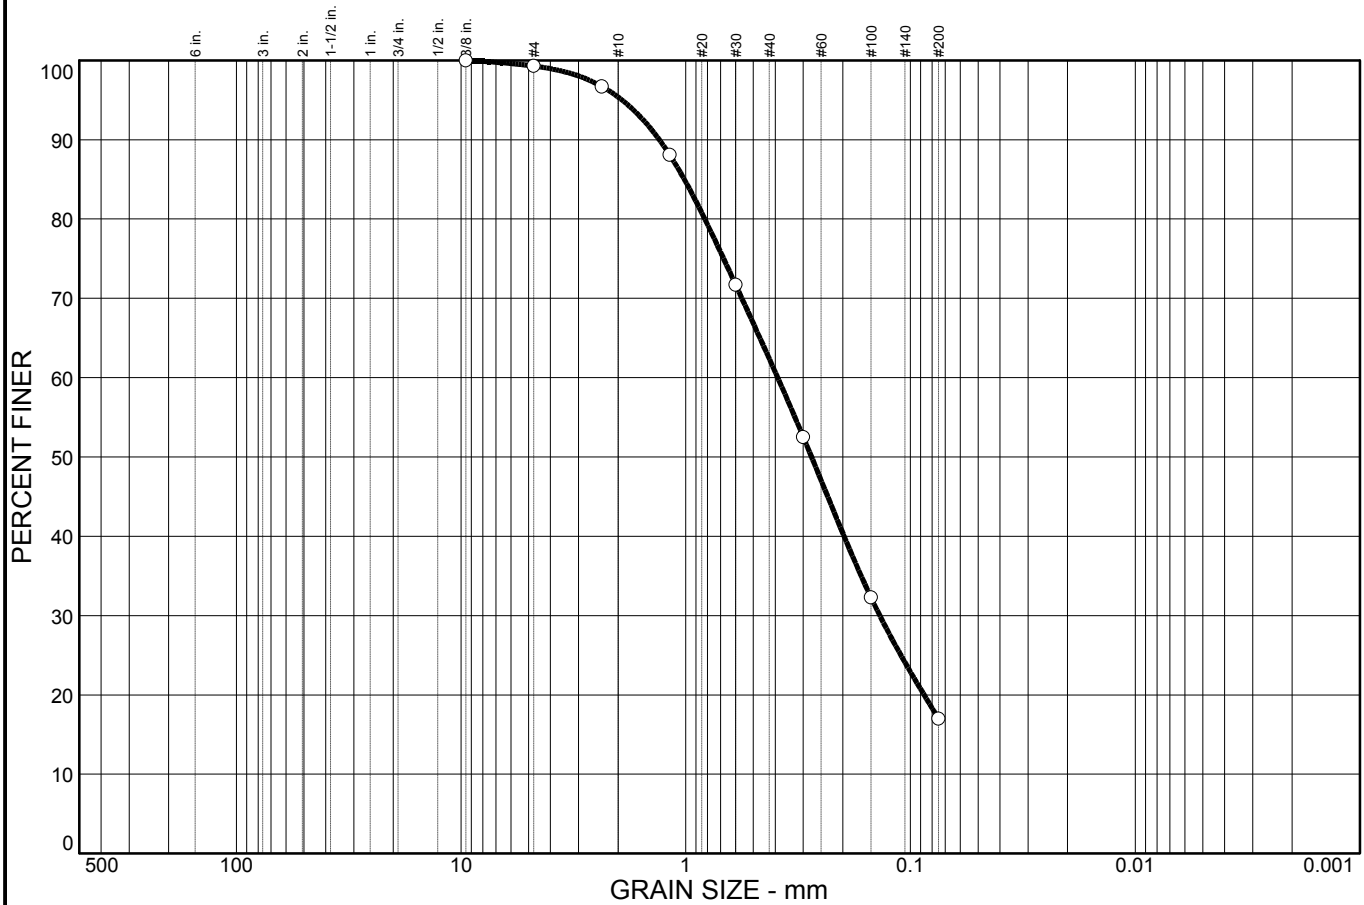
# Particle Size Distribution Report

% COBBLES	% GRAVEL		% SAND			% FINES	
	CRS.	FINE	CRS.	MEDIUM	FINE	SILT	CLAY
0.0	0.0	0.7	3.9	33.0	45.4	17.0

SIEVE SIZE	PERCENT FINER	SPEC.* PERCENT	PASS? (X=NO)
3/8 in.	100.0		
#4	99.3		
#8	96.7		
#16	88.1		
#30	71.7		
#50	52.5		
#100	32.3		
#200	17.0

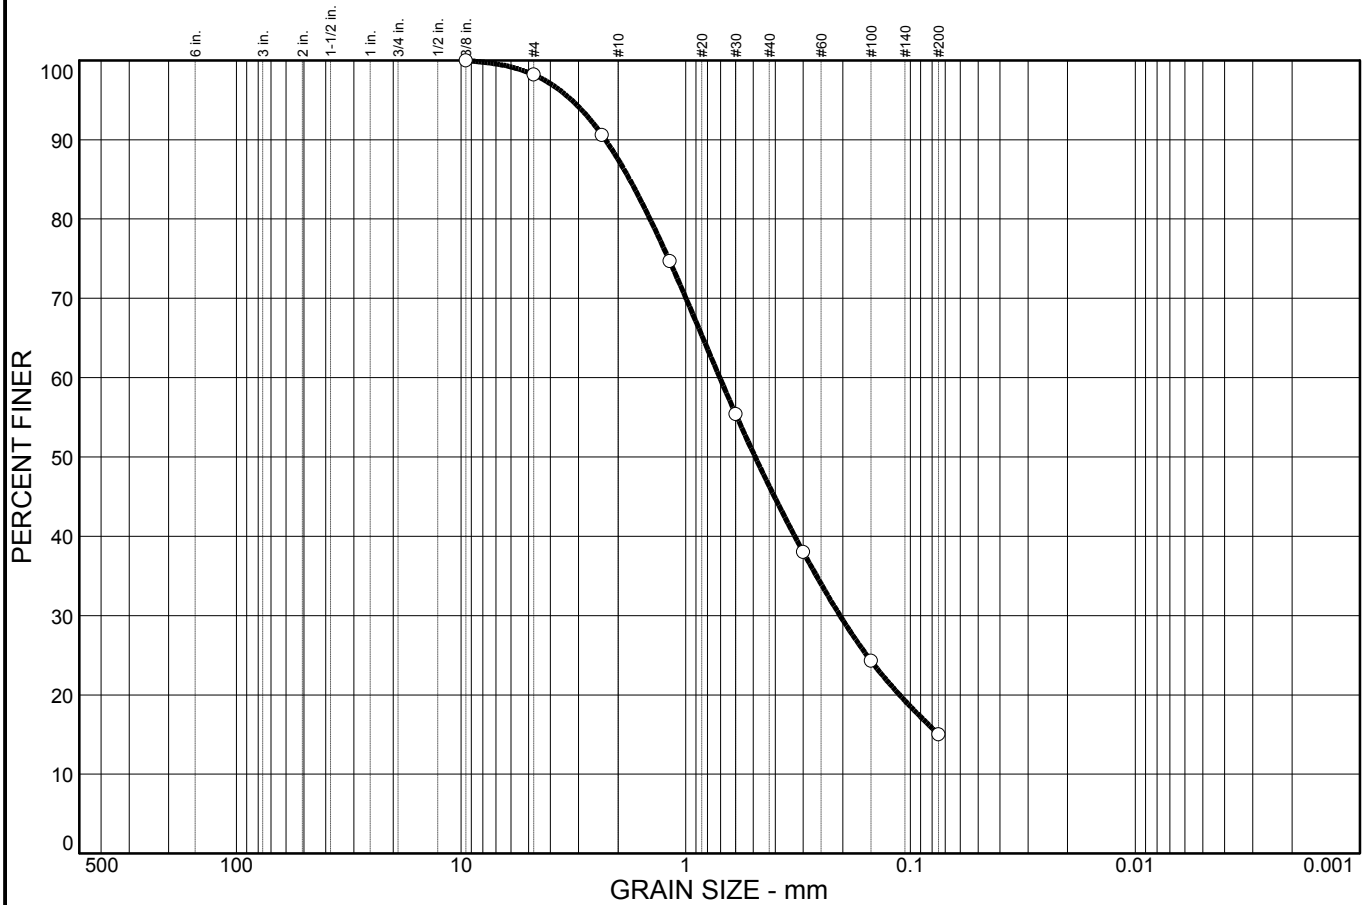
# Particle Size Distribution Report

% COBBLES	% GRAVEL		% SAND			% FINES	
	CRS.	FINE	CRS.	MEDIUM	FINE	SILT	CLAY
0.0	0.0	1.8	10.7	41.2	31.3	15.0

SIEVE SIZE	PERCENT FINER	SPEC.* PERCENT	PASS? (X=NO)
3/8 in.	100.0		
#4	98.2		
#8	90.6		
#16	74.7		
#30	55.4		
#50	38.0		
#100	24.3		
#200	15.0

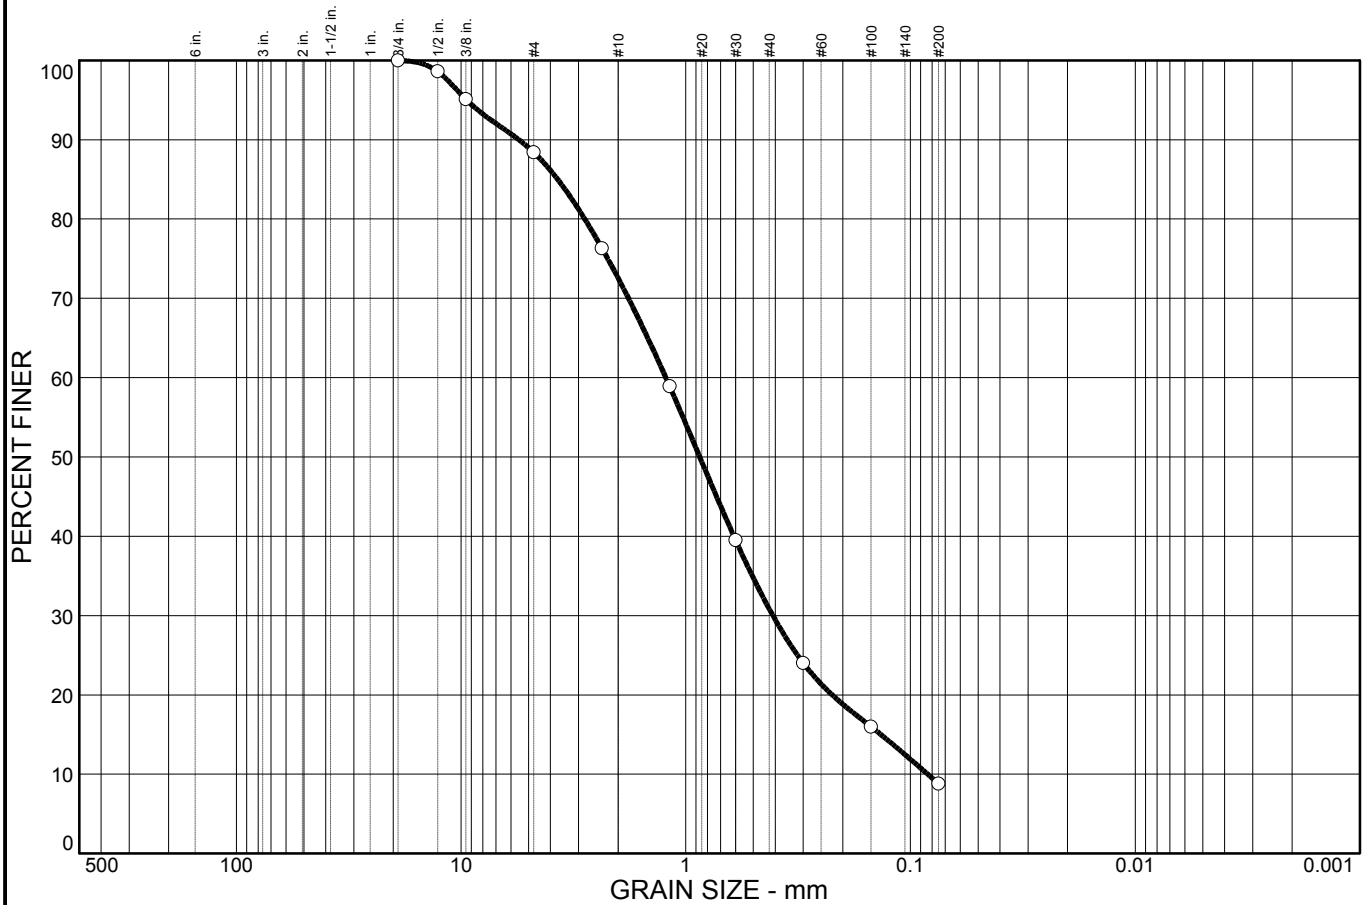
# Particle Size Distribution Report

% COBBLES	% GRAVEL		% SAND			% FINES	
	CRS.	FINE	CRS.	MEDIUM	FINE	SILT	CLAY
0.0	0.0	11.6	15.9	41.7	22.0	8.8

SIEVE SIZE	PERCENT FINER	SPEC.* PERCENT	PASS? (X=NO)
3/4 in.	100.0		
1/2 in.	98.6		
3/8 in.	95.1		
#4	88.4		
#8	76.3		
#16	58.9		
#30	39.5		
#50	24.0		
#100	16.0		
#200	8.8

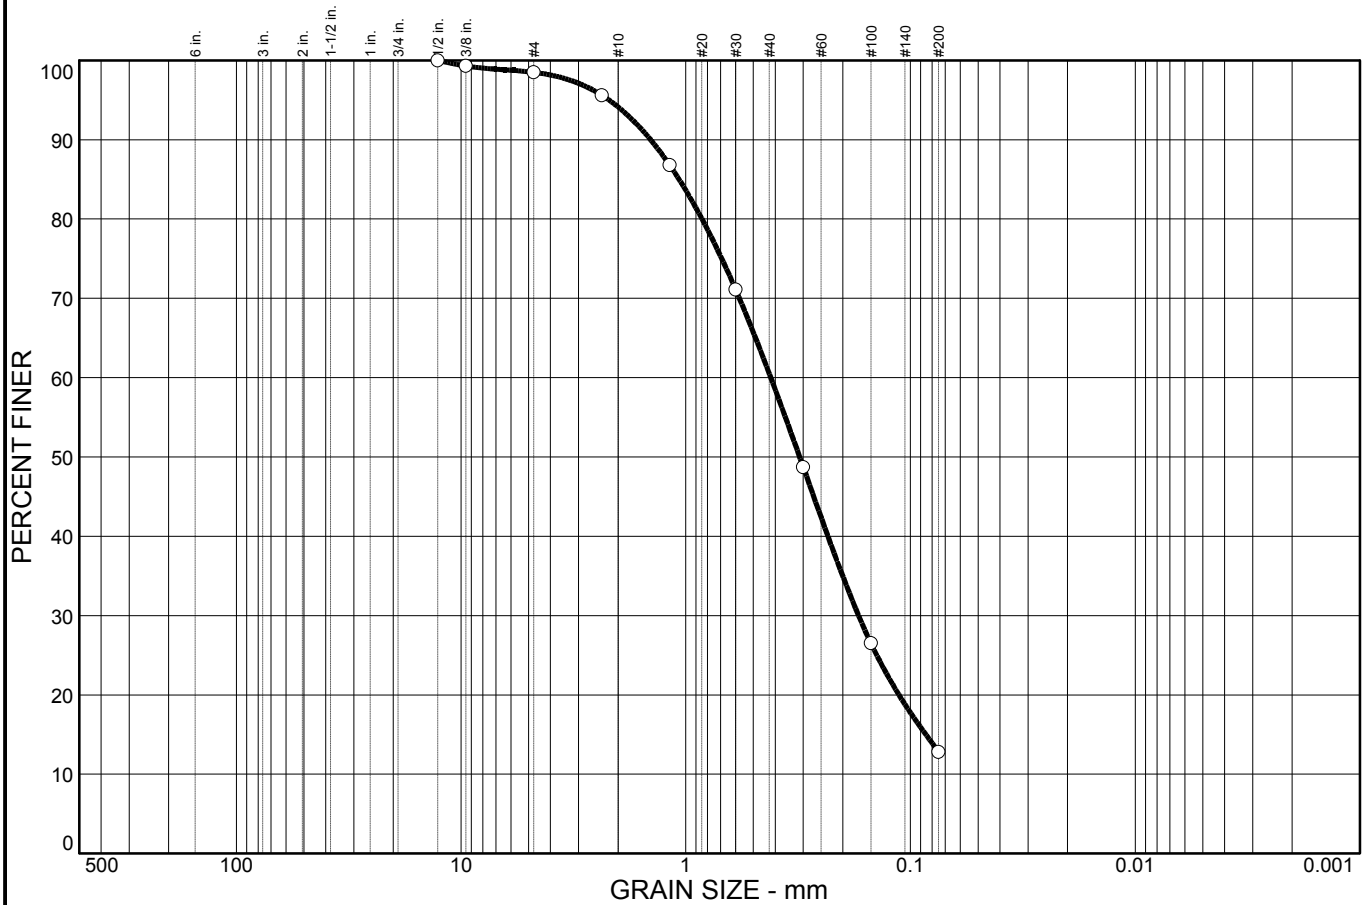
# Particle Size Distribution Report

% COBBLES	% GRAVEL		% SAND			% FINES	
	CRS.	FINE	CRS.	MEDIUM	FINE	SILT	CLAY
0.0	0.0	1.5	4.4	33.6	47.7	12.8

SIEVE SIZE	PERCENT FINER	SPEC.* PERCENT	PASS? (X=NO)
1/2 in.	100.0		
3/8 in.	99.3		
#4	98.5		
#8	95.6		
#16	86.8		
#30	71.1		
#50	48.7		
#100	26.5		
#200	12.8

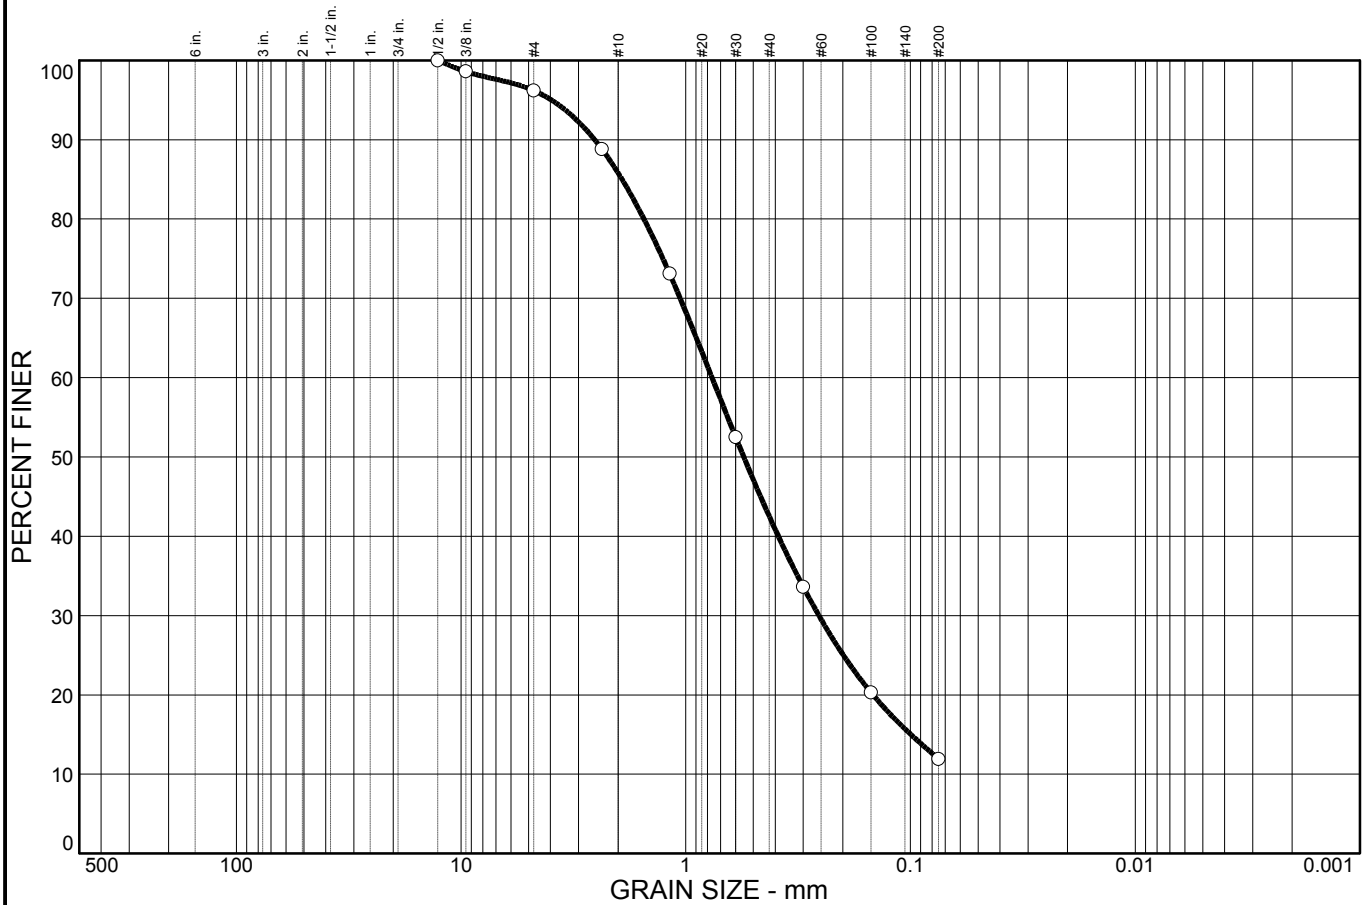
# Particle Size Distribution Report

% COBBLES	% GRAVEL		% SAND			% FINES	
	CRS.	FINE	CRS.	MEDIUM	FINE	SILT	CLAY
0.0	0.0	3.8	10.4	43.3	30.6	11.9

SIEVE SIZE	PERCENT FINER	SPEC.* PERCENT	PASS? (X=NO)
1/2 in.	100.0		
3/8 in.	98.6		
#4	96.2		
#8	88.8		
#16	73.1		
#30	52.5		
#50	33.6		
#100	20.3		
#200	11.9

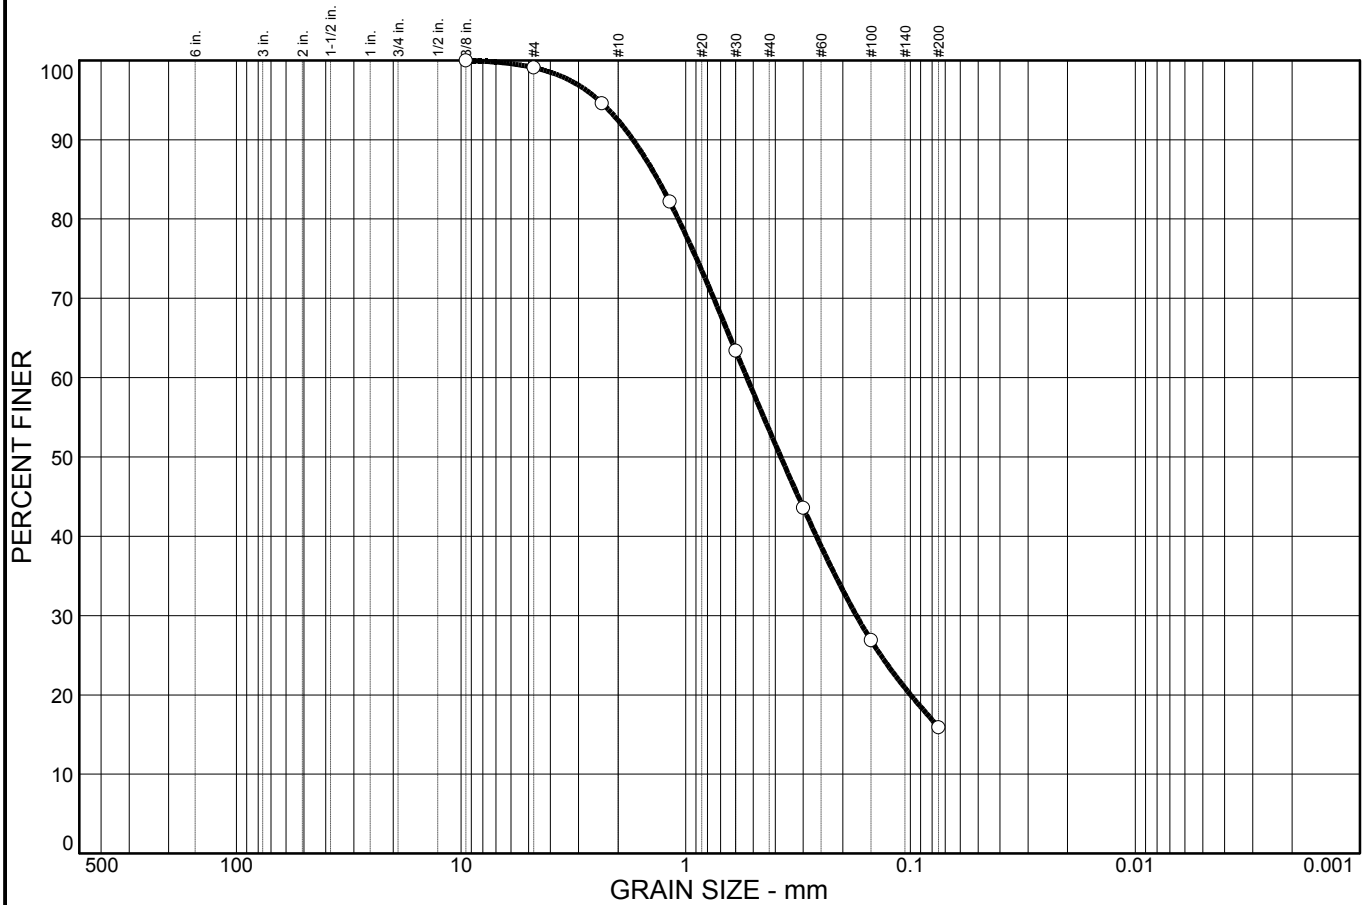
# Particle Size Distribution Report

% COBBLES	% GRAVEL		% SAND			% FINES	
	CRS.	FINE	CRS.	MEDIUM	FINE	SILT	CLAY
0.0	0.0	0.9	6.7	39.1	37.4	15.9

SIEVE SIZE	PERCENT FINER	SPEC.* PERCENT	PASS? (X=NO)
3/8 in.	100.0		
#4	99.1		
#8	94.6		
#16	82.2		
#30	63.4		
#50	43.6		
#100	26.9		
#200	15.9

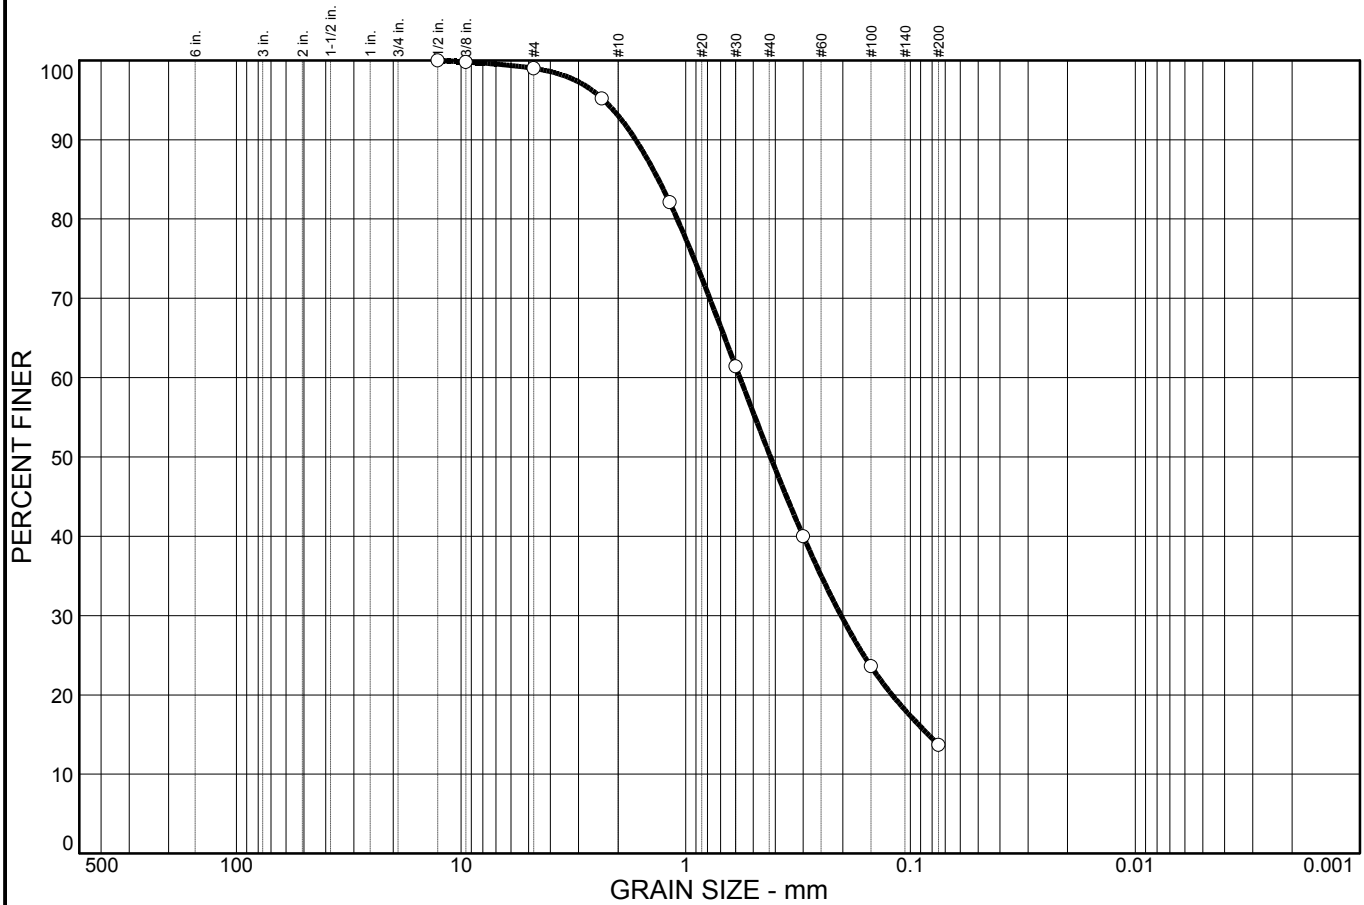
# Particle Size Distribution Report

% COBBLES	% GRAVEL		% SAND			% FINES	
	CRS.	FINE	CRS.	MEDIUM	FINE	SILT	CLAY
0.0	0.0	1.0	6.0	42.6	36.7	13.7

SIEVE SIZE	PERCENT FINER	SPEC.* PERCENT	PASS? (X=NO)
1/2 in.	100.0		
3/8 in.	99.8		
#4	99.0		
#8	95.2		
#16	82.1		
#30	61.4		
#50	40.0		
#100	23.6		
#200	13.7

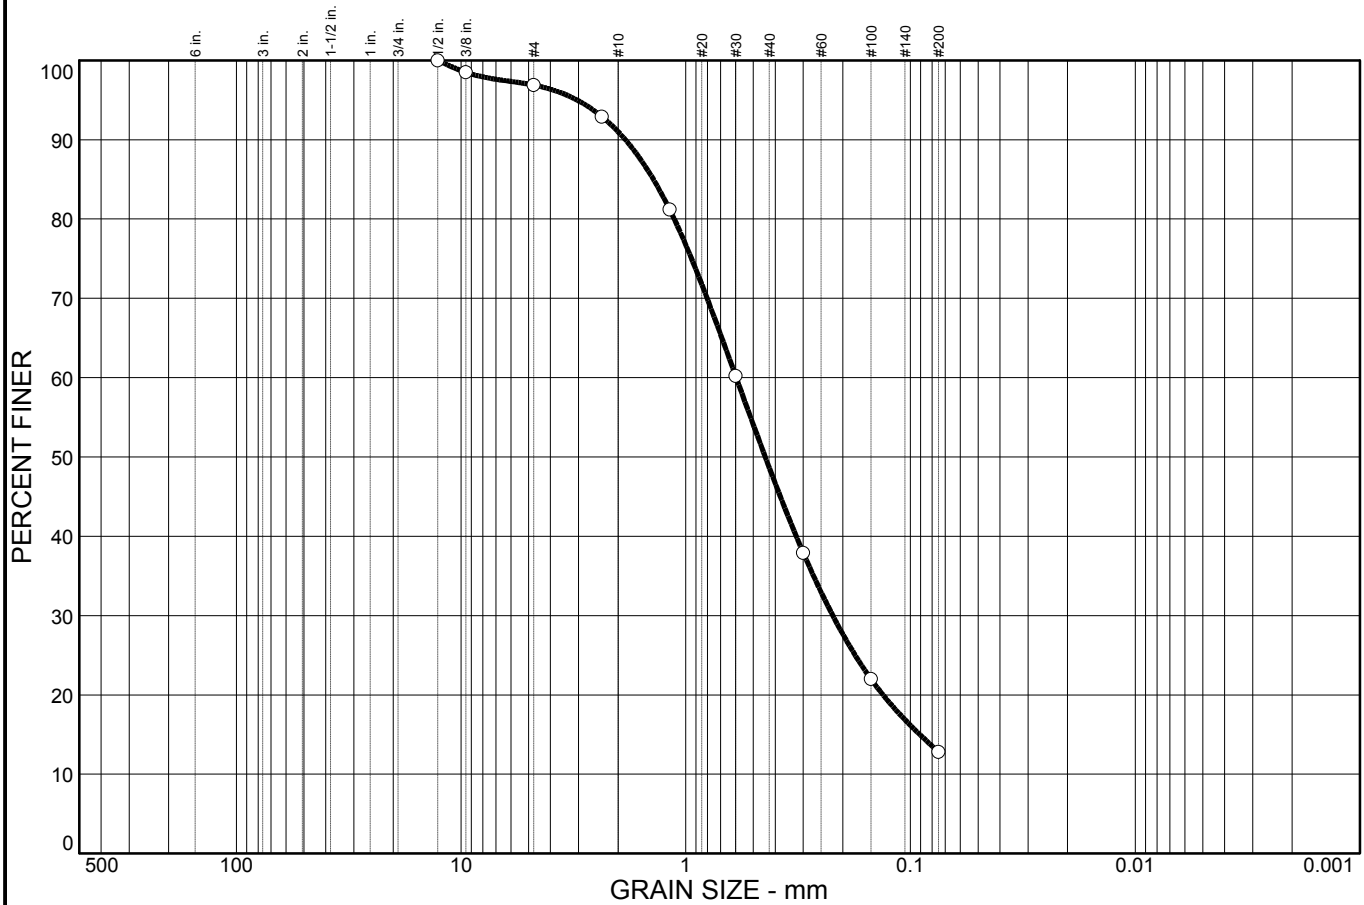
# Particle Size Distribution Report

% COBBLES	% GRAVEL		% SAND			% FINES	
	CRS.	FINE	CRS.	MEDIUM	FINE	SILT	CLAY
0.0	0.0	3.1	5.9	42.4	35.8	12.8

SIEVE SIZE	PERCENT FINER	SPEC.* PERCENT	PASS? (X=NO)
1/2 in.	100.0		
3/8 in.	98.5		
#4	96.9		
#8	92.9		
#16	81.2		
#30	60.2		
#50	37.9		
#100	22.0		
#200	12.8

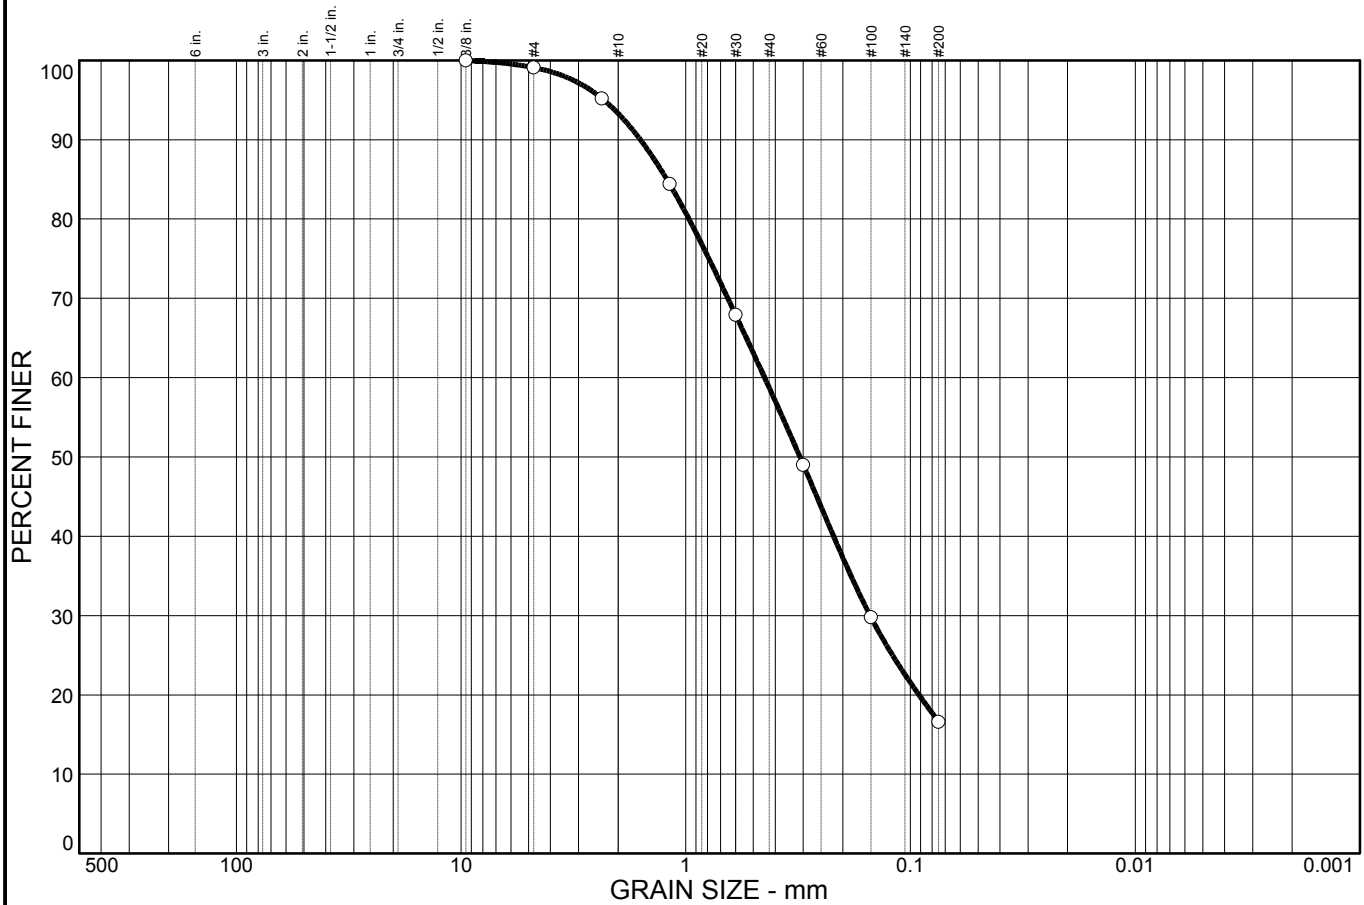
# Particle Size Distribution Report

% COBBLES	% GRAVEL		% SAND			% FINES	
	CRS.	FINE	CRS.	MEDIUM	FINE	SILT	CLAY
0.0	0.0	0.9	5.8	34.6	42.1	16.6

SIEVE SIZE	PERCENT FINER	SPEC.* PERCENT	PASS? (X=NO)
3/8 in.	100.0		
#4	99.1		
#8	95.2		
#16	84.4		
#30	67.9		
#50	49.0		
#100	29.8		
#200	16.6

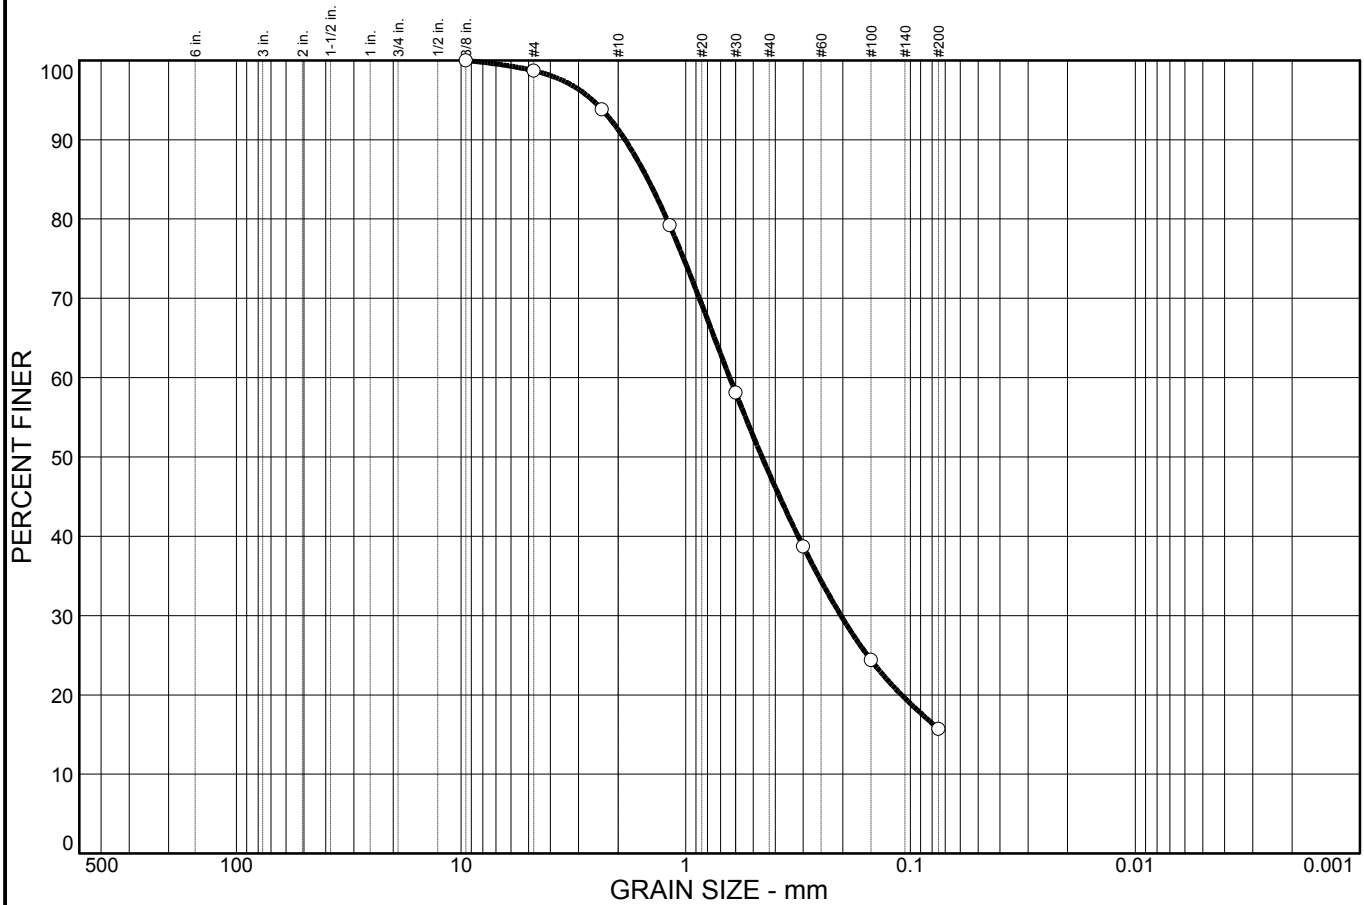
# Particle Size Distribution Report

% COBBLES	% GRAVEL		% SAND			% FINES	
	CRS.	FINE	CRS.	MEDIUM	FINE	SILT	CLAY
0.0	0.0	1.3	7.4	43.4	32.2	15.7

SIEVE SIZE	PERCENT FINER	SPEC.* PERCENT	PASS? (X=NO)
3/8 in.	100.0		
#4	98.7		
#8	93.8		
#16	79.2		
#30	58.1		
#50	38.7		
#100	24.4		
#200	15.7

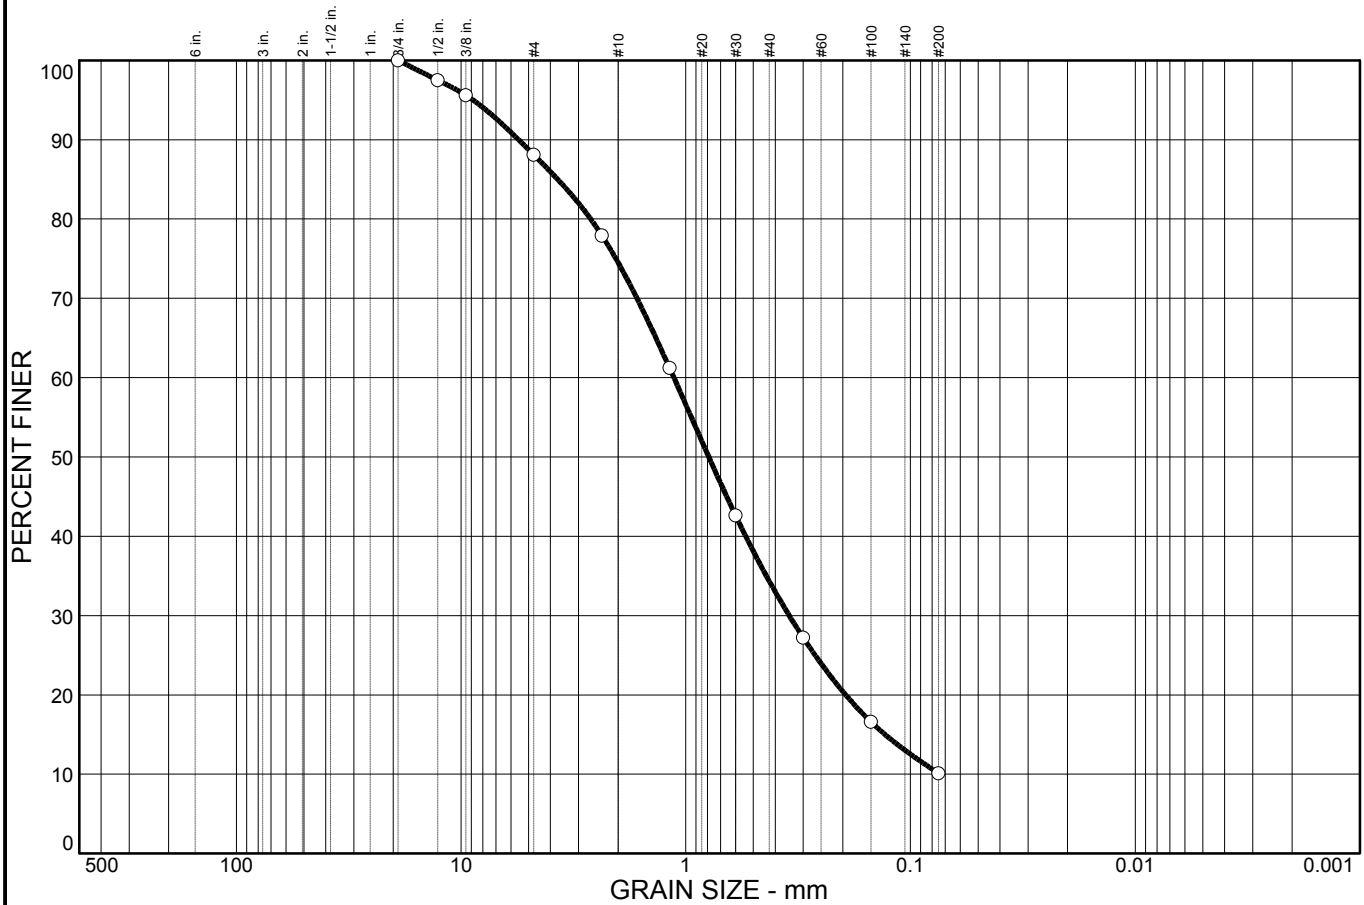
# Particle Size Distribution Report

% COBBLES	% GRAVEL		% SAND			% FINES	
	CRS.	FINE	CRS.	MEDIUM	FINE	SILT	CLAY
0.0	0.0	11.9	13.6	40.2	24.2	10.1

SIEVE SIZE	PERCENT FINER	SPEC.* PERCENT	PASS? (X=NO)
3/4 in.	100.0		
1/2 in.	97.5		
3/8 in.	95.6		
#4	88.1		
#8	77.9		
#16	61.2		
#30	42.6		
#50	27.2		
#100	16.6		
#200	10.1

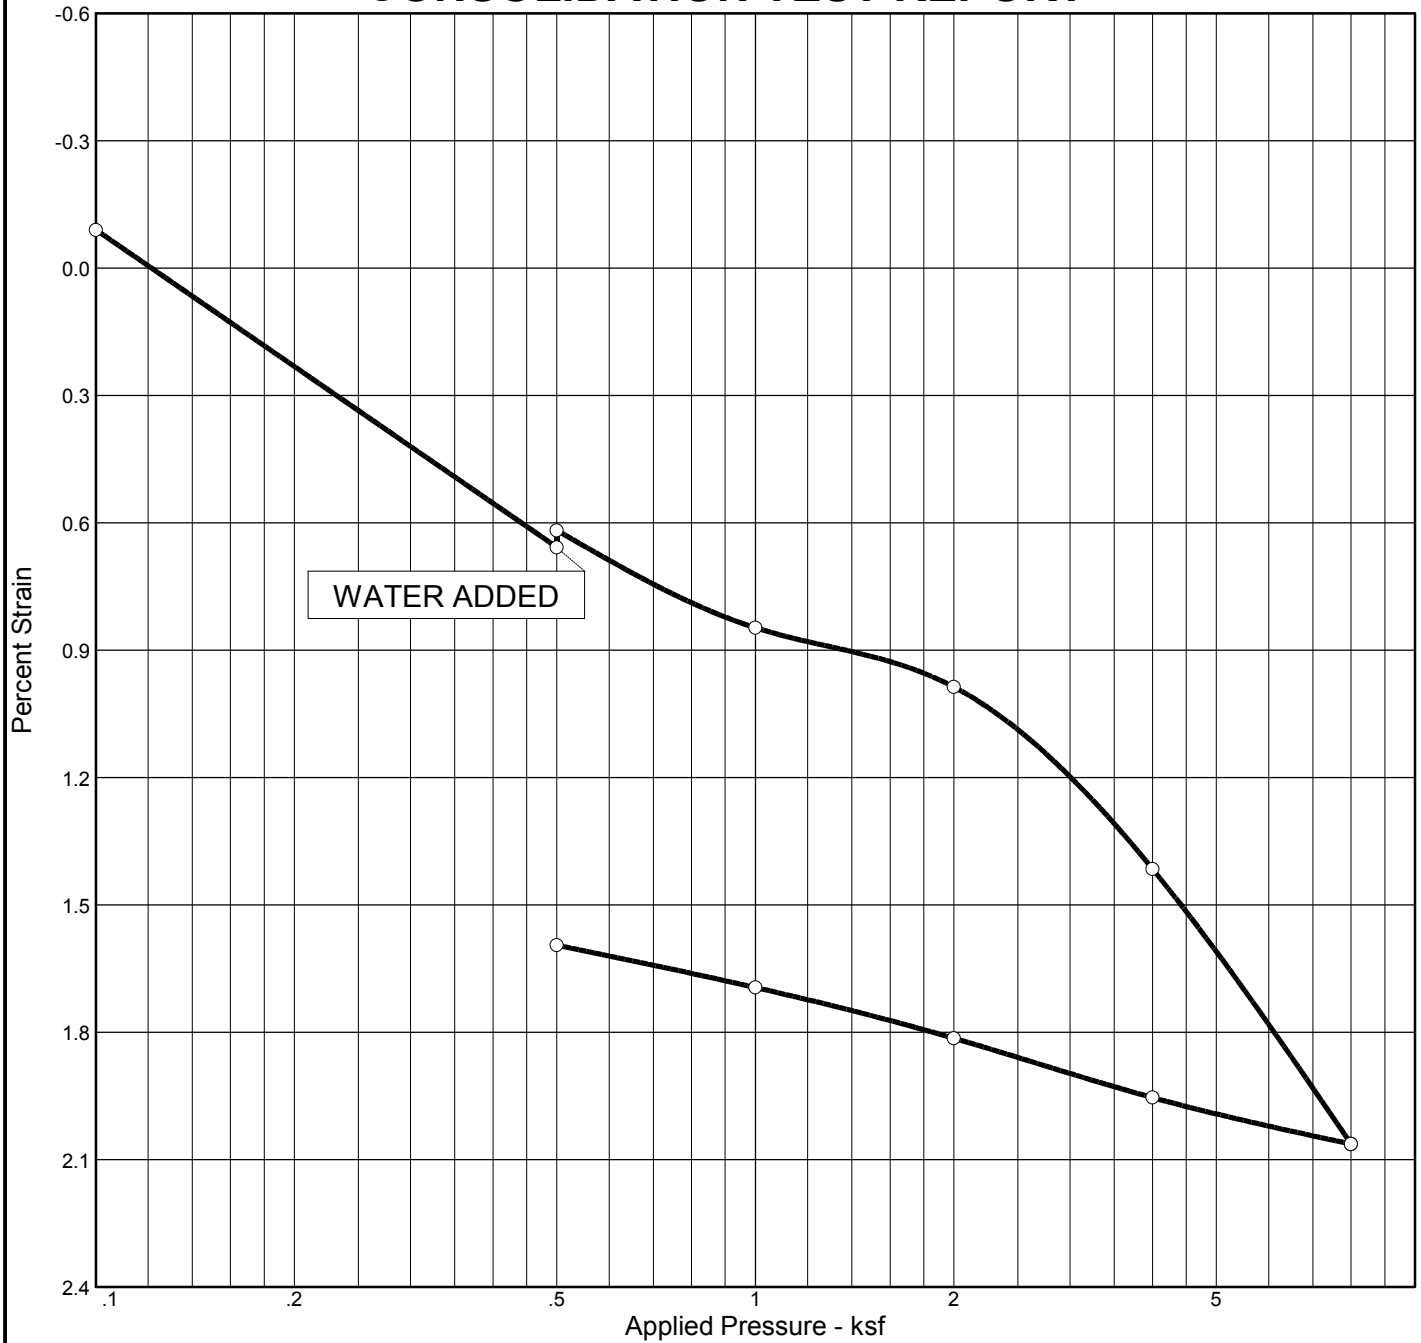
# CONSOLIDATION TEST REPORT

Natural		Dry Dens. (pcf)	LL	PI	Sp. Gr.	Overburden (ksf)	P <sub>c</sub> (ksf)	C <sub>c</sub>	C <sub>s</sub>	Swell Press. (ksf)	Swell %	e <sub>0</sub>
Sat.	Moist.											
30.8 %	4.6 %	118.4			2.65		2.75	0.03	0.01	0.55	0.1	0.397

MATERIAL DESCRIPTION	USCS	AASHTO
Silty sand	SM

<p><b>Project No.</b> G28851.02      <b>Client:</b> Circle K Stores, Inc.</p> <p><b>Project:</b> Circle K Yucca Valley</p> <p><b>Source:</b>                      <b>Sample No.:</b> B-7                      <b>Elev./Depth:</b> 1.5-3'</p> <p style="text-align: center;"><b>Moore Twining Associates, Inc.</b></p> <p style="text-align: center;"><b>Fresno, CA</b></p>	<p><b>Remarks:</b></p>
--	------------------------

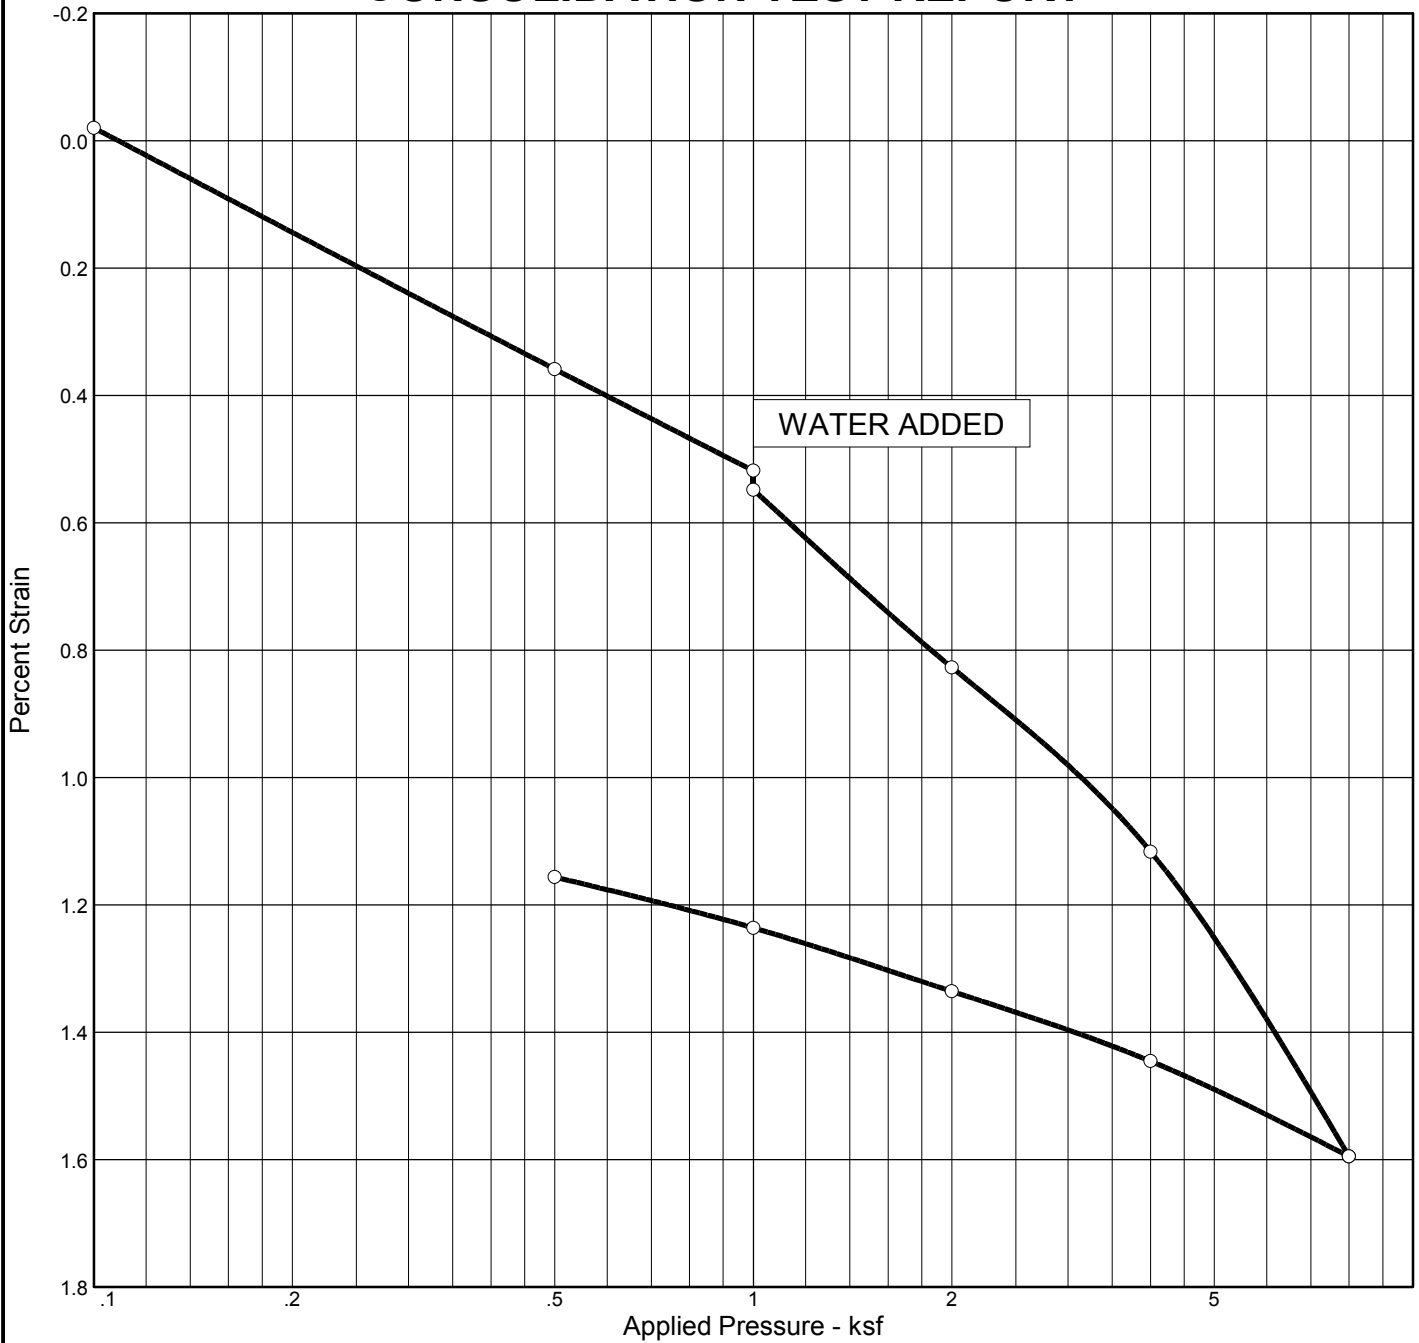
# CONSOLIDATION TEST REPORT

Natural		Dry Dens. (pcf)	LL	PI	Sp. Gr.	Overburden (ksf)	P <sub>c</sub> (ksf)	C <sub>c</sub>	C <sub>s</sub>	Swell Press. (ksf)	Swell %	e <sub>0</sub>
Sat.	Moist.											
21.0 %	3.8 %	112.0			2.65		4.24	0.02	0.01			0.477

MATERIAL DESCRIPTION	USCS	AASHTO
Silty sand	SM

<b>Project No.</b> G28851.02 <b>Client:</b> Circle K Stores, Inc. <b>Project:</b> Circle K Yucca Valley  <b>Source:</b> <b>Sample No.:</b> B-6 <b>Elev./Depth:</b> 5-6.5' <div style="text-align: center; border: 1px solid black; padding: 5px;"> <b>Moore Twining Associates, Inc.</b>  <b>Fresno, CA</b> </div>	<b>Remarks:</b>          
--	---

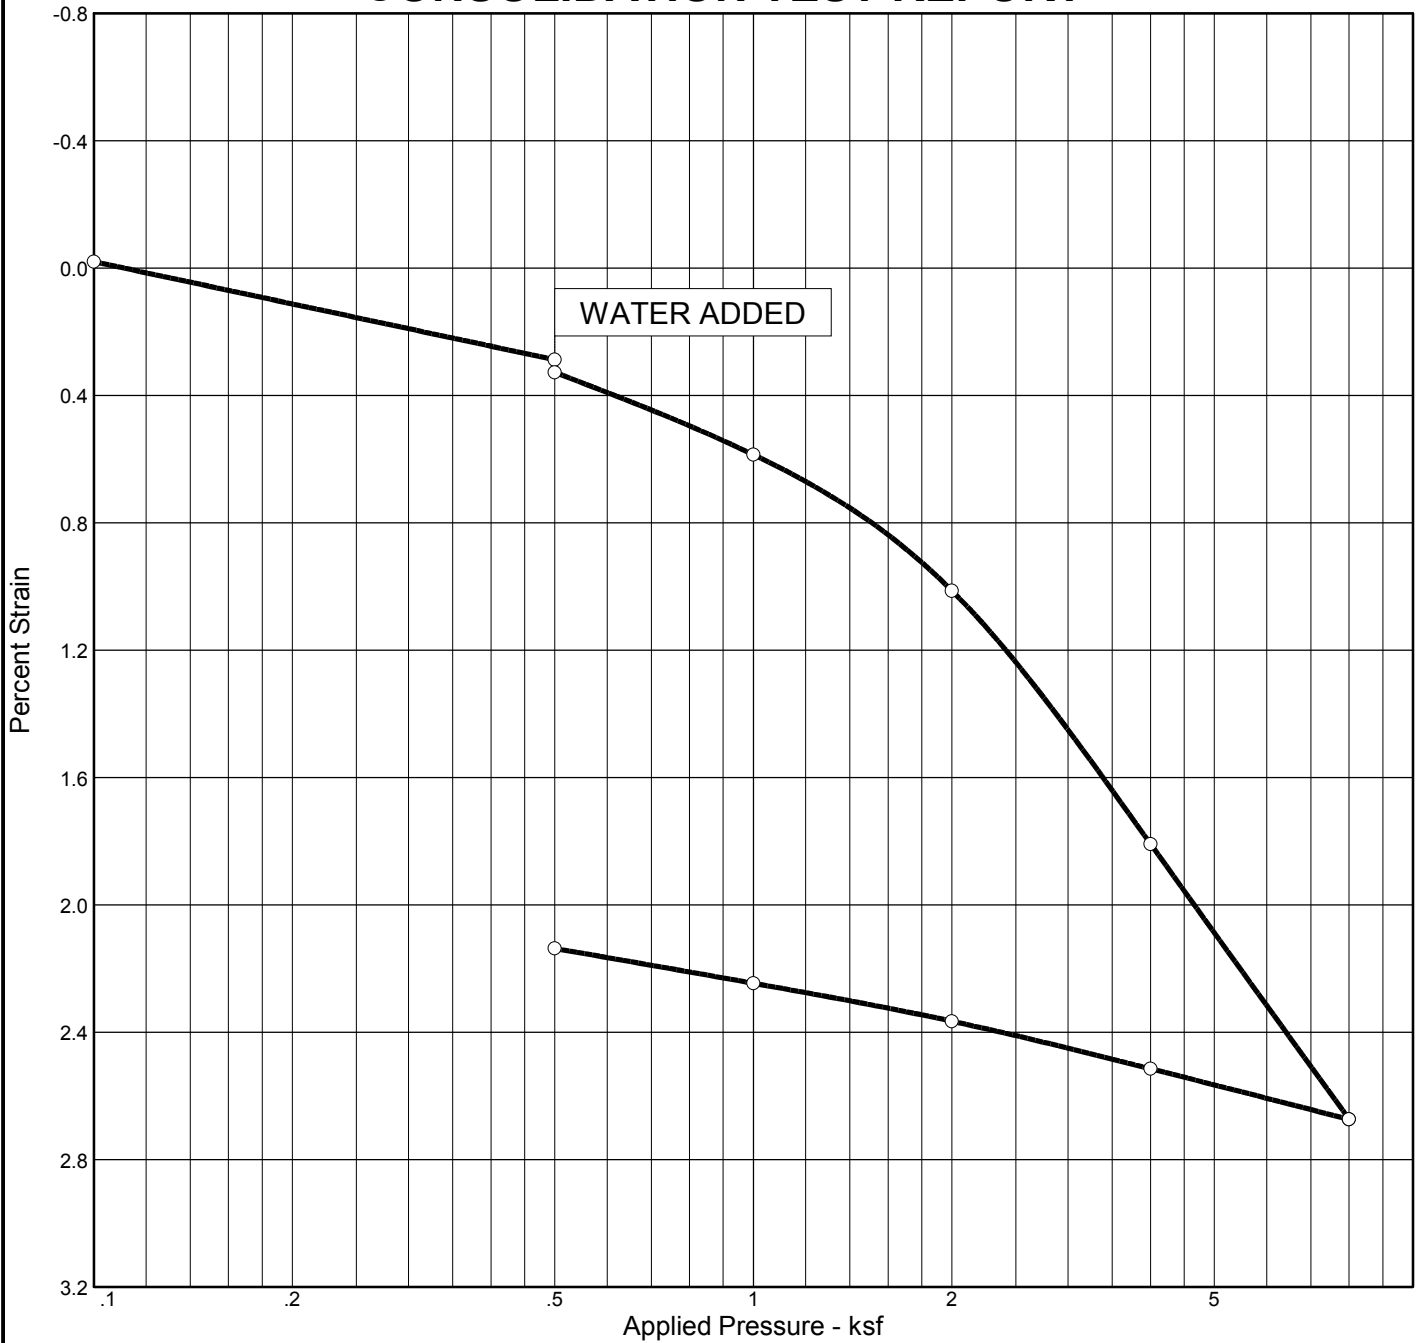
# CONSOLIDATION TEST REPORT

Natural		Dry Dens. (pcf)	LL	PI	Sp. Gr.	Overburden (ksf)	P <sub>c</sub> (ksf)	C <sub>c</sub>	C <sub>s</sub>	Swell Press. (ksf)	Swell %	e <sub>0</sub>
Sat.	Moist.											
28.6 %	5.3 %	111.0			2.65		2.07	0.04	0.01			0.490

MATERIAL DESCRIPTION	USCS	AASHTO
Silty sand	SM

<b>Project No.</b> G28851.02 <b>Client:</b> Circle K Stores, Inc. <b>Project:</b> Circle K Yucca Valley  <b>Source:</b> <b>Sample No.:</b> B-6 <b>Elev./Depth:</b> 2-3.5' <div style="text-align: center; border: 1px solid black; padding: 5px;"> <b>Moore Twining Associates, Inc.</b>  <b>Fresno, CA</b> </div>	<b>Remarks:</b>     
--	-------------------------------------

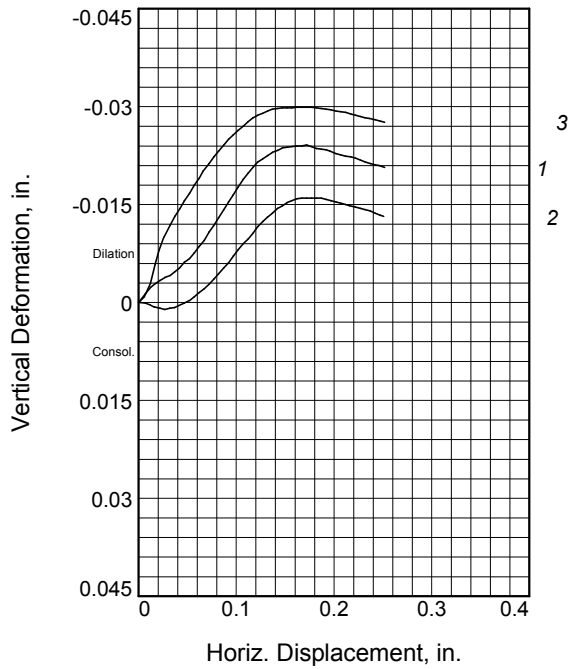
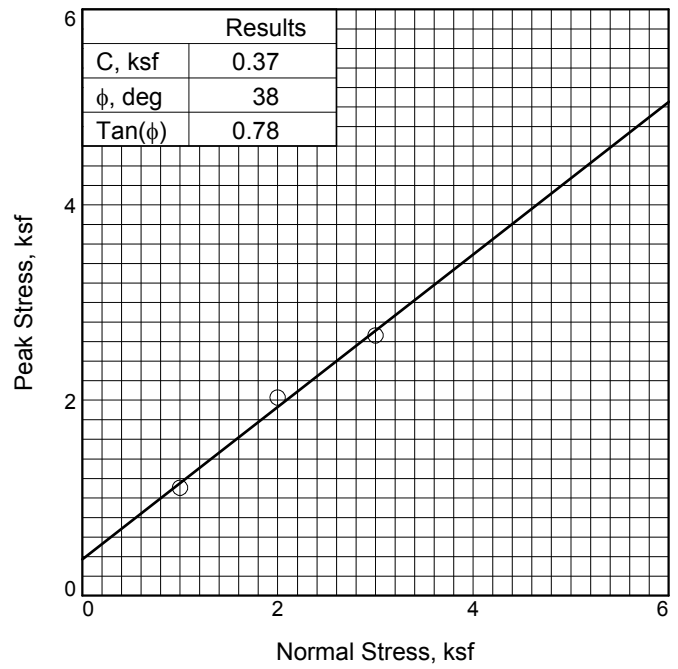
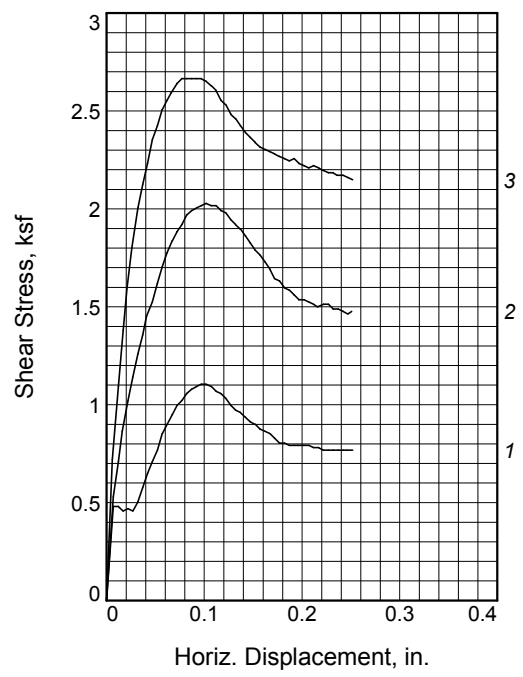
DIRECT SHEAR TEST REPORT  
 Moore Twining Associates, Inc.  
 Fresno, CA

Sample No.	1	2	3	
Initial	Water Content, %	4.6	5.3	5.6
	Dry Density, pcf	118.0	114.9	117.8
	Saturation, %	30.6	31.8	36.5
	Void Ratio	0.4020	0.4395	0.4050
	Diameter, in.	2.42	2.42	2.42
	Height, in.	1.00	1.00	1.00
At Test	Water Content, %	14.8	16.0	14.7
	Dry Density, pcf	118.0	115.0	118.0
	Saturation, %	97.5	96.7	96.7
	Void Ratio	0.4018	0.4381	0.4021
	Diameter, in.	2.42	2.42	2.42
	Height, in.	1.00	1.00	1.00
Normal Stress, ksf	1.00	2.00	3.00	
Peak Stress, ksf	1.10	2.03	2.66	
Displacement, in.	0.10	0.10	0.08	
Ultimate Stress, ksf				
Displacement, in.				
Strain at peak, %	4.0	4.2	3.2

**Sample Type:**  
**Description:** Silty sand  
**Specific Gravity=** 2.65  
**Remarks:**

**Client:** Circle K Stores, Inc.  
**Project:** Circle K Yucca Valley  
**Sample Number:** B-4      **Depth:** 5-6.5'  
**Proj. No.:** G28851.02      **Date Sampled:** 8/16/24
