**GEOTECHNICAL ENGINEERING INVESTIGATION**

**PROPOSED CIRCLE K**

**NORTHWEST CORNER OF TWENTYNINE PALMS HIGHWAY**

**Project Number: G28851.02**

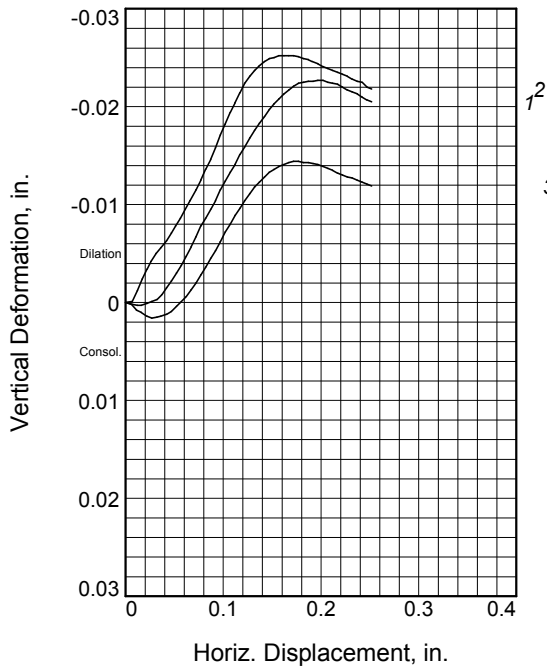
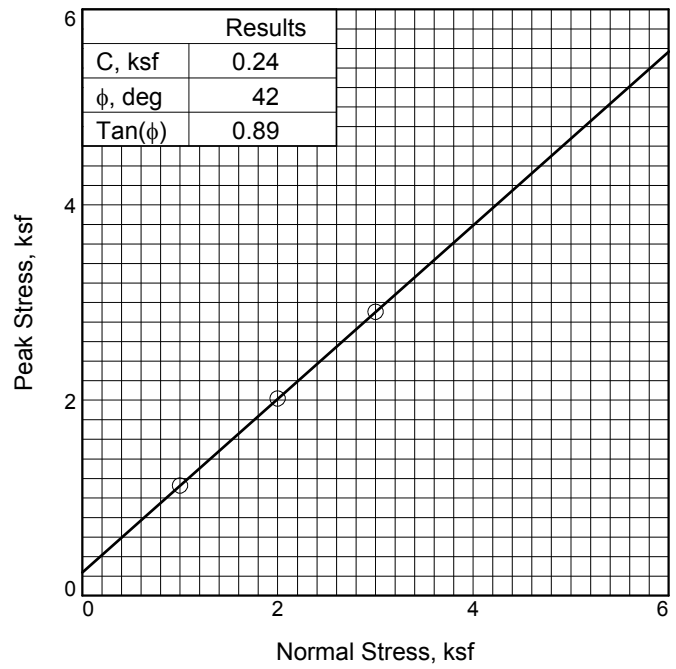
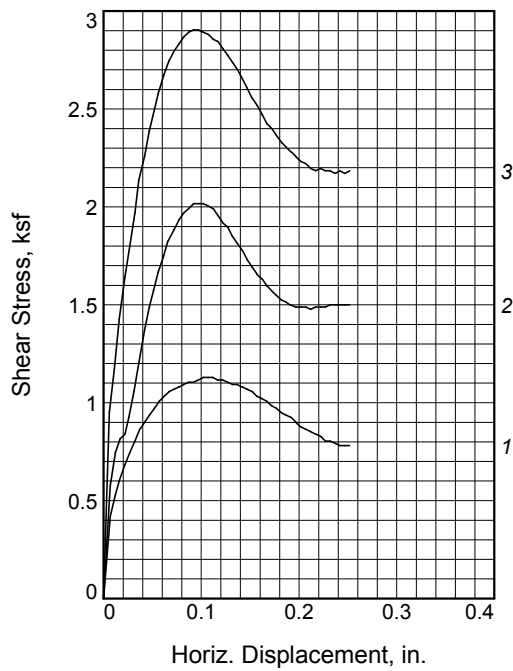
DIRECT SHEAR TEST REPORT  
 Moore Twining Associates, Inc.  
 Fresno, CA

Sample No.	1	2	3	
Initial	Water Content, %	5.8	5.0	7.3
	Dry Density, pcf	113.2	112.1	109.2
	Saturation, %	33.3	27.7	37.6
	Void Ratio	0.4617	0.4758	0.5151
	Diameter, in.	2.42	2.42	2.42
	Height, in.	1.00	1.00	1.00
At Test	Water Content, %	17.1	17.5	18.9
	Dry Density, pcf	113.4	112.3	109.4
	Saturation, %	98.7	98.0	97.7
	Void Ratio	0.4595	0.4731	0.5119
	Diameter, in.	2.42	2.42	2.42
	Height, in.	1.00	1.00	1.00
Normal Stress, ksf	1.00	2.00	3.00	
Peak Stress, ksf	1.13	2.02	2.90	
Displacement, in.	0.10	0.09	0.09	
Ultimate Stress, ksf				
Displacement, in.				
Strain at peak, %	4.2	3.8	3.8

**Sample Type:**  
**Description:** Silty sand

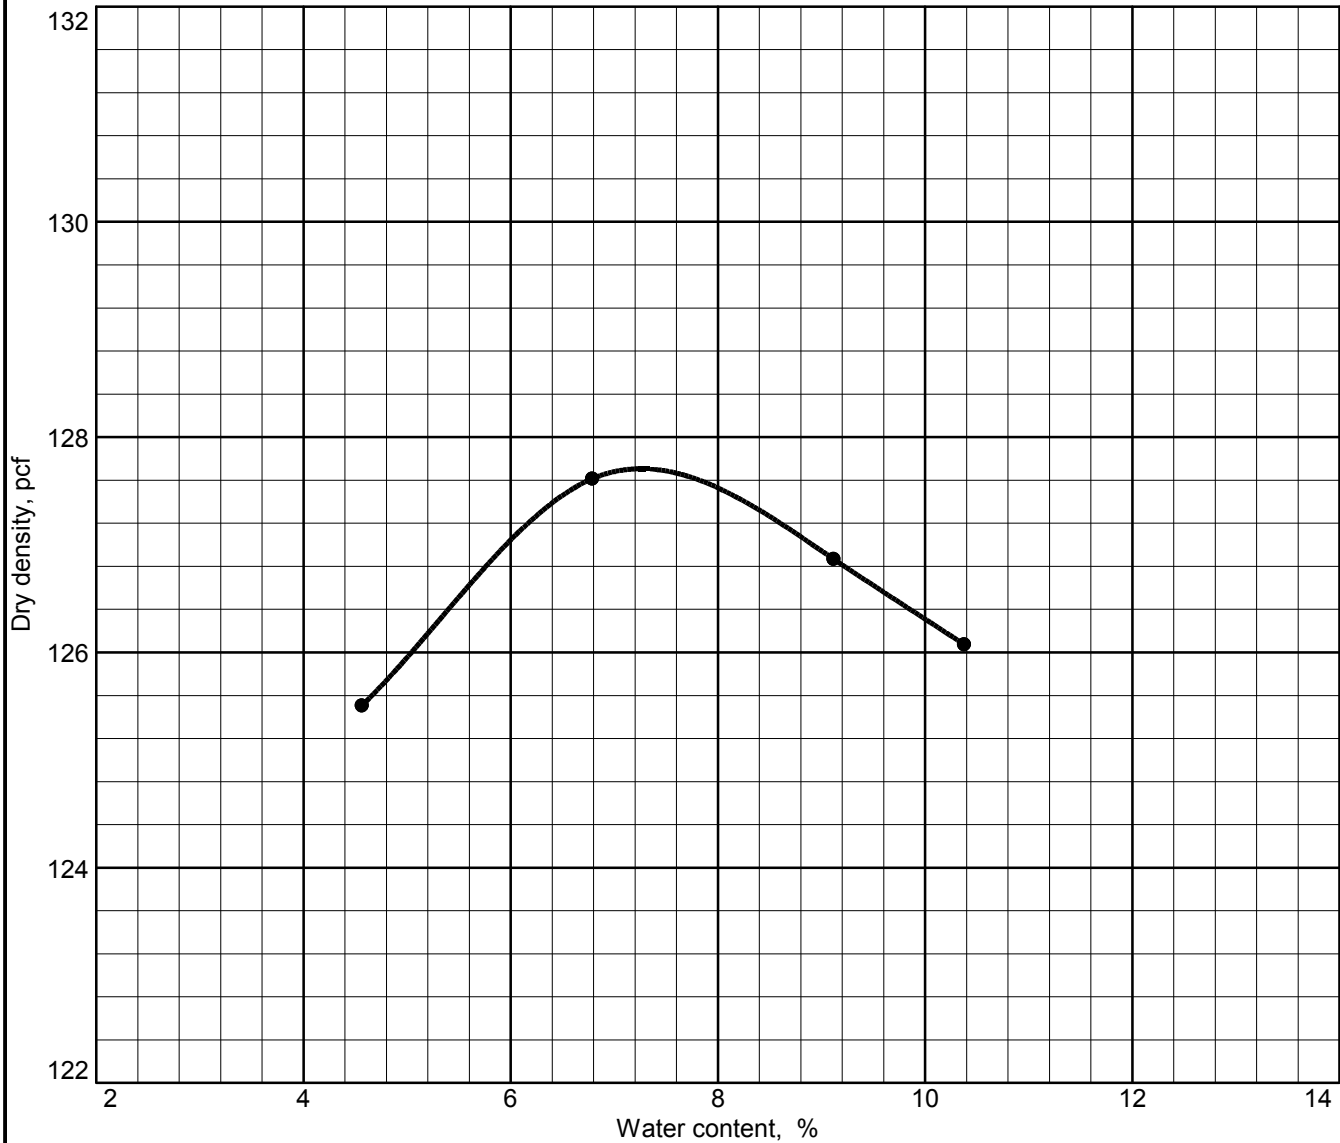
# COMPACTION TEST REPORT

Test specification: ASTM D 1557-12 Method A Modified

Elev/ Depth	Classification		Nat. Moist.	Sp.G.	LL	PI	% > No.4	% < No.200
	USCS	AASHTO						
0-3.5'	SM						1.3	15.7

TEST RESULTS	MATERIAL DESCRIPTION
Maximum dry density = 127.7 pcf Optimum moisture = 7.3 %	Silty sand
<b>Project No.</b> G28851.02 <b>Client:</b> Circle K Stores, Inc. <b>Project:</b> Circle K Yucca Valley  <b>● Source:</b> <b>Sample No.:</b> B-8 <b>Elev./Depth:</b> 0-3.5'	<b>Remarks:</b>
<b>Moore Twining Associates, Inc.</b> <b>Fresno, CA</b>

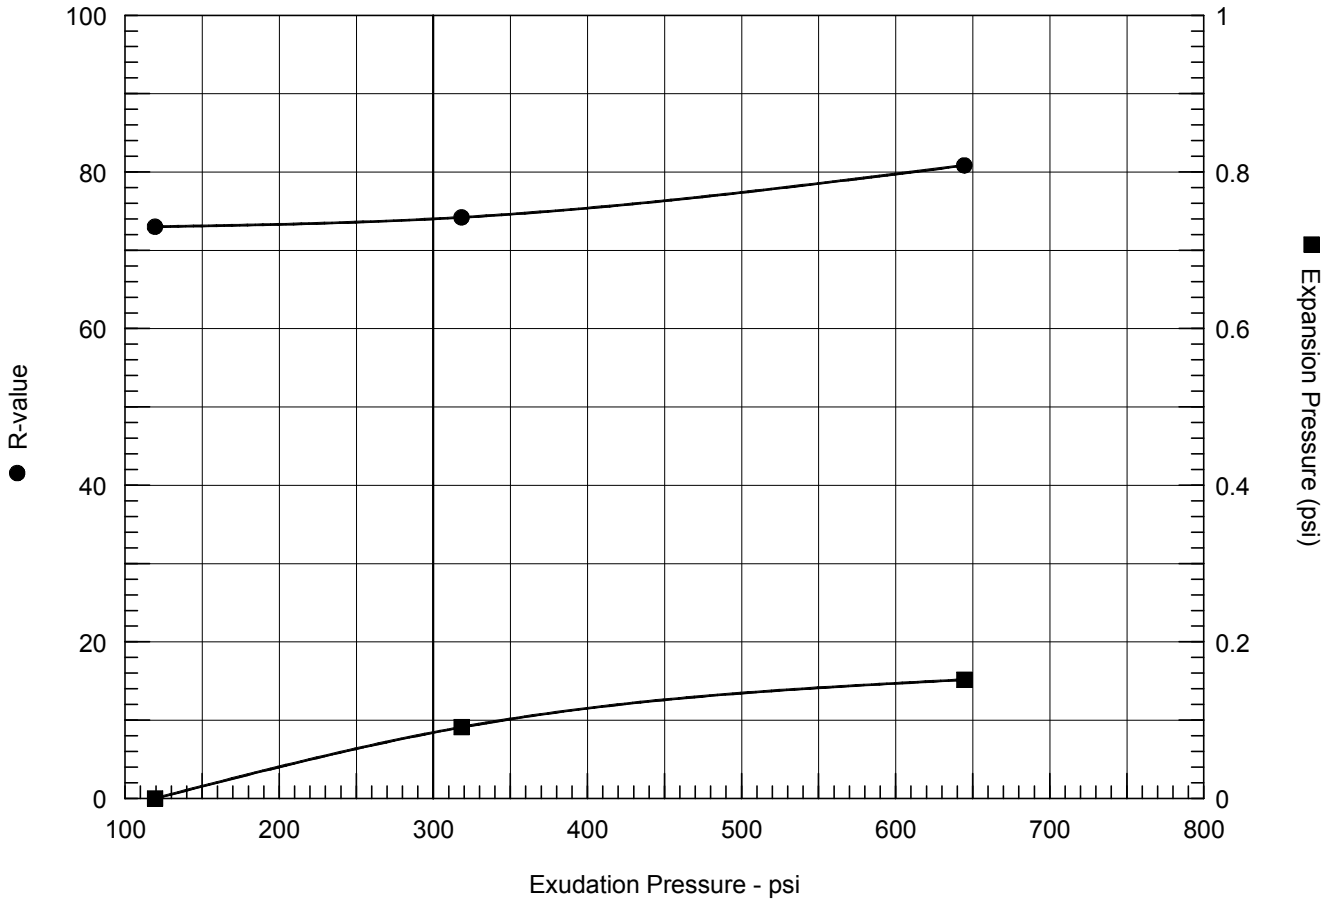
# R-VALUE TEST REPORT

**Resistance R-Value and Expansion Pressure - ASTM D 2844**

No.	Compact. Pressure psi	Density pcf	Moist. %	Expansion Pressure psi	Horizontal Press. psi @ 160 psi	Sample Height in.	Exud. Pressure psi	R Value	R Value Corr.
1	350	125.1	8.8	0.15	18	2.62	645	79	81
2	350	124.0	9.7	0.09	24	2.64	318	71	74
3	350	122.6	10.6	0.00	29	2.66	119	70	73

Test Results	Material Description
<p><b>R-value at 300 psi exudation pressure = 74</b></p> <p><b>Exp. pressure at 300 psi exudation pressure = 0.08 psi</b></p>	Silty sand
<p><b>Project No.:</b> G28851.02</p> <p><b>Project:</b> Circle K Yucca Valley</p> <p><b>Sample Number:</b> B-2/P-1                      <b>Depth:</b> 0-3.5'</p> <p><b>Date:</b> 8/26/2024</p>	<p><b>Tested by:</b> CG</p> <p><b>Checked by:</b> MS</p> <p><b>Remarks:</b></p>
<p>R-VALUE TEST REPORT</p> <p><b>Moore Twining Associates, Inc.</b></p>

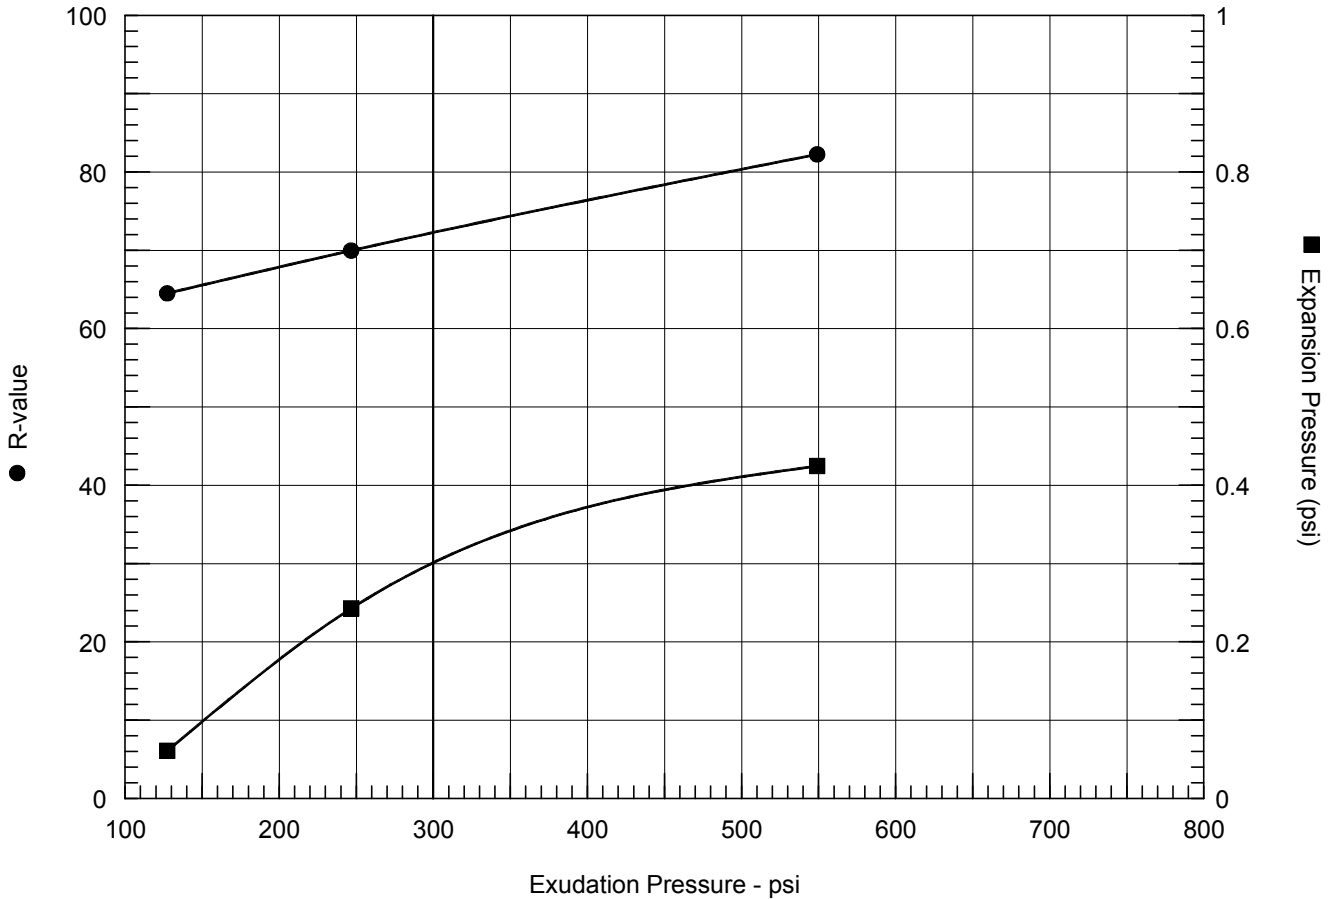
# R-VALUE TEST REPORT

**Resistance R-Value and Expansion Pressure - ASTM D 2844**

No.	Compact. Pressure psi	Density pcf	Moist. %	Expansion Pressure psi	Horizontal Press. psi @ 160 psi	Sample Height in.	Exud. Pressure psi	R Value	R Value Corr.
1	350	127.6	9.4	0.42	17	2.54	549	82	82
2	350	128.2	10.3	0.06	34	2.53	127	64	64
3	350	128.5	9.8	0.24	29	2.52	247	70	70

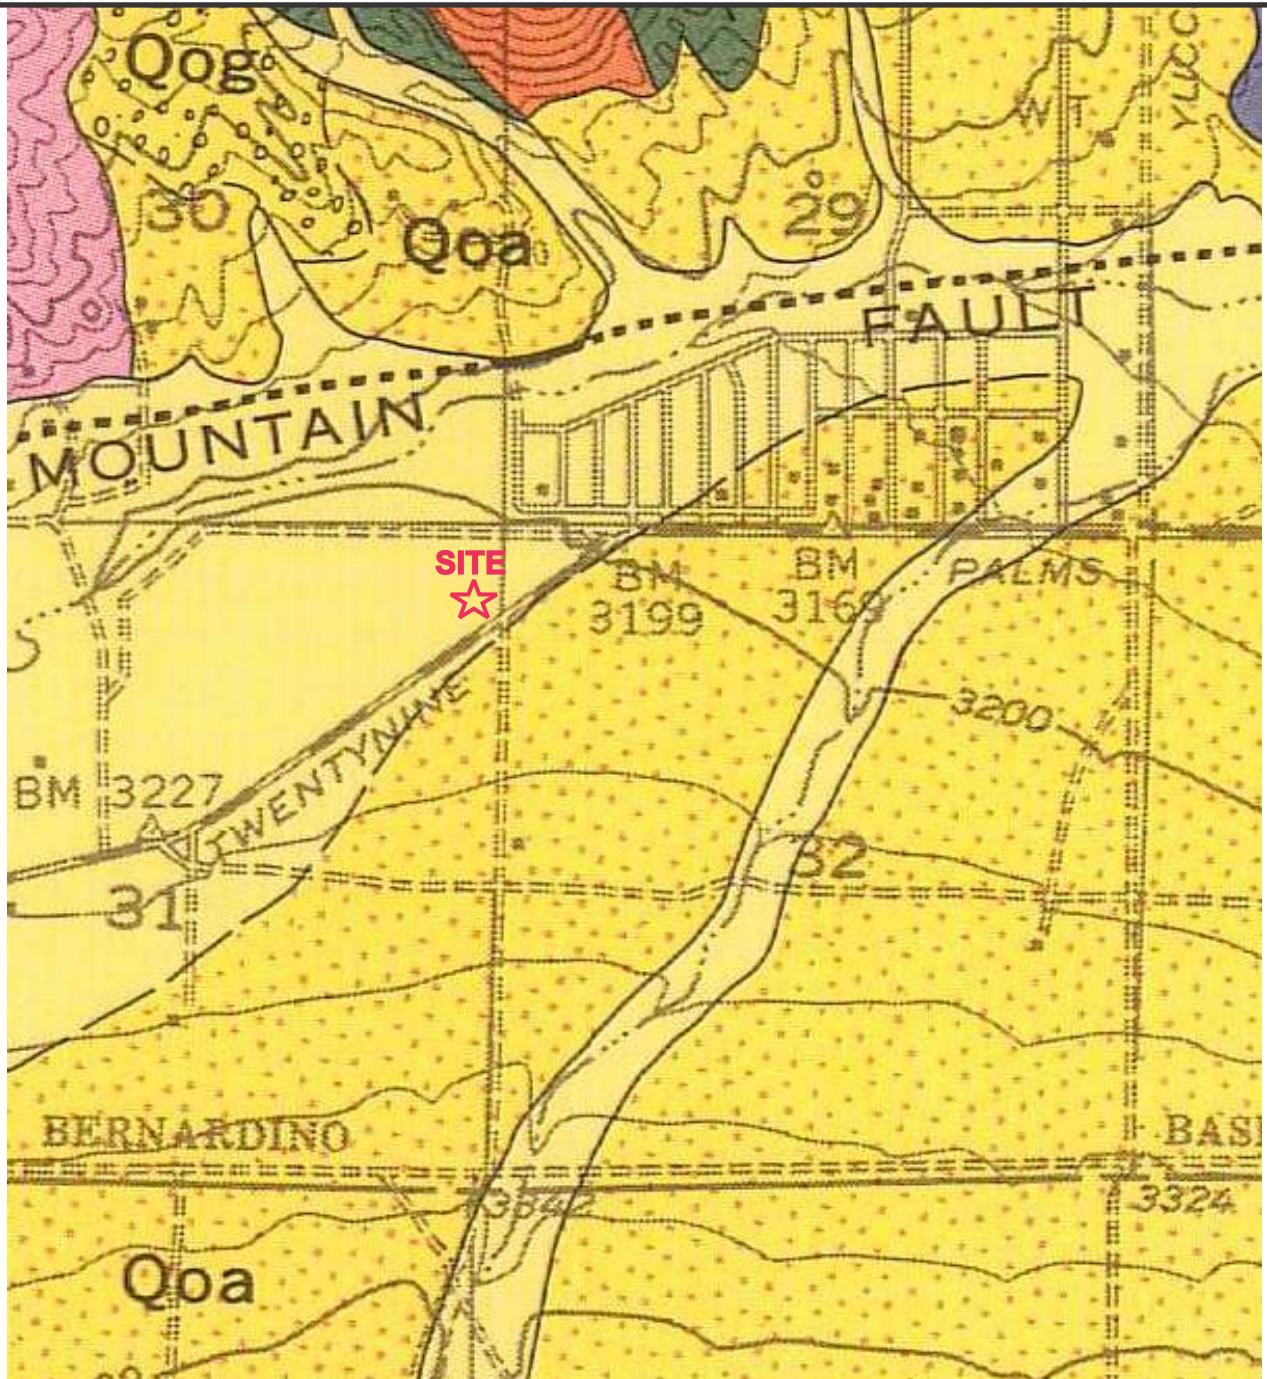
<b>REGIONAL GEOLOGIC MAP</b>	
APN 0601-543-01, Avalon Avenue, Yucca Valley	
By: MC	Date: 8/2024
Project No.: 1664-01.1	<b>Figure 2</b>

- Qa Qa, *alluvium*
- Qoa Qoa, *older alluvium*

‘Regional Geologic Map’ ..... Figure No. 2

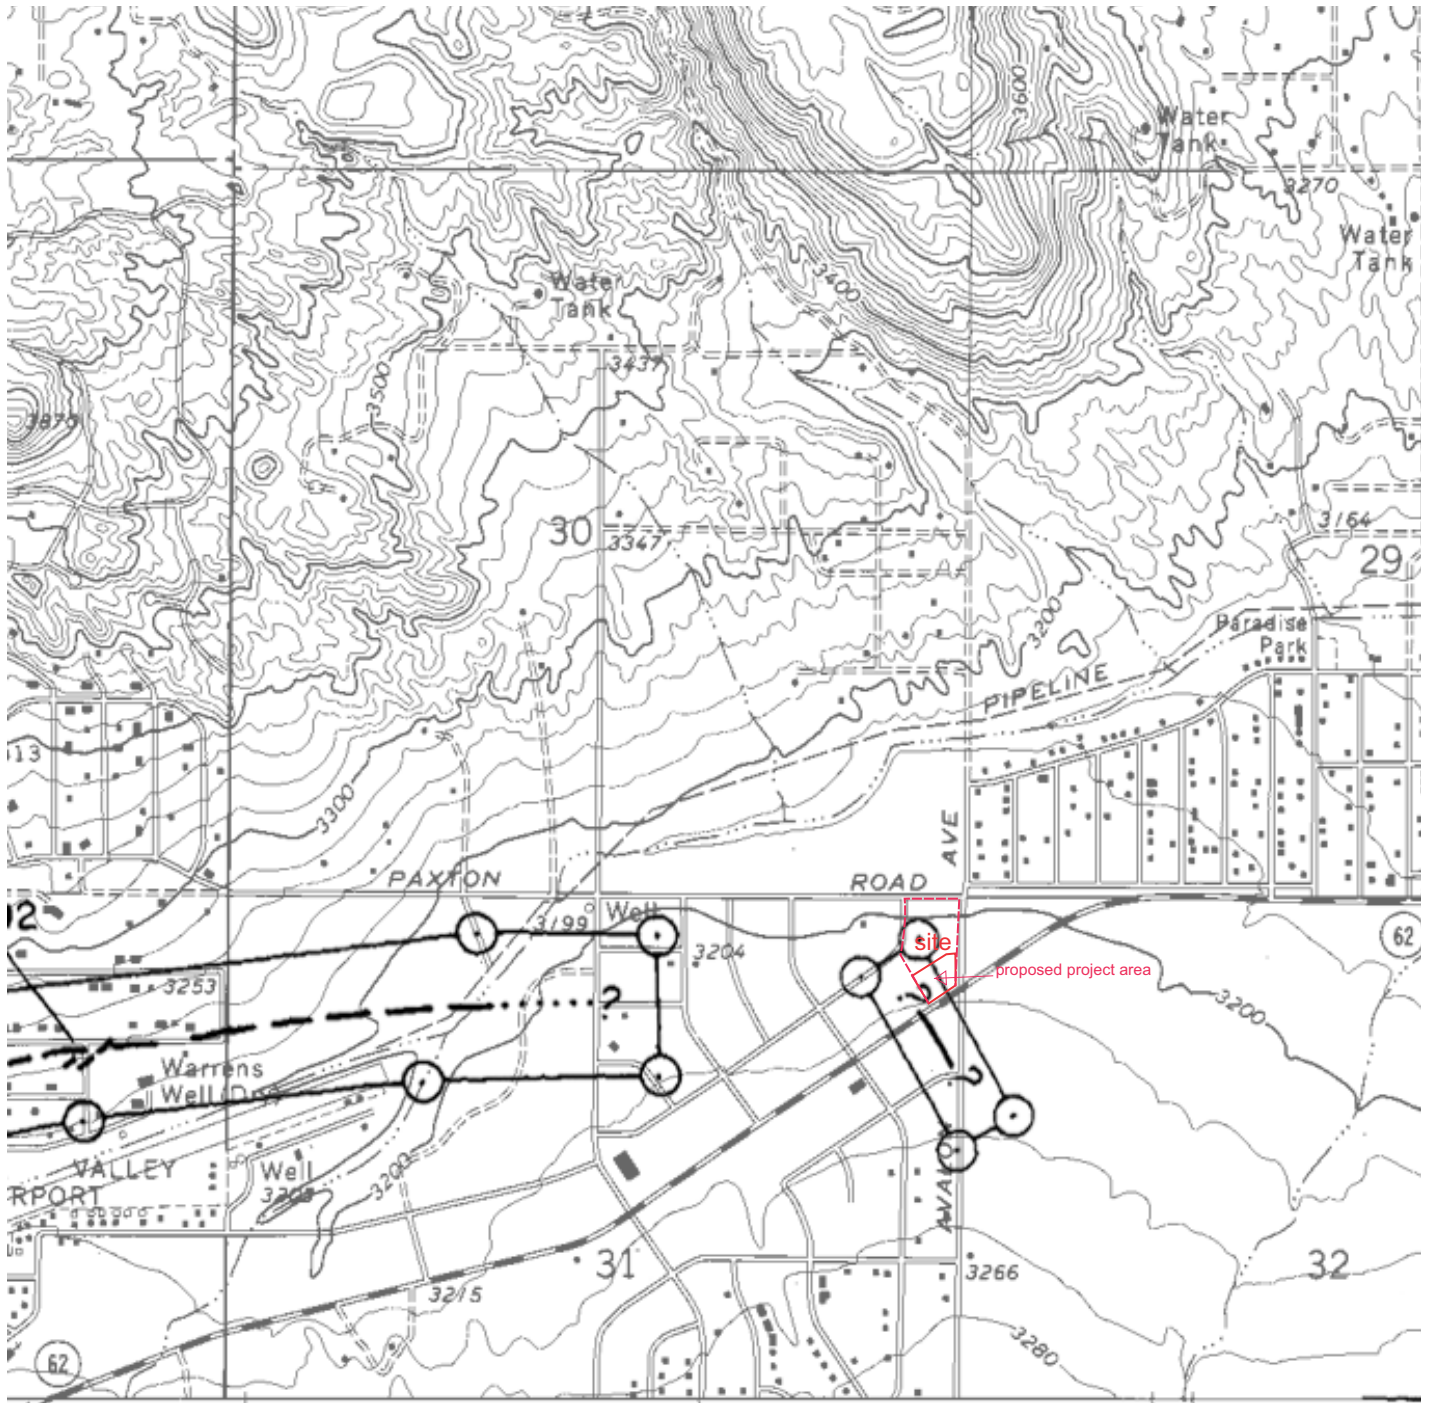
**Figure 3**

Source: excerpt for Special Studies Zones-Yucca Valley North Quadrangle-Revised Official Map Effective: July 1, 1993.

The Eureka Peak fault is located approximately 0.6 miles southwest of the site per Earthquake Zone of Required Investigation (**Figure 3**). The Eureka Peak fault is included in an Alquist-Priolo Earthquake Fault Zone, designated by CGS, as a result of the Landers Earthquake. Investigations by Rasmussen & Associates documented up to 8 inches of right-lateral, strike-slip offset along the Eureka Peak fault associated with the Landers earthquake (Rasmussen, 1992).

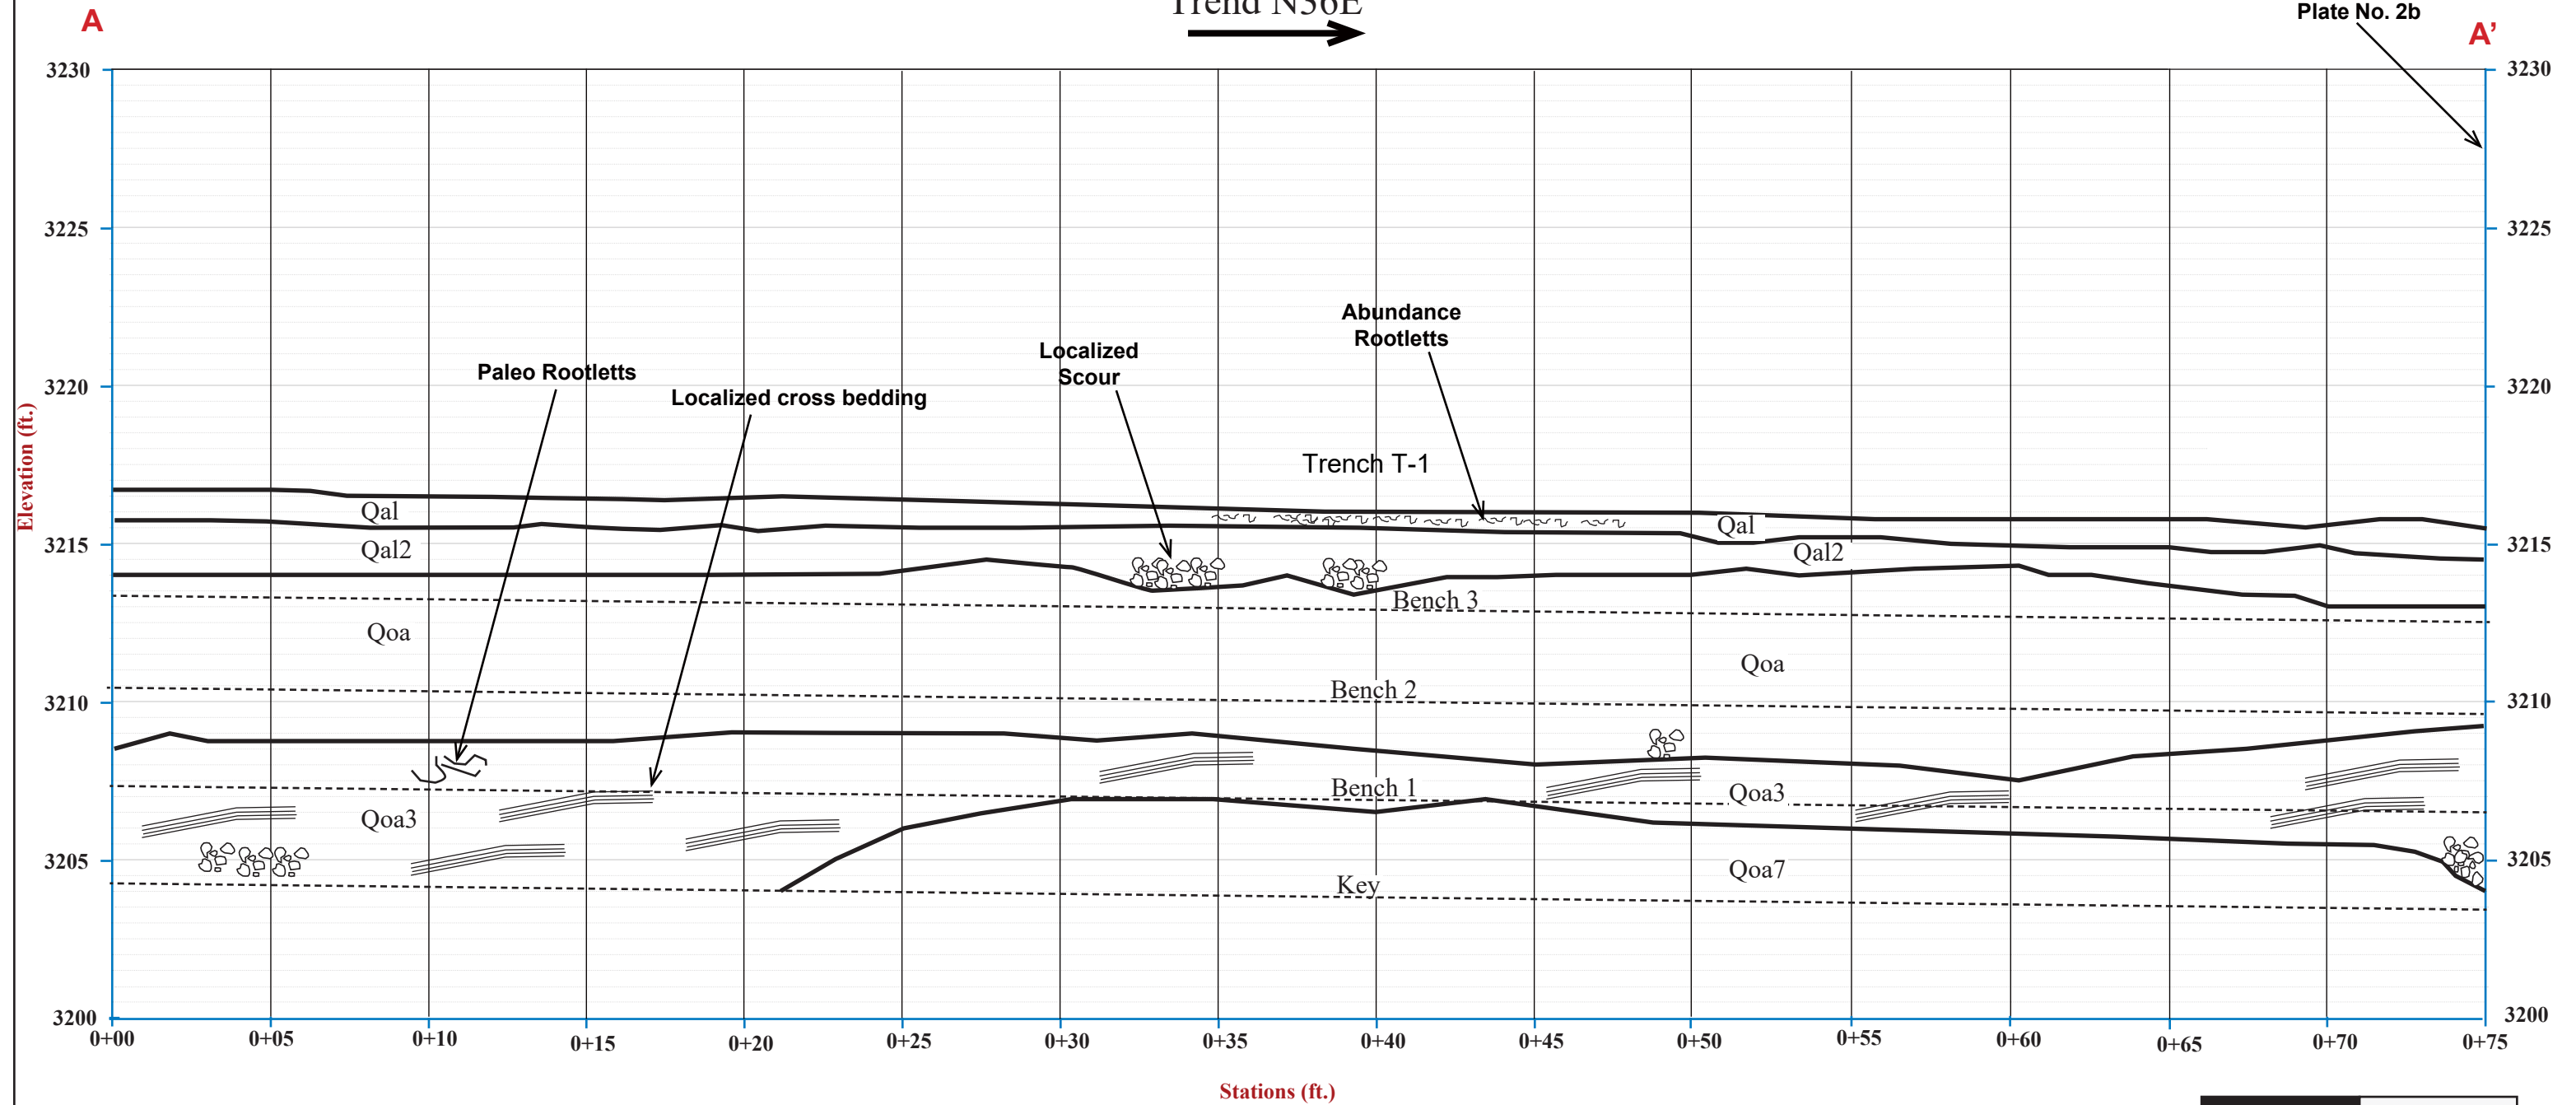
Plate No.:  
**2a**

Trench Log 1 of 3  
Trend N36E

- Approximate Soil Stratigraphy Contacts
- - - Trench Benching

‘Trench Log 1 of 3’ ..... Plate No. 2a

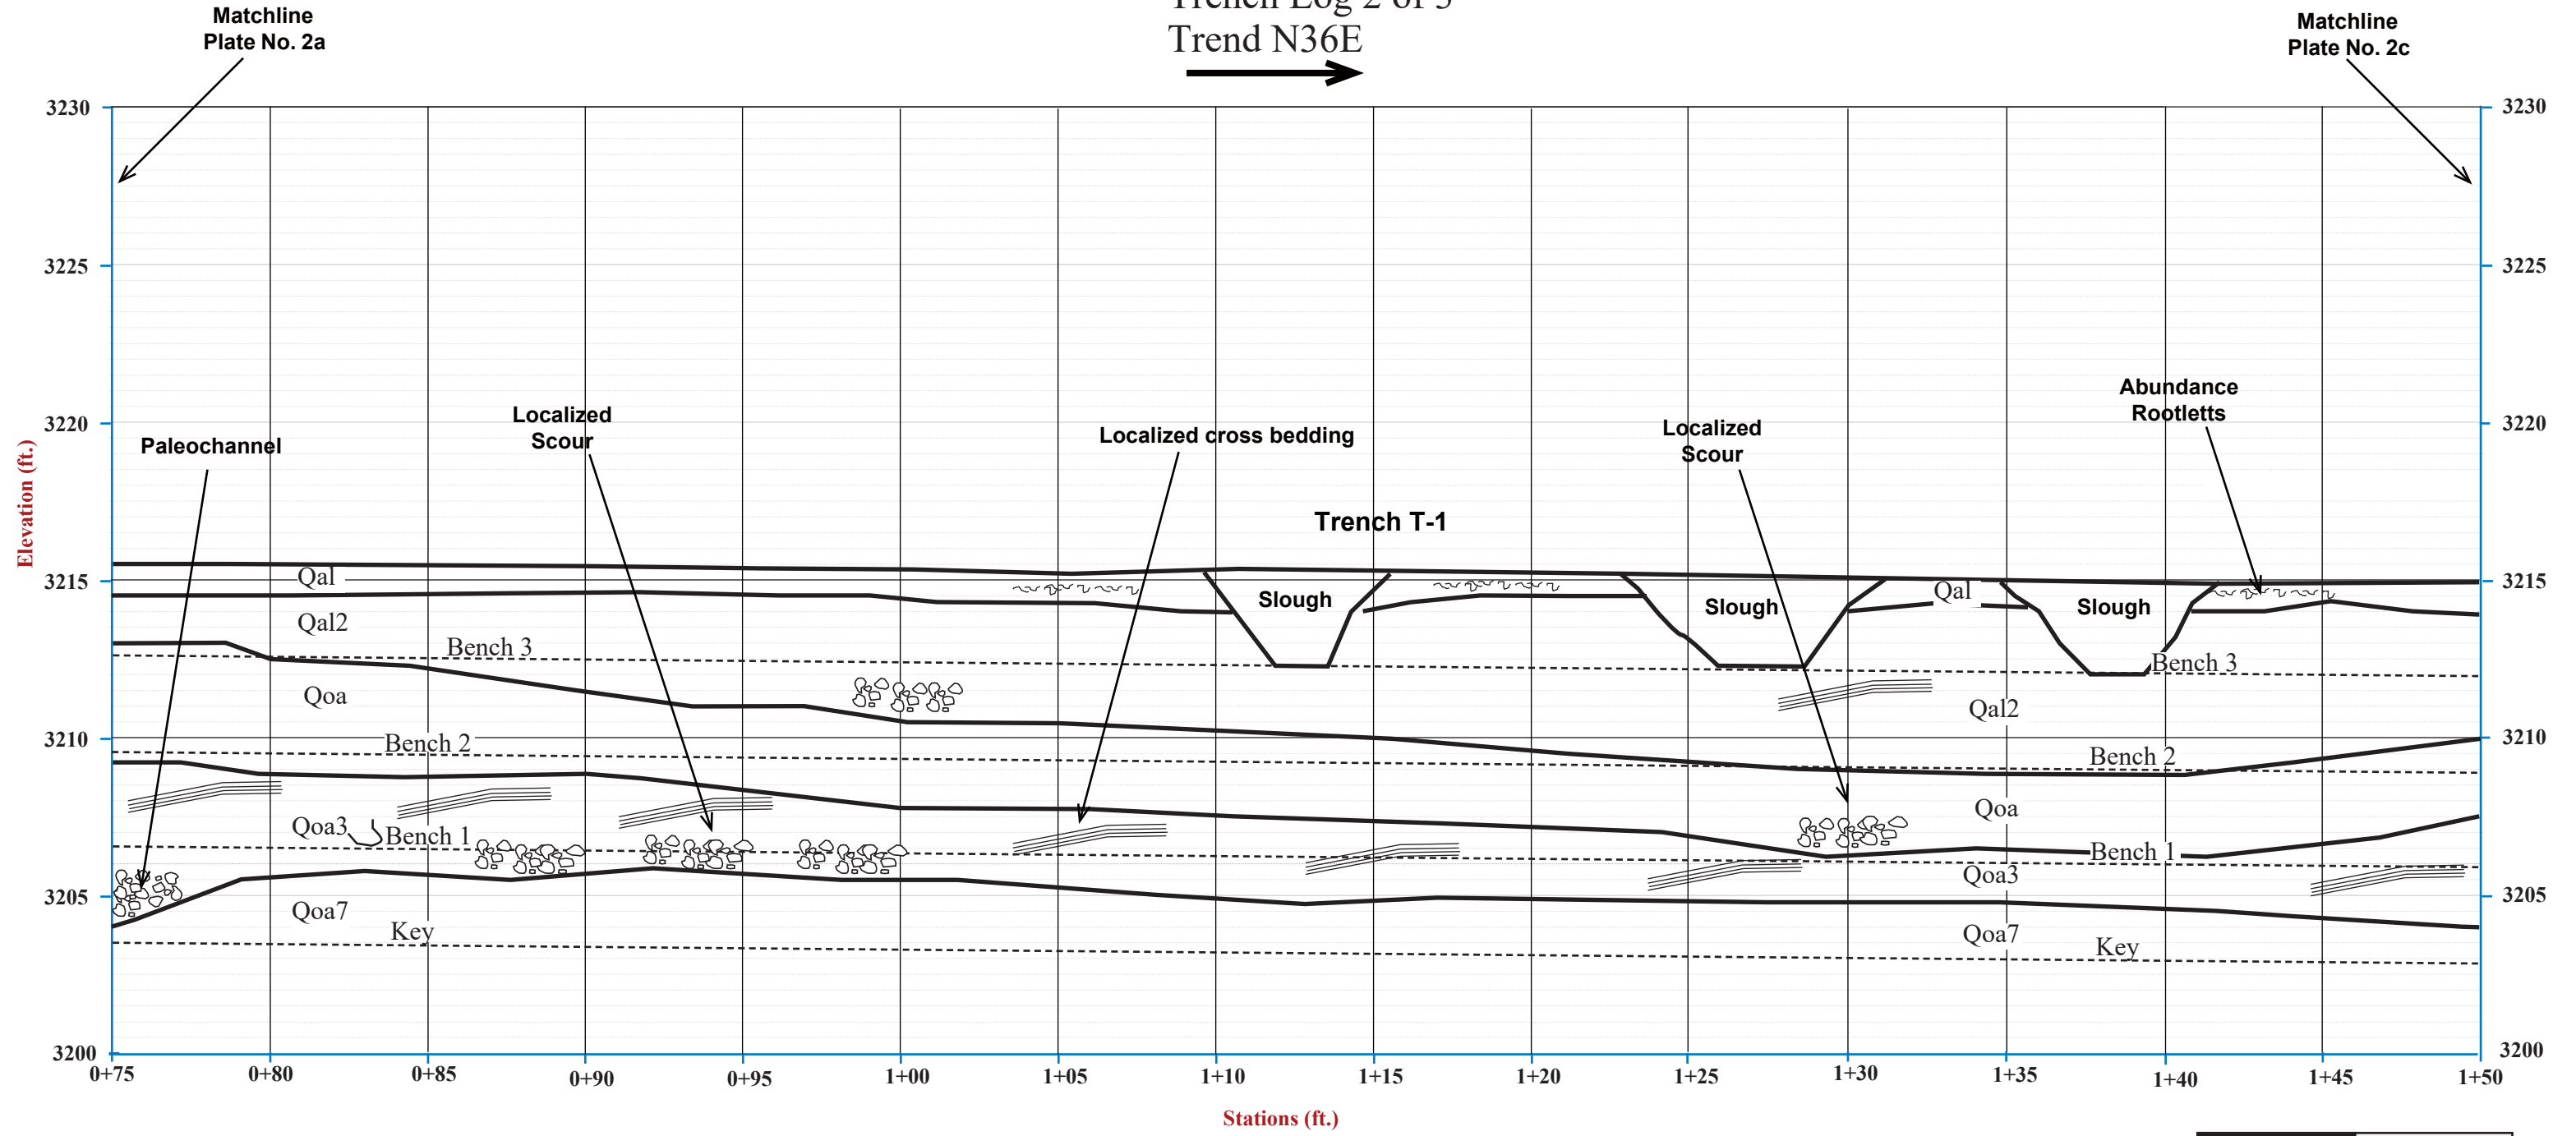
**Plate No.**  
2b

Trench Log 2 of 3  
Trend N36E

—	Approximate Soil Stratigraphy Contacts	Qal	Young Alluvium	Qoa3	Old Alluvium Unit 3
- - -	Trench Benching	Qal2	Young Alluvium Unit 2	Qoa7	Old Alluvium Unit 7
		Qoa	Old Alluvium

‘Trench Log 2 of 3’ ..... Plate No. 2b

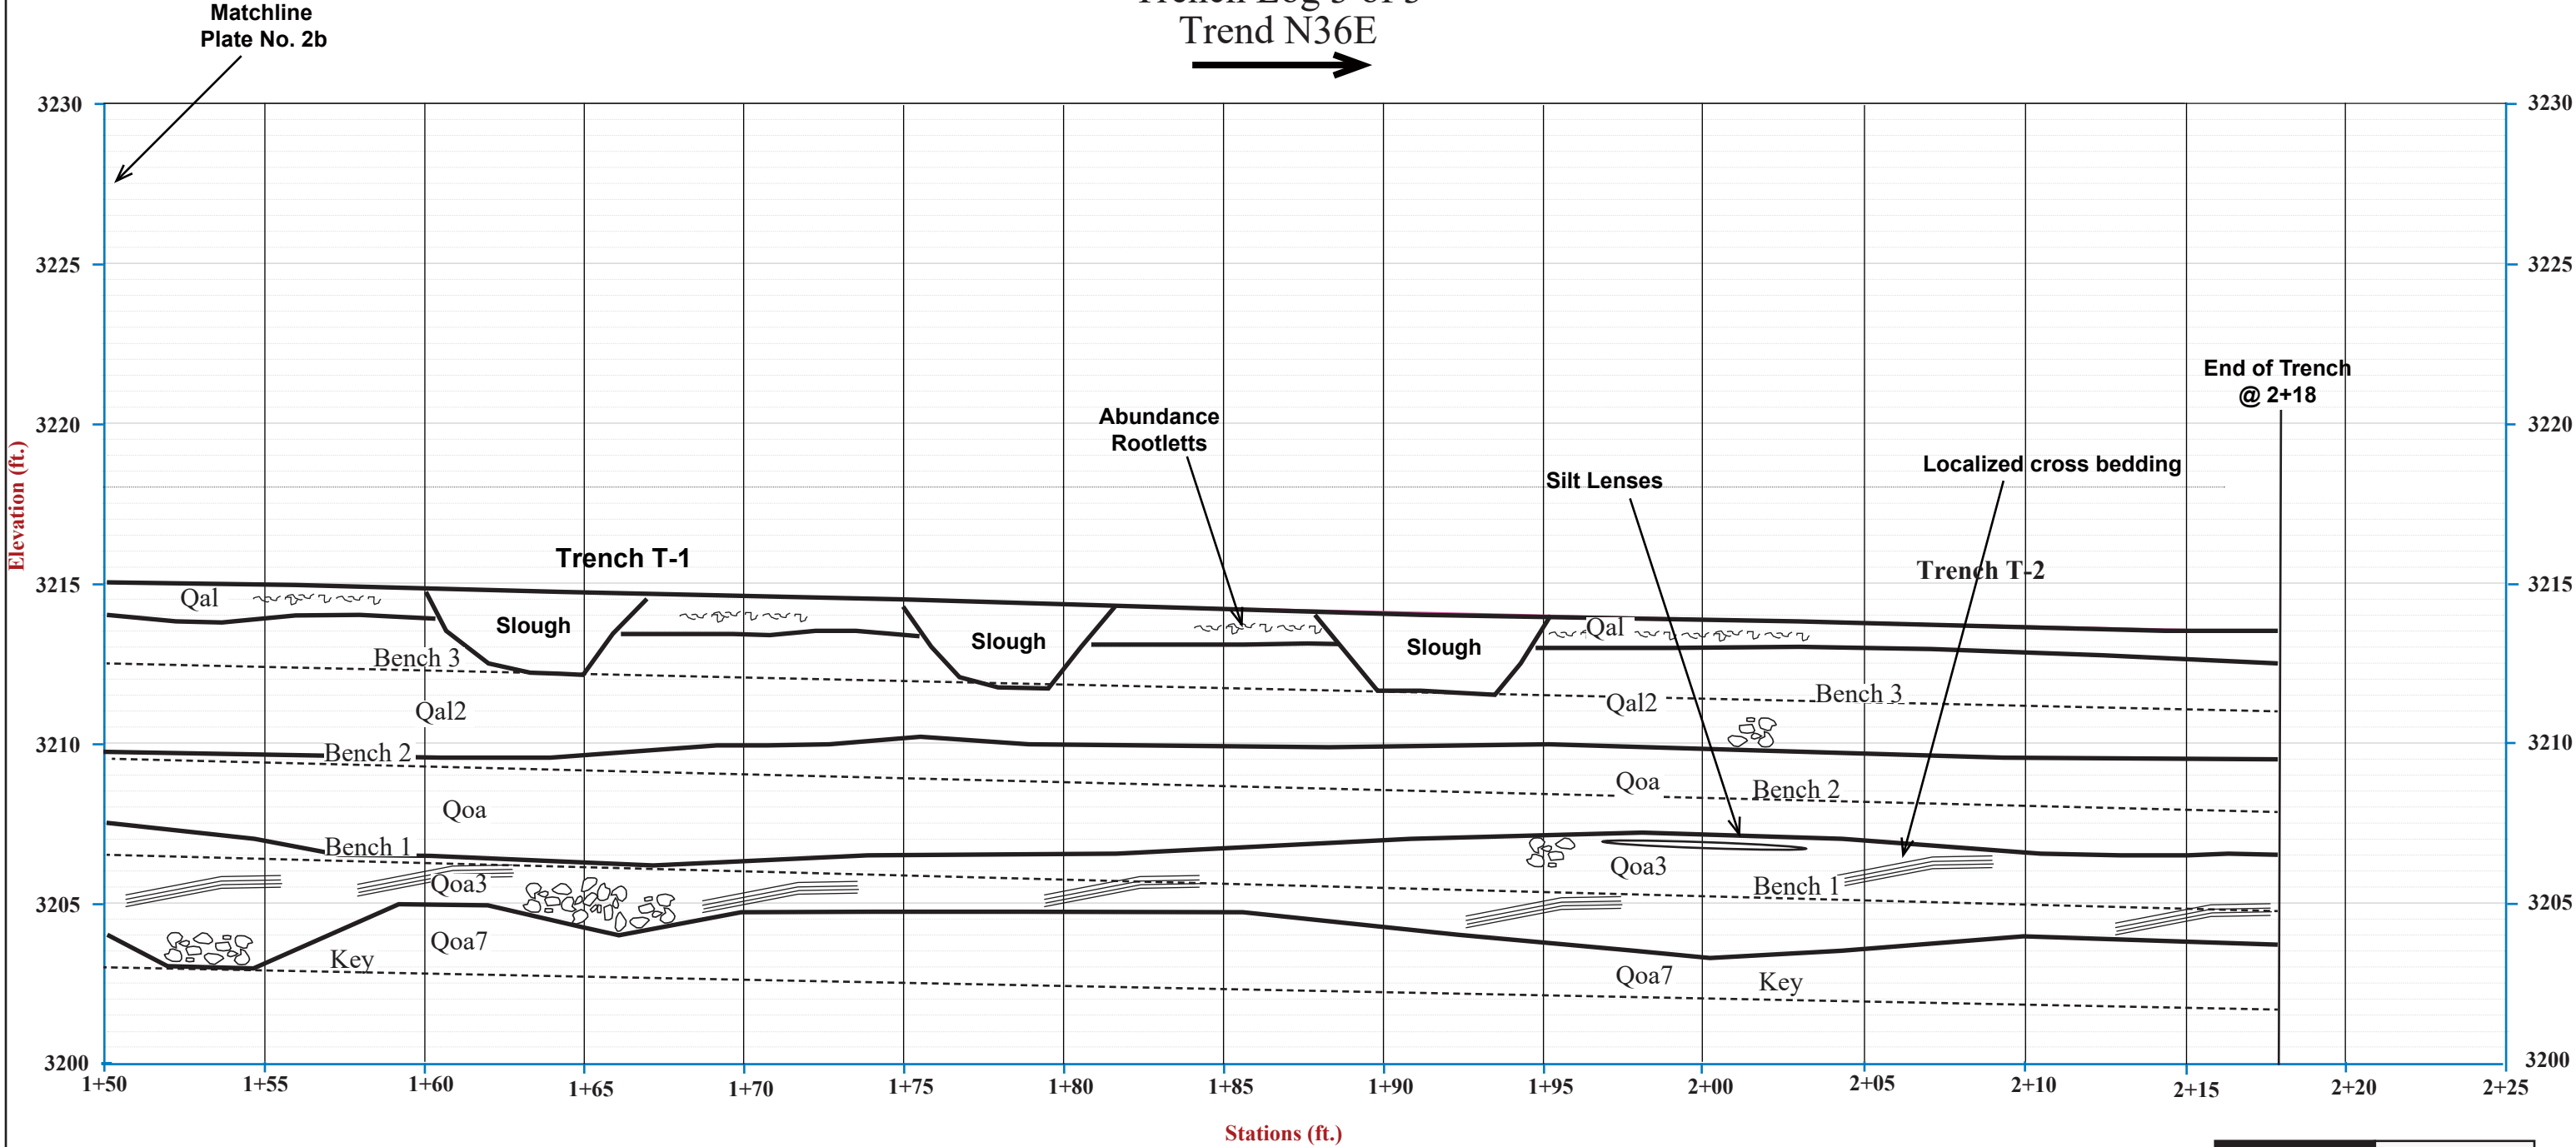
Trench Log 3 of 3  
Trend N36E

End of Trench  
@ 2+18

‘Trench Log 3 of 3’ ..... Plate No. 2c
